Muskrat Falls Project - Exhibit 39 Page 1 of 122

July 2008

MF1260 - Assessment of Existing Pumpwell System

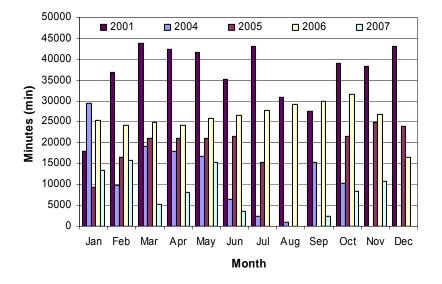
Figure 18 demonstrates the total monthly on-time for pump no.4 for the last four years (2004 to 2007) as well as a randomly chosen year, 2001, for comparison purposes. This figure shows that the data are usually well recorded for the first six months of each year. The pump experienced its most active year of the four in 2006; however, the values are significantly lower than in 2001. The pump P-4 in well W-4 was changed in September 2007, and the recorded values show that there is a significant decrease in the on-time Oct and Nov 2007 when compared with Oct and Nov 2004 to 2006. The relatively high on-time throughout 2006 suggests that the pump was not performing satisfactorily during this year, as the well water inflow to the well could not be evacuated fast enough. As a result, pump on-time data might be a useful tool for the purpose of system maintenance. The decreased on-time values in the recent years in comparison to 2001 suggest that P-4 has become less active which should be considered carefully.

Figure 18 - Monthly on-time for pump no. 4 (P-4)

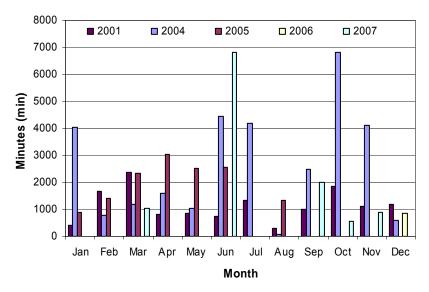
Figure 20 shows the on-time for pump no. 19. This figure suggests that the pump is generally inactive for years after 2005. This pump is located in the northern block where the water table level has significantly increased in the years after 2005.

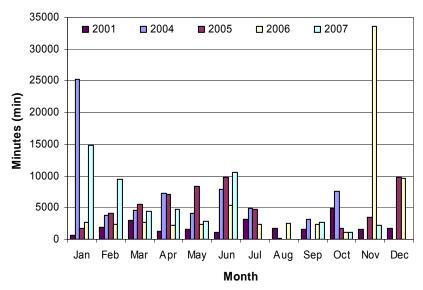
Figure 23 confirms that Block-3 (Northern Block) is generally much less active than the other two blocks. The two monthly on-time values, Jan 2004 and Nov 2006, are significantly higher than the other years. This might be the result of inconsistent recordings of some on-time activities.

Figure 23 - Total monthly on-time for Block-3 (Northern Block)

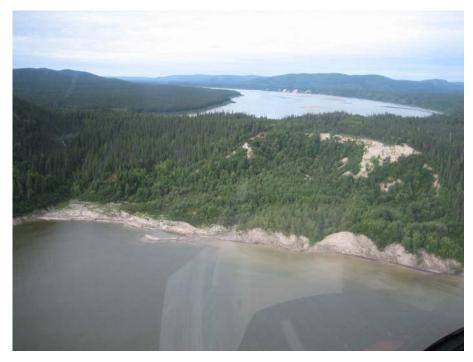
Downstream slope (Site Visit -1)

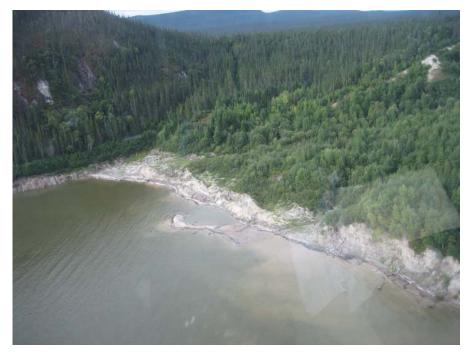
Downstream slope (Site Visit -1)

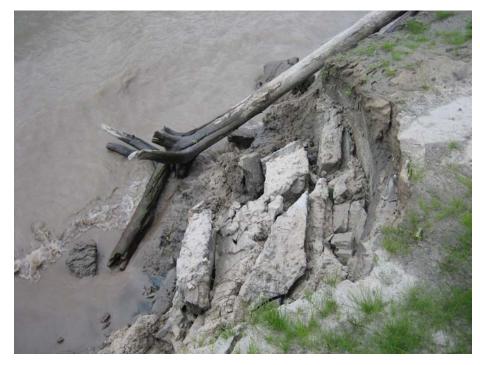
- Ongoing erosion and sloughing and active springs exist at the downstream toe of the spur.
- The upstream toe was also inspected and no significant erosion was observed.
- Access to the discharge point of the well system was difficult as the area was very overgrown.

Erosion at downstream slope toe (Site Visit -1)

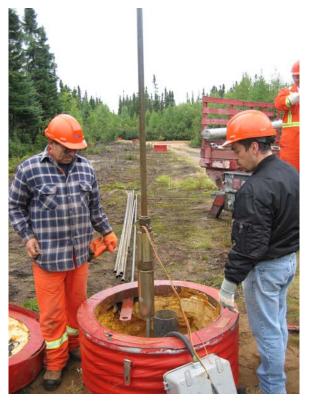
- During the site visit, the existing pump in W-4 was removed and a new pump was installed by Hydro. The replacement started about 10 am (September 11) and the system returned back to operation around 1 pm.
- Silt and fine sand were produced from W4 (observed in discharged water, the pump riser, and the pump) which may have intensified after 4 months of operation with a weaker pump (0.5 hp pump instead of 1.5 hp).
- The discharge from W4 has been reduced significantly as a result of a weaker pump.
- Silt and fine sand were also produced in Wells 9 and 10.

Pull-out of the pump in W4 (Site Visit -1)

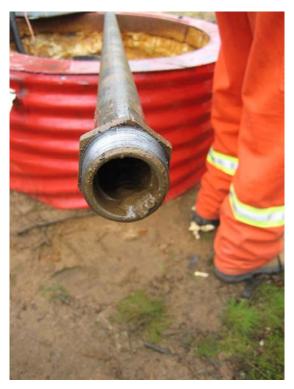
Silt and fines in W4 riser pipe (Site Visit -1)

- It would be also appropriate to consider the use of a television camera to inspect the screen and confirm its integrity. The use of a down-hole test called a γ - γ Test (Radiation Absorption or Density test) is also recommended to allow the inspection of possible voids behind and within the filter given the volume of fines which have passed through both since 1981 (immediate).

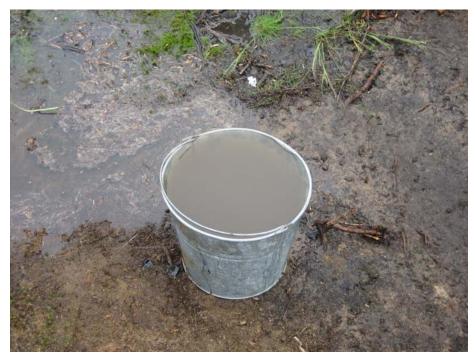
Cloudy water from W4, after pump replacement (2.5 hours of system shutdown) (Site Visit -1)

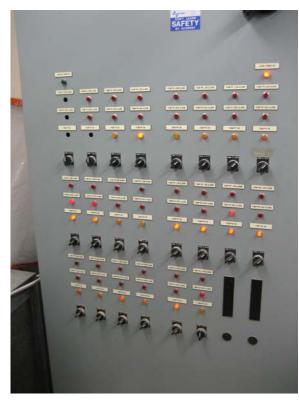
- The telephone operating via the Hawk 2 VHF radio had heavy static and was unable to transmit a call.
- W-10 relay underwent approximately 10 minutes of continuous switching between operating and high level alarms after power returned to the control panel (subsequent to system shutdown during W-4 replacement).

Control panel after system restoration (Site Visit -1)

Hydro should investigate the cause of the troublesome data with a review of all overload relays and sensors. The remote terminal unit should undergo self testing. To ensure the data being collected is meaningful, a computer should be installed at the shelter to collect the data before transmission. This data would then be compared with the transmitted data to determine whether the errors are caused by the monitoring or the radio transmission components of the system. It is understood that the transmission components have been upgraded in recent years, and if it is concluded that they are still at fault, the following options for data transmission should then be explored:

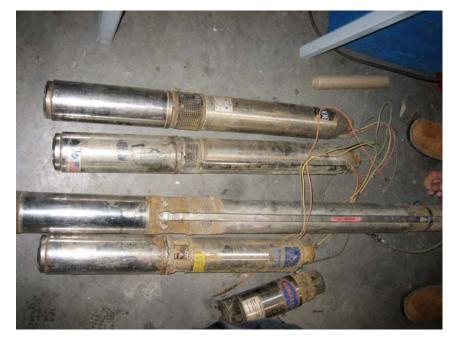
Decommissioned pumps (Site Visit -1)

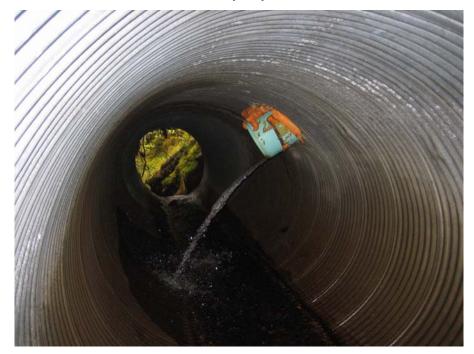
Discharge water from outfall pipe (Site Visit -1)

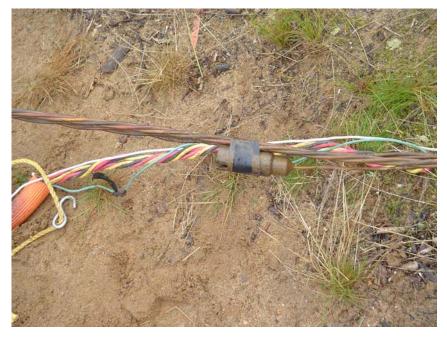
- Multiple pumps are fed from a single power cable. A similar arrangement exists for the control cables.
- Five sensors were identified at W-4 suggesting that a replacement was installed and the broken sensor was not removed.
- Electrical cables were exposed along the outfall pipe. It is assumed these are the heat trace cables at the outfall, as installed during initial construction.
- The pump function in W-3 was not fully understood as the pump operation signal was on prior to the system shutdown (for the replacement of pump in W-4); however, it did not return to pumping after 2.5 hours, when the pumping system returned on.

Level Electrode removed from W4 (Site Visit -1)

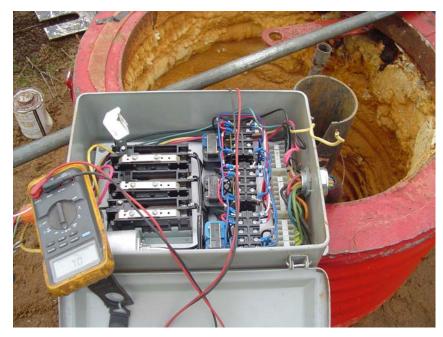
Electrical Junction Box in W4 (Site Visit -1)

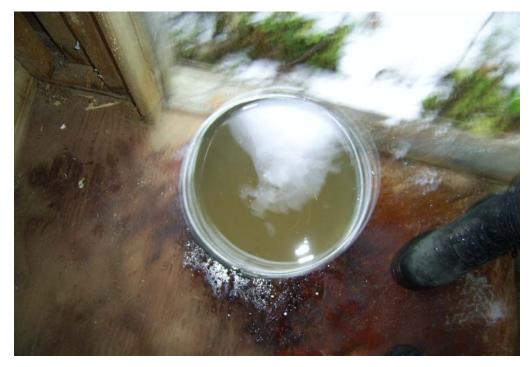
Water quality at outlet - Cloudy with silt and twigs (Site Visit -2)
