1 Q. Provide a document that clearly outlines the retirement costs to take Holyrood out
2 of service 2017 (or beyond)? What is the cost to convert unit(s) to synchronous
3 condenser operation? Are these costs factored into the CPW analysis?
4

1 Q. With respect to Exhibit 19 (Muskrat Falls), has there been any detailed analysis
2 carried out relating to the clay spur and the effectiveness of the sump pump system
3 under impounded conditions (tests, simulations, experience of other dam
4 operators)? Please provide supporting documentation.

The purpose of this WTO was to determine the suitability of the pumpwell system installed in the north spur at the Muskrat Falls site with a view to a life extension of ten years. The review included an on-site inspection of the system to determine the present physical condition and operational characteristics.

CLIENT  		PRIME CONSULTANT  	
PROJECT TITLE LOWER CHURCHILL HYDROELECTRIC PROJECT ENGINEERING STUDIES		WTO NUMBER & TITLE MF-1260 CONDITION ASSESSMENT OF EXISTING EQUIPMENT	DRAWING TITLE SPUR LOCATION RELATIVE TO HAPPY VALLEY-GOOSE BAY
DATE: NOVEMBER 2007		PROJECT No. H325967	DRAWING No. FIGURE 1

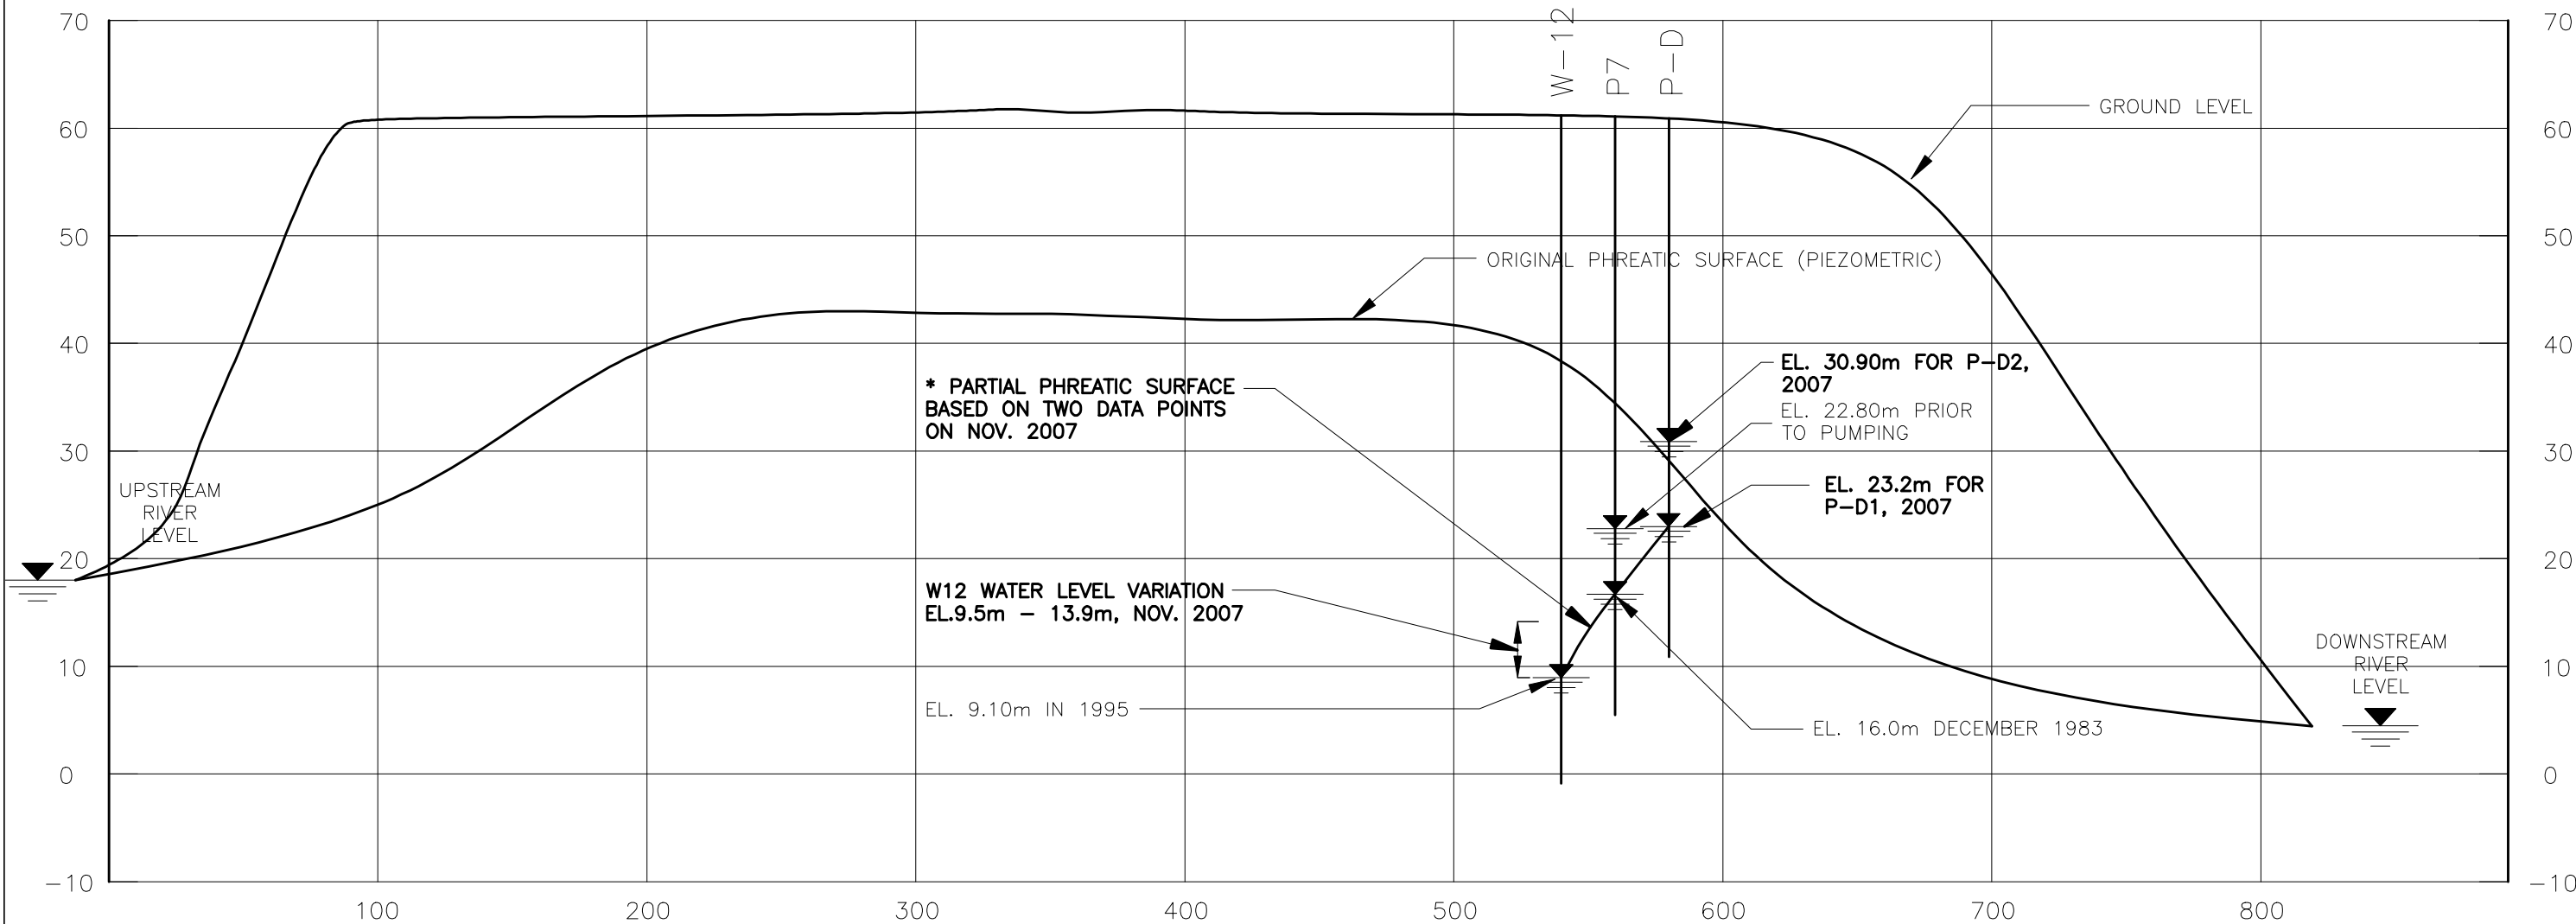
SECTION C1-C1

- NOTE:
 1. DRAWING THE CURRENT PHREATIC SURFACE IS NOT PRACTICAL WITH ONLY TWO DATA POINTS.
 2. ELEVATION IN P-D IS SIGNIFICANTLY HIGH.

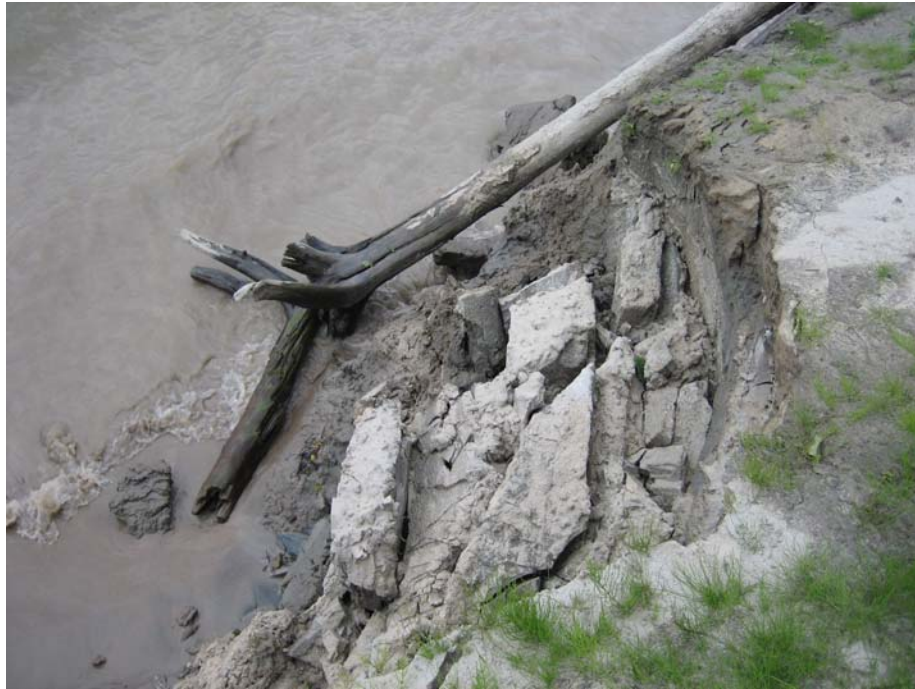
Erosion at downstream slope toe (Site Visit -1)

- Re-bury the exposed portion of the outfall pipe and re-grade the slope to prevent further erosion;
- Replace and/or repair the outfall heater.

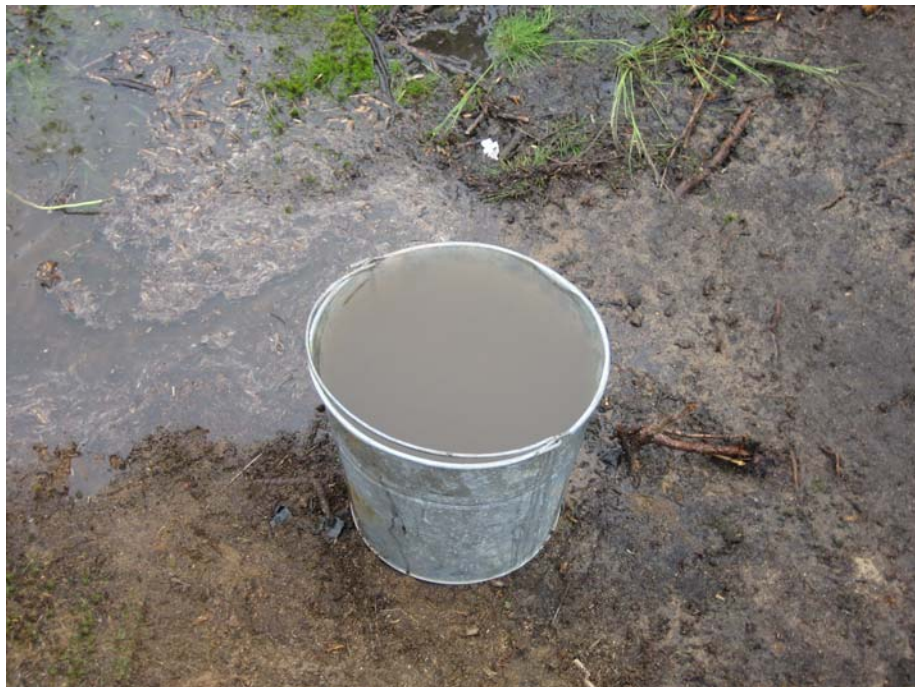
Cloudy water from W4, after pump replacement (2.5 hours of system shutdown) (Site Visit -1)

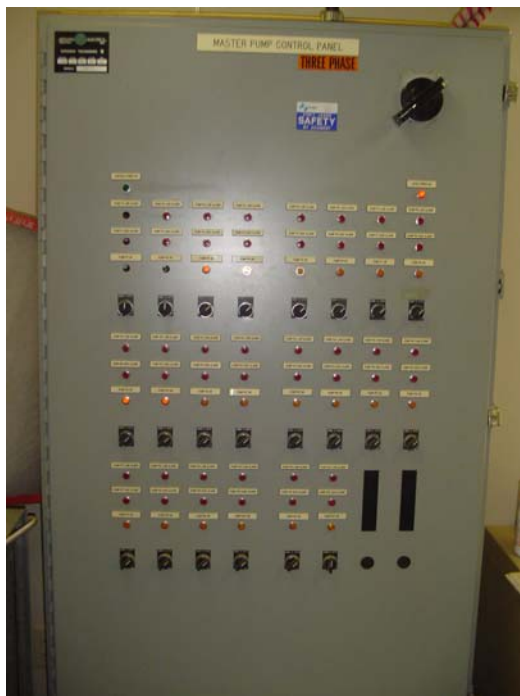
Common pump operation before the replacement of pump at W4 (Site Visit -1)

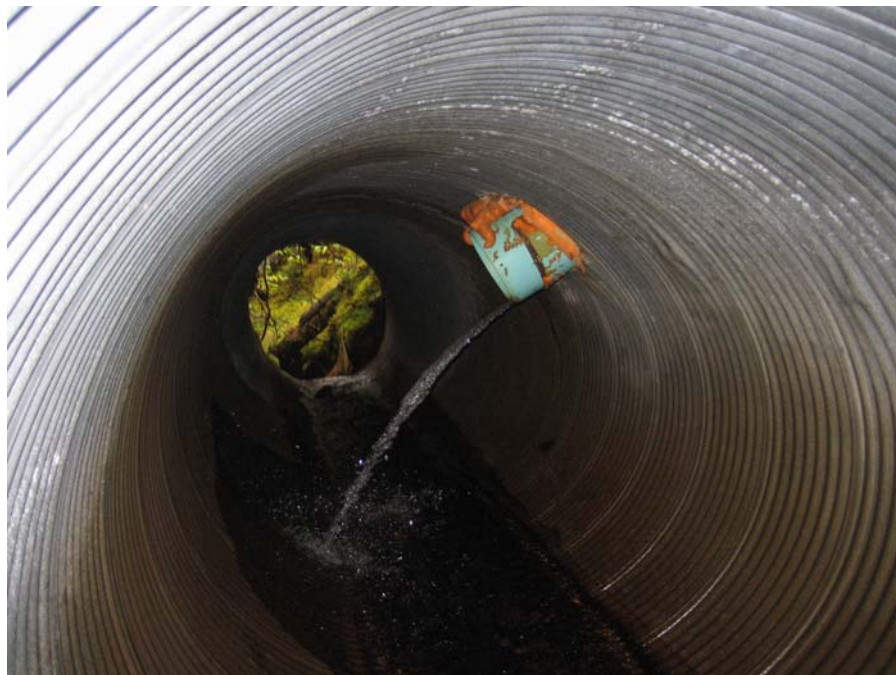
Discharge water from outfall pipe (Site Visit -1)

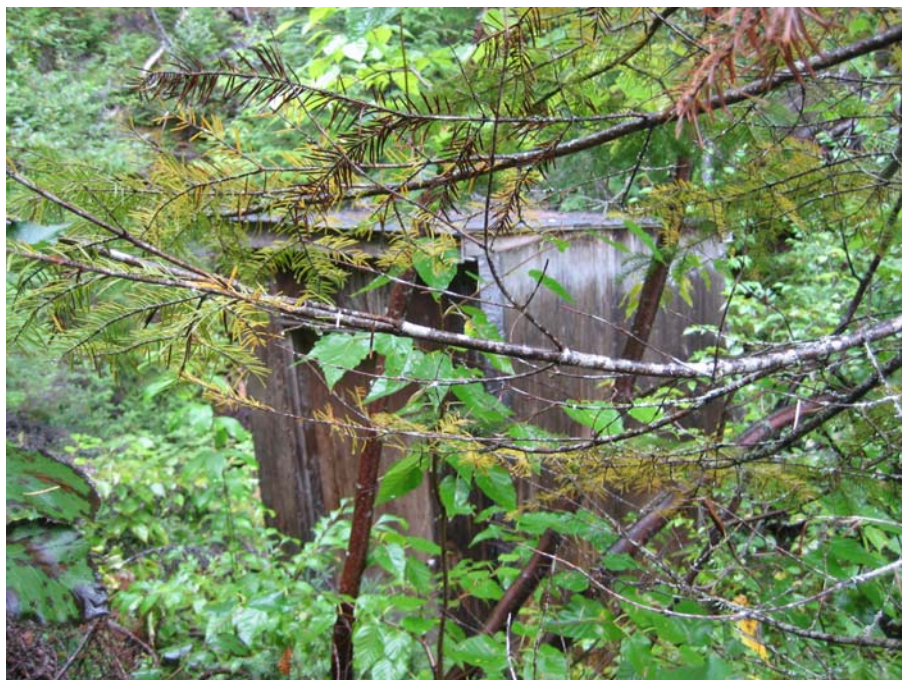
Shelter room at water outfall (Site Visit -1)

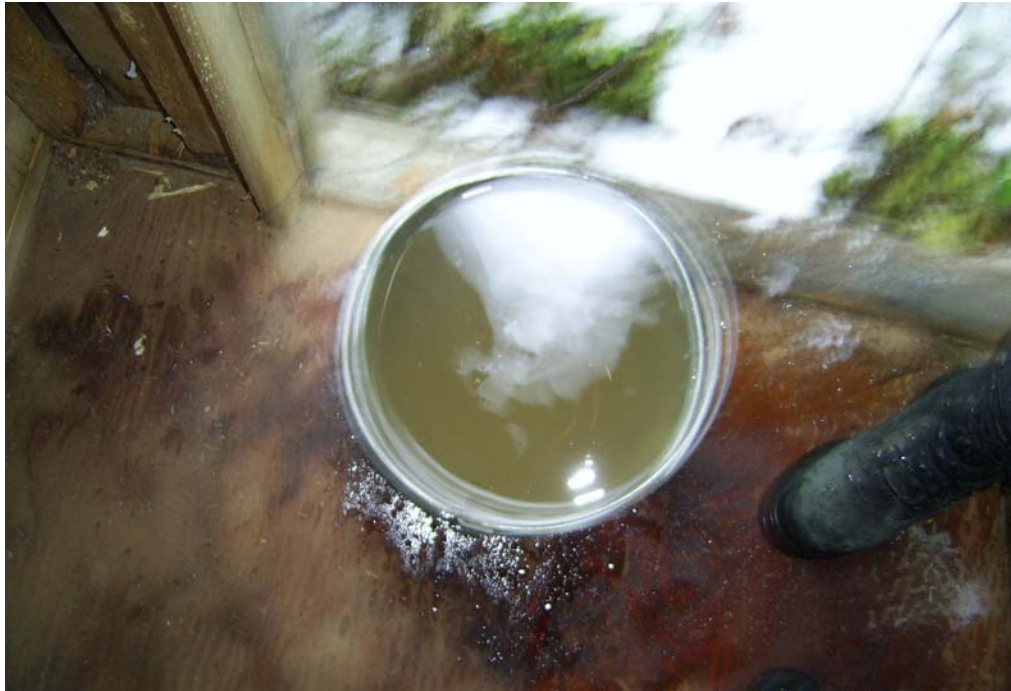
Water quality at outlet – Cloudy with silt and twigs (Site Visit -2)

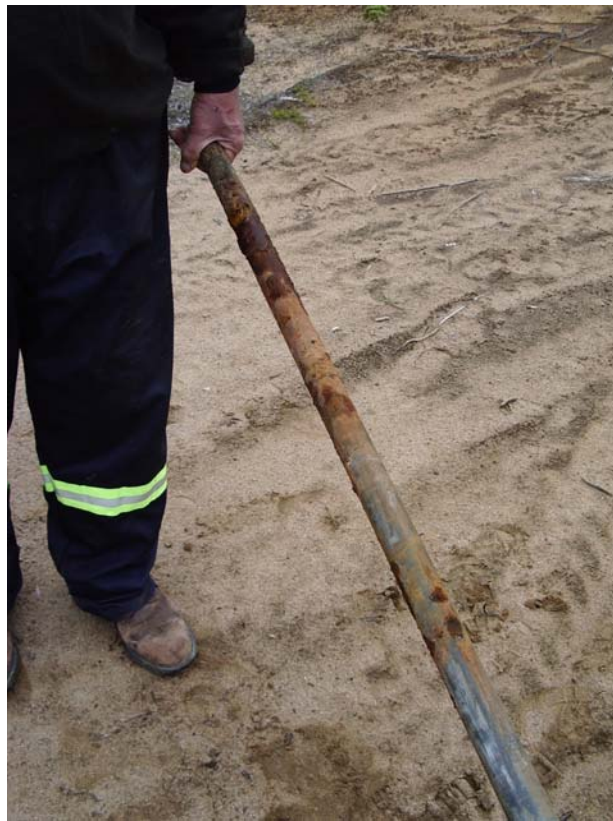
The bottom riser, just above the pump, of most of the wells was covered in silt, iron and Manganese deposits and in some cases was corroded. The bottom riser was replaced in 11 wells.

Photograph 4: The risers were inspected for corrosion and replaced as required.

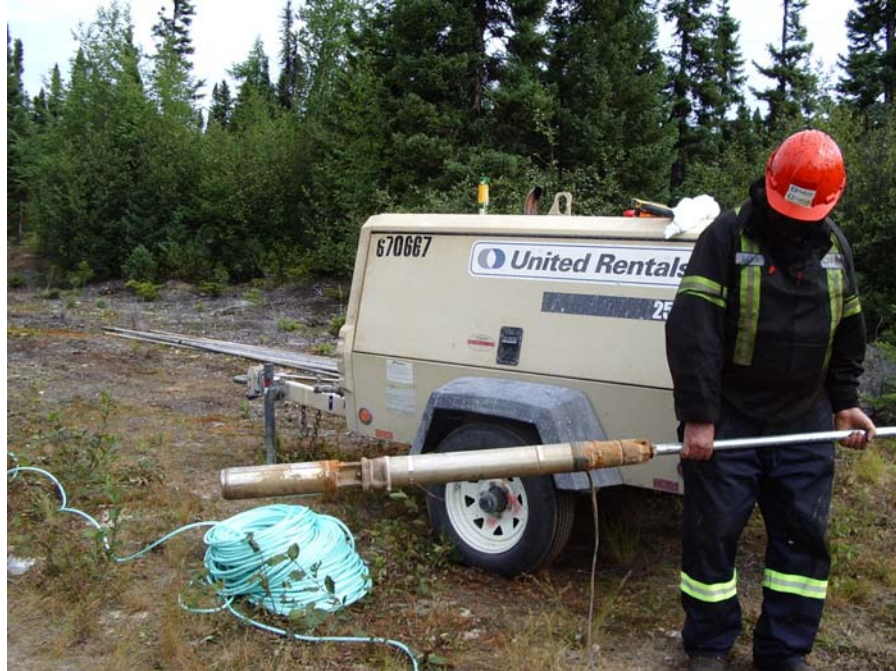
Photograph 5: The pump was inspected, the screen removed and all cleaned.

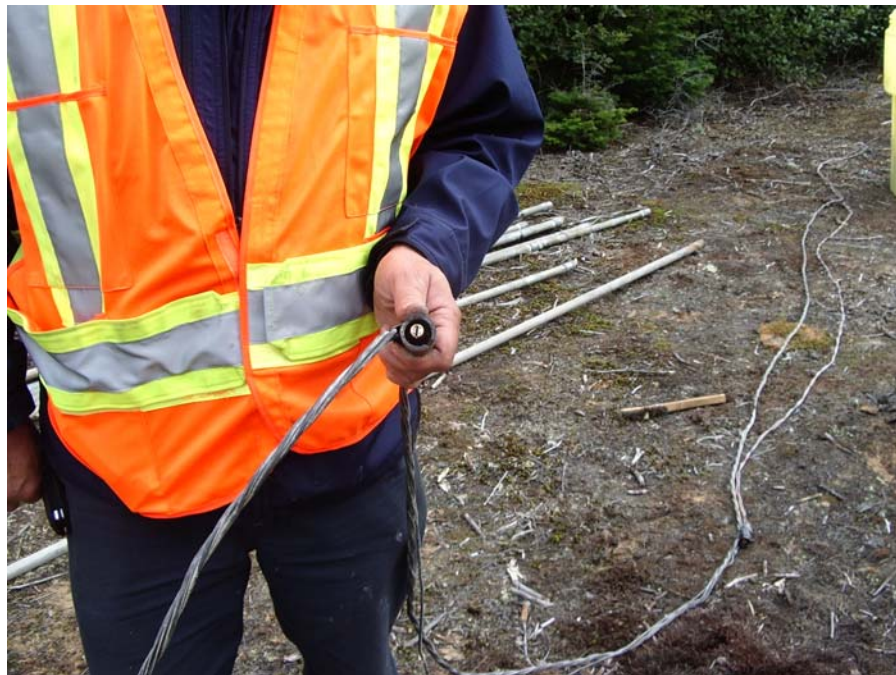
Photograph 6: The four sensors at each well installation were inspected, tested and cleaned. If sensors were in poor condition or malfunctioning, they were replaced.

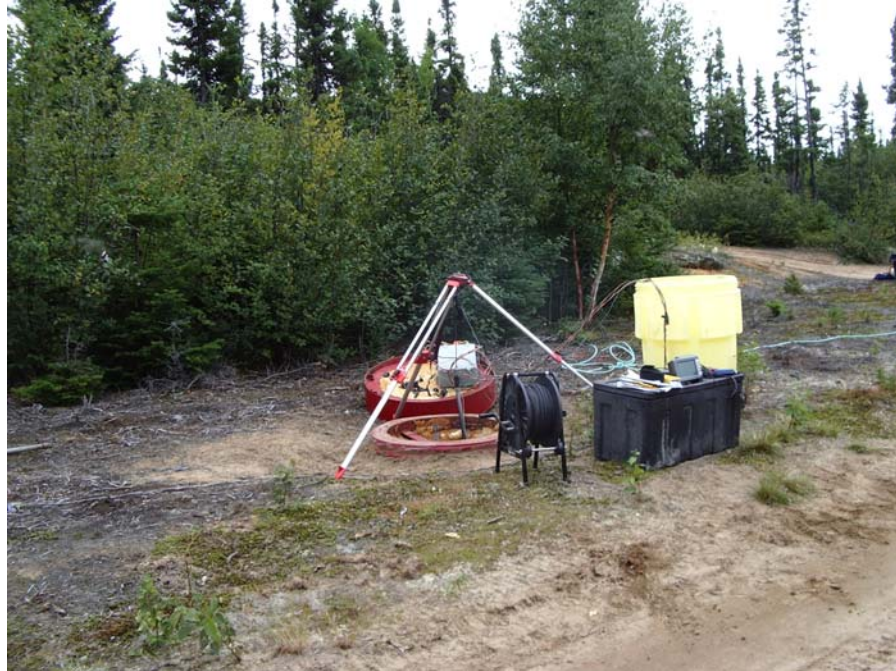
Photograph 7: A downhole camera inspection was completed before and after cleaning and logs made of the observations. The inspections were recorded as digital videos.
