**2010 CAPITAL BUDGET
APPLICATION**

PLANT LIFE EXTENSION UPGRADES

Hardwoods Gas Turbine

June 2009

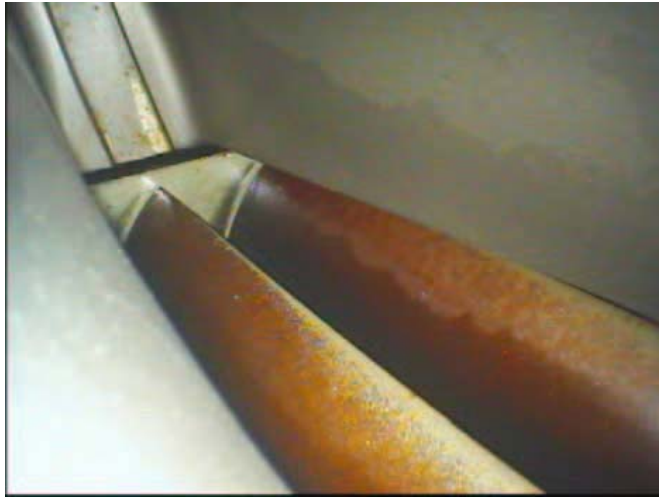
Figure 3: Corrosion on End B Engine

It is stated in Stantec's Condition Assessment and Life Cycle Cost Analysis report for Hardwoods, that the gas turbine engines and power turbines show signs of operational wear and require remedial work (Appendix A: Executive Summary, page A-2). Further testing is required to determine the condition of the alternator. Auxiliary systems and structures were found to be in generally good condition, however, some refurbishment work is required.

The photo below (Figure 3), taken during an internal inspection on May 30, 2007, shows corrosion due to coating loss inside the End B gas turbine engine at Hardwoods.

- Disassemble End A and End B gas turbine engines. Inspect and refurbish as required.
- Inspect End A and End B power turbines upon removal of gas turbine engines. Perform required repairs.
- Completely disassemble and inspect End A and End B clutches.
- Replace ignition igniters.
- Replace speed governors/fuel valve assemblies.
