**RELIABILITY STUDY
OF TRANSMISSION LINES
ON THE AVALON AND CONNAIGRE PENINSULAS**

REPORT PREPARED BY: Asim Haldar, Ph.D., P. Eng.
Sr. Engineer
Technical Support,
TRO Engineering

DATE: April, 1996

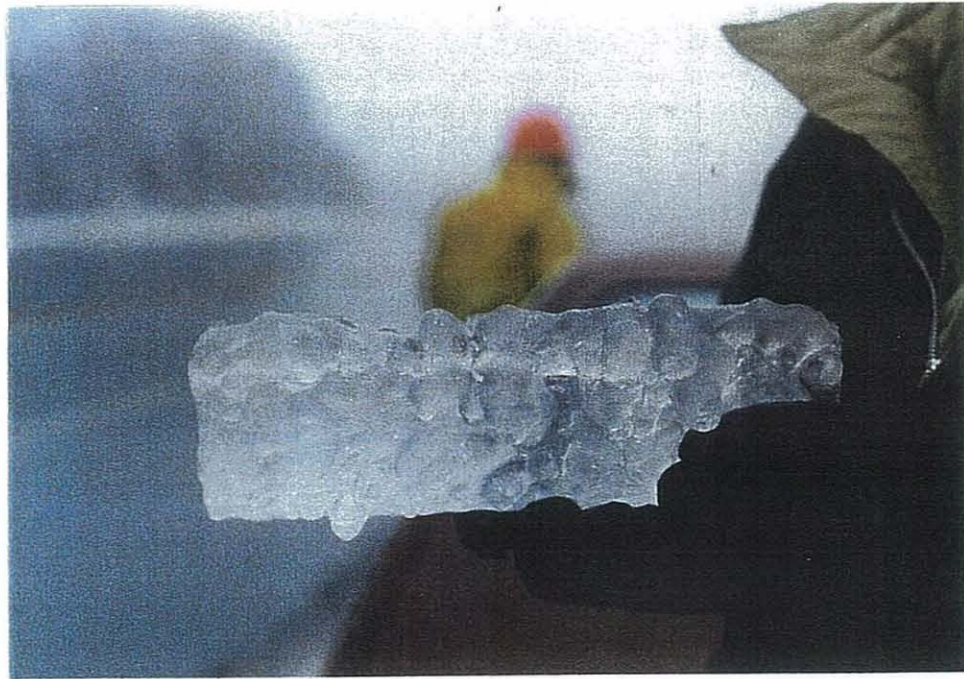
Photo No. 2-1
April 1984
Glaze Ice sample from Conductor-TL-237
(weight 7.8 kg/m)

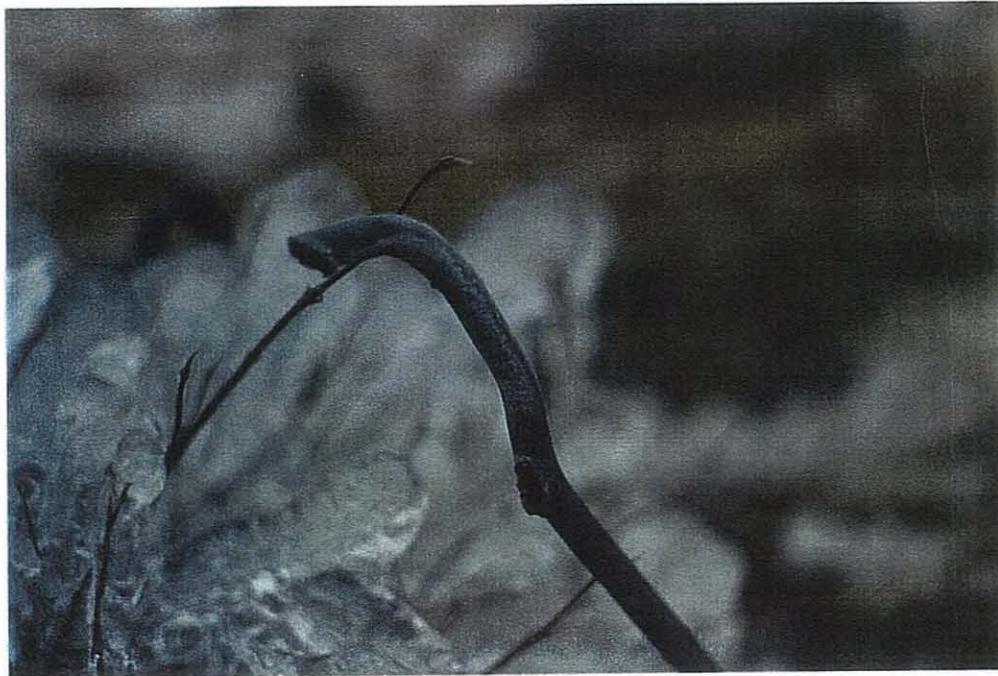
Photo No. 2-2
April 1984
Failed single eye Anchor Rod (TL-217)

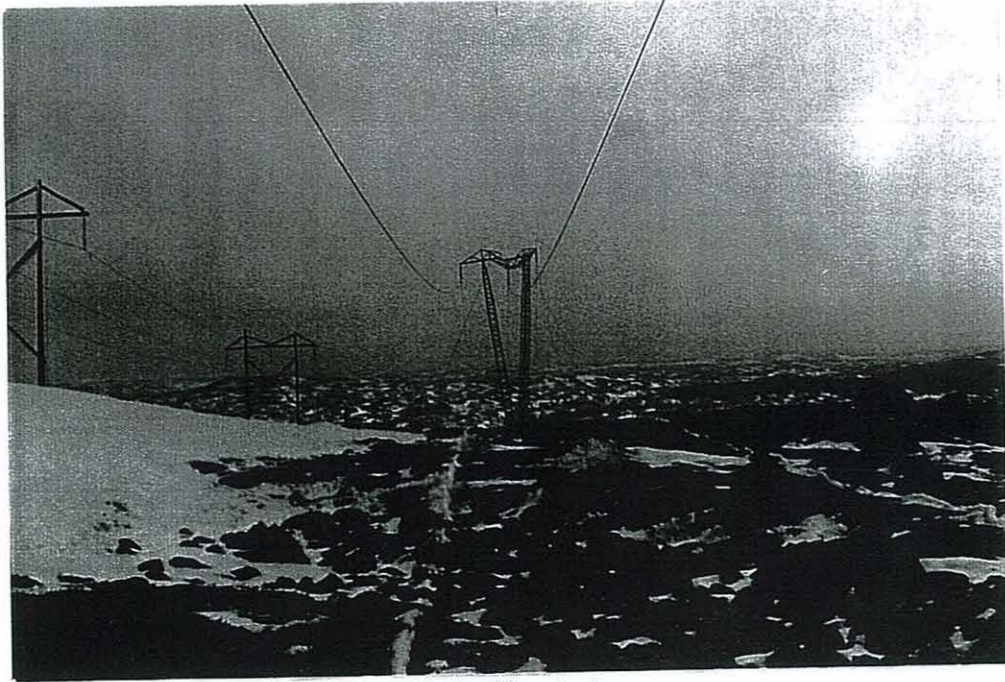
Photo No. 2-3
April 1988
Failure of bridge on Suspension Tower
(TL-217) at Hawke Hill

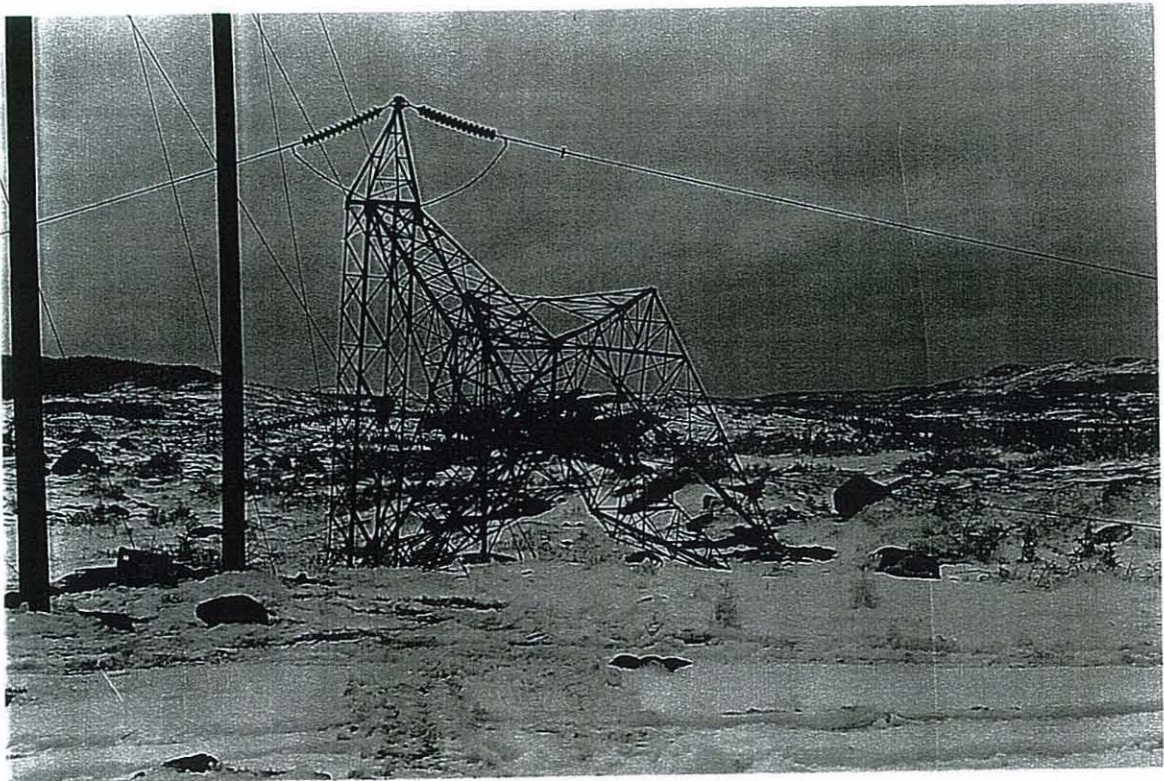
Photo No. 2-4
April 1988
"C" Tower (Heavy Angle) Failure on TL-217

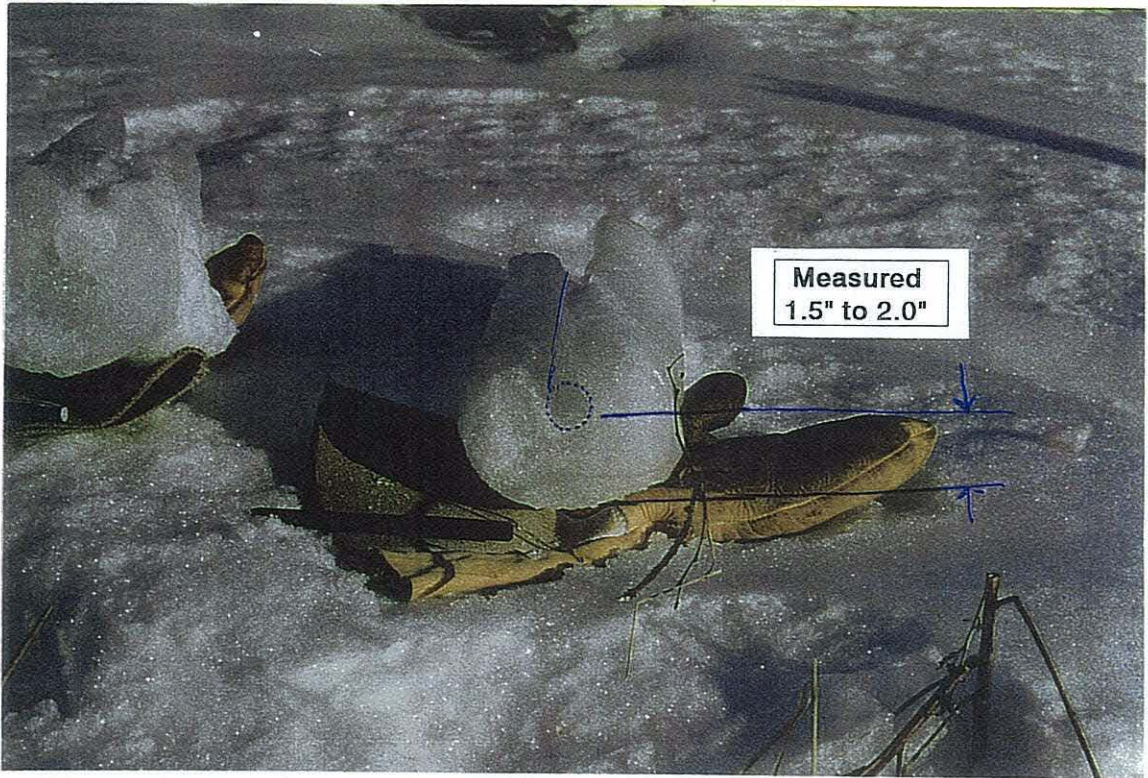
Photo No. 2-5
9 Dec. 1994

Icing observed on TL-201 1.5" to 2.0" (Radial)

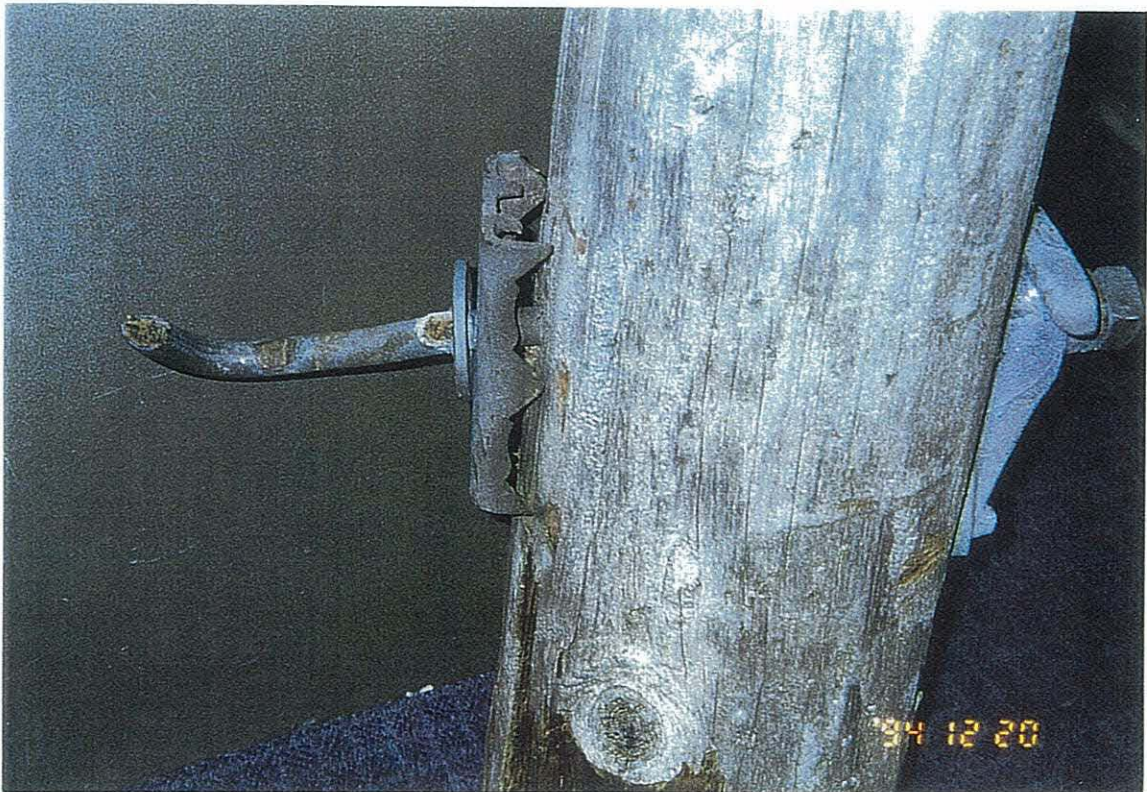
Photo No. 2-6
20 Dec. 1994

7/8" diameter welded Eye Bolt failure on TL-201
