Geotechnical Site Investigation Proposed Island Pond Hydro Electric Development (as prepared by AMEC)

**Geotechnical Site Investigation
Proposed Island Pond Hydro Electric
Development
South Central Newfoundland
Date: January 03, 2007
Final Report
Submitted by:
AMEC Earth & Environmental**

**GEOTECHNICAL INVESTIGATION
PROPOSED ISLAND POND
HYDROELECTRIC DEVELOPMENT
SOUTH CENTRAL NEWFOUNDLAND**

January 2007
TF6316540

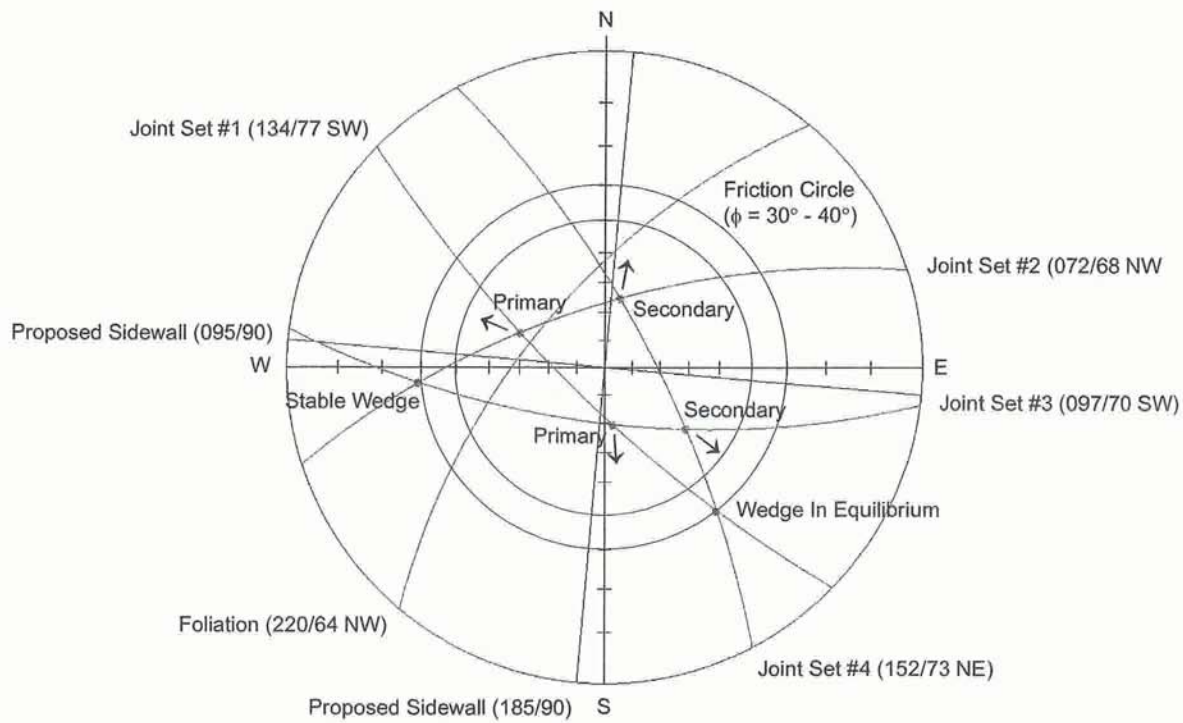
- Unstable Wedges are Shown in Orange and the Direction of Sliding is Indicated by the Arrows
- Wedge in Equilibrium and Stable Wedge
