NEWFOUNDLAND AND LABRADOR HYDRO

REPORT ON

1977/78 WEATHER STUDY

YEAR 1

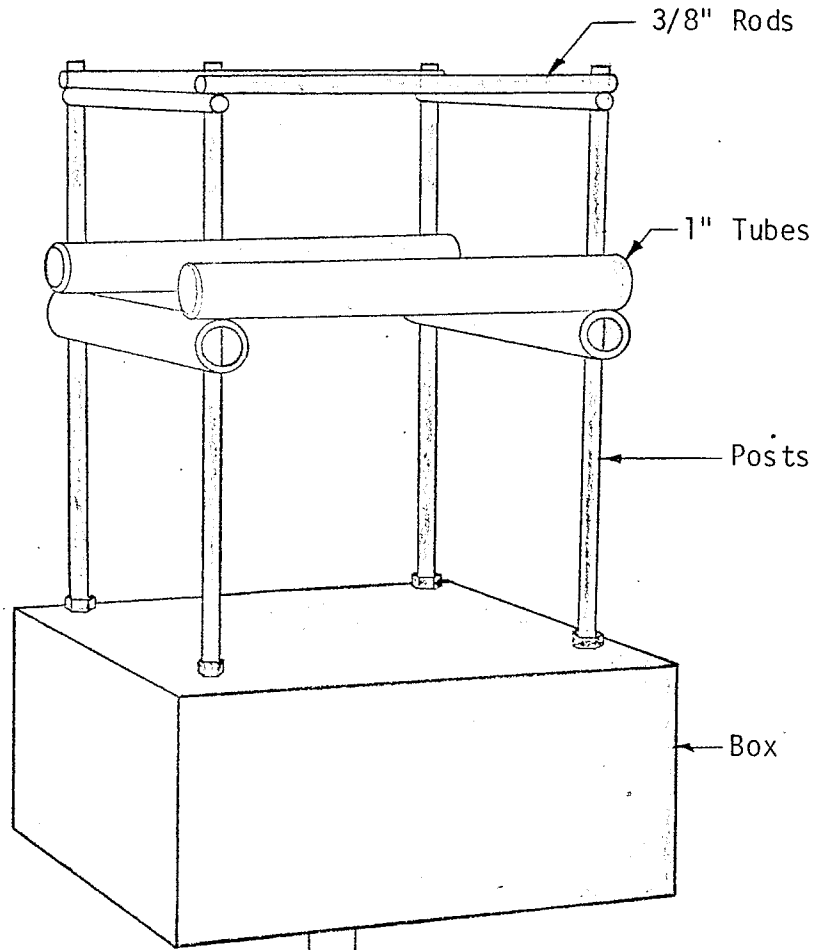
FIGURE 1

At Yankee Point, Sunnyside and St. John's Airport a second PIM has been installed on which the 1" tubes have been replaced by 2" tubes to simulate the proposed HVDC conductor diameter.

PASSIVE ICE METER

The Passive Ice Meters (PIM), Figure I, were installed at 30 locations throughout Newfoundland and Labrador during the summer of 1977. See Appendix I for list of sites.

The meters consisting of a system of rods and flat surfaces, placed in both horizontal and vertical planes, are designed as a medium to measure ice accretion. The rods simulate ice accretion on conductors and the flat surfaces simulate ice accretion on tower surfaces.

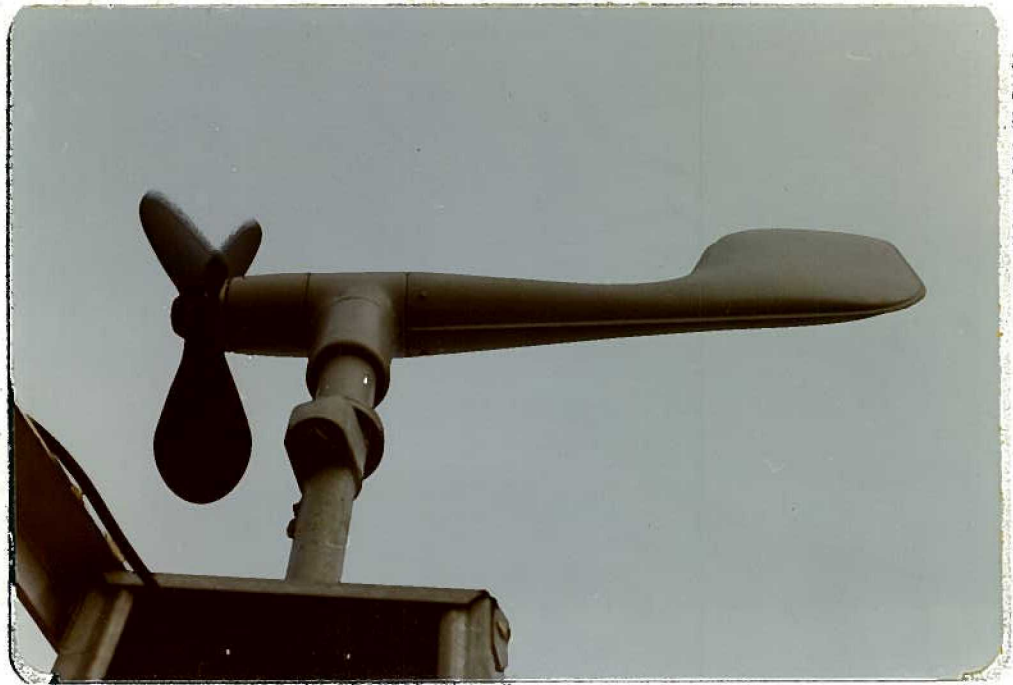
Photo I - Anemometer

Anemometer and analog recorders, Photo I and II, were installed at Yankee Point, Sunnyside and Four Mile Pond - Holyrood. These units operate on a year round basis.

The wind driven DC magneto generates an output voltage directly proportional to wind speed, which is inputted to a 2 channel recorder which records an analog trace on a paper chart. Simultaneously, a direction trace is obtained and recorded from a direction vane through a set of synchros.

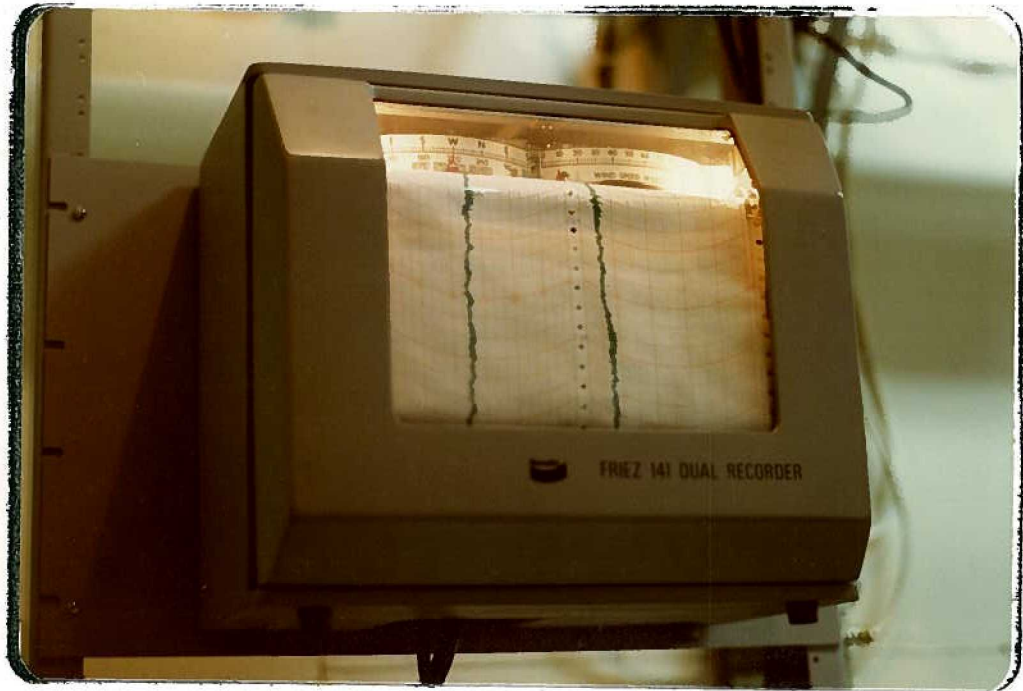
Photo II - Anemometer Recorder

From the chart paper the data is abstracted and summarized as instructed in the "Manual of Standards for Abstracting and Recording Wind Data". See Appendix IX. The summarized data is shown in Appendix III.

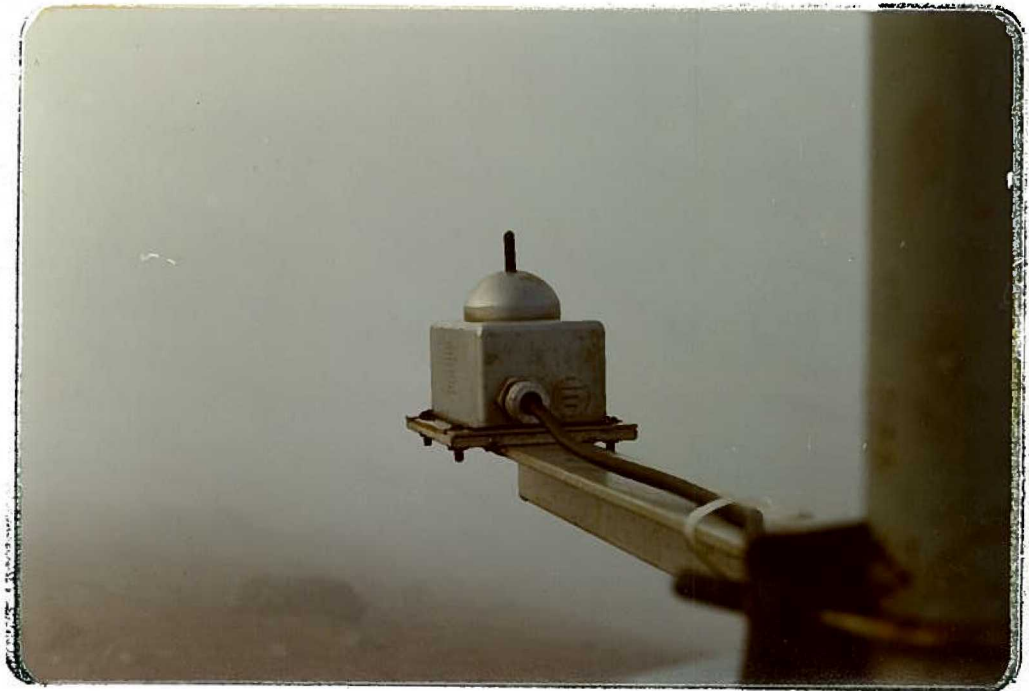
Photo III - Rosemount Ice Detector

The Rosemount Ice Detectors were installed in conjunction with the anemometers at the above-mentioned sites. See Photo III and IV. This equipment operated on a continuing basis between December 1977 to May 15, 1978.

The Detector works on the principle of magnetostriction where ice accretion on the sensor changes the natural frequency of vibration of the probe and thereby produces an ice-warning signal. The signal, in turn, activates a built-in heater which de-ices the detector and prepares it for the detection of additional ice. The icing signals, which are recorded on a paper chart, give an indication of the duration of the icing storm and the amount of accumulation.

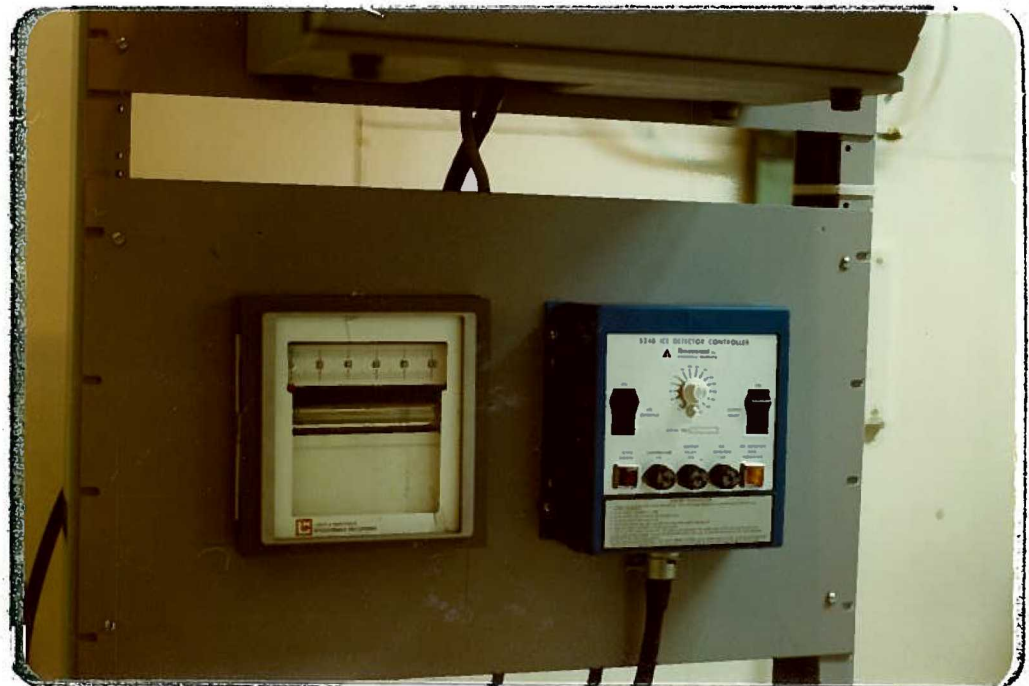
Photo IV - Rosemount - Controller and Recorder

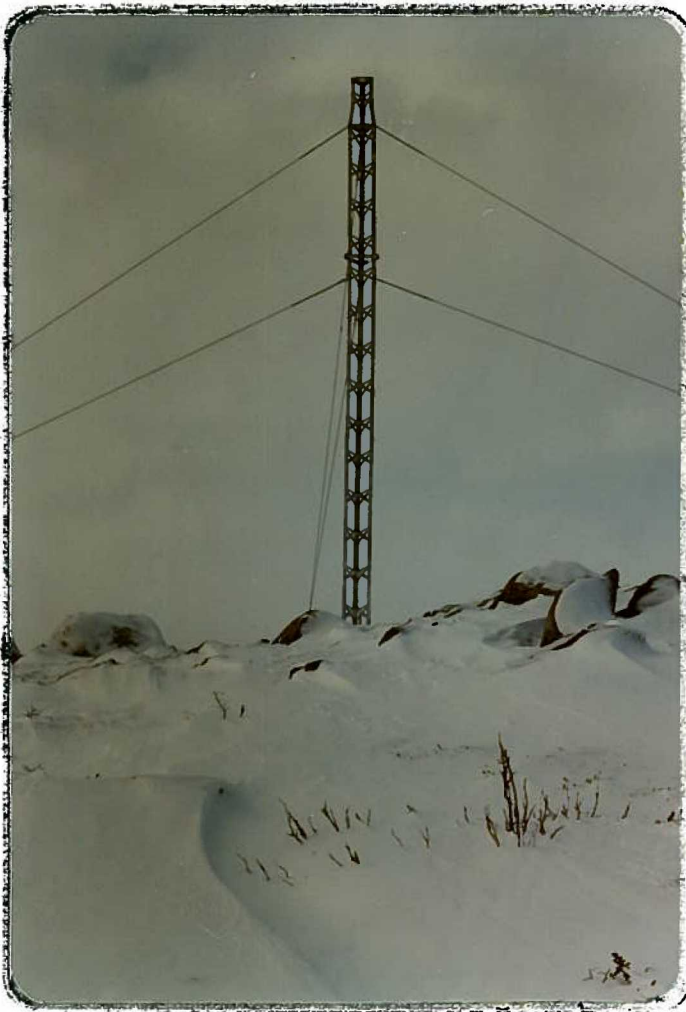
Photo V - New Test Site

The Test Tower Sites, Photo V and VI, consisting of 30-foot guyed masts, are at a total of ten locations along the original and alternative routes of the HVDC line associated with the Gull Island Project. The towers do not have any instrumentation and are passive in nature. See Appendix V for locations.

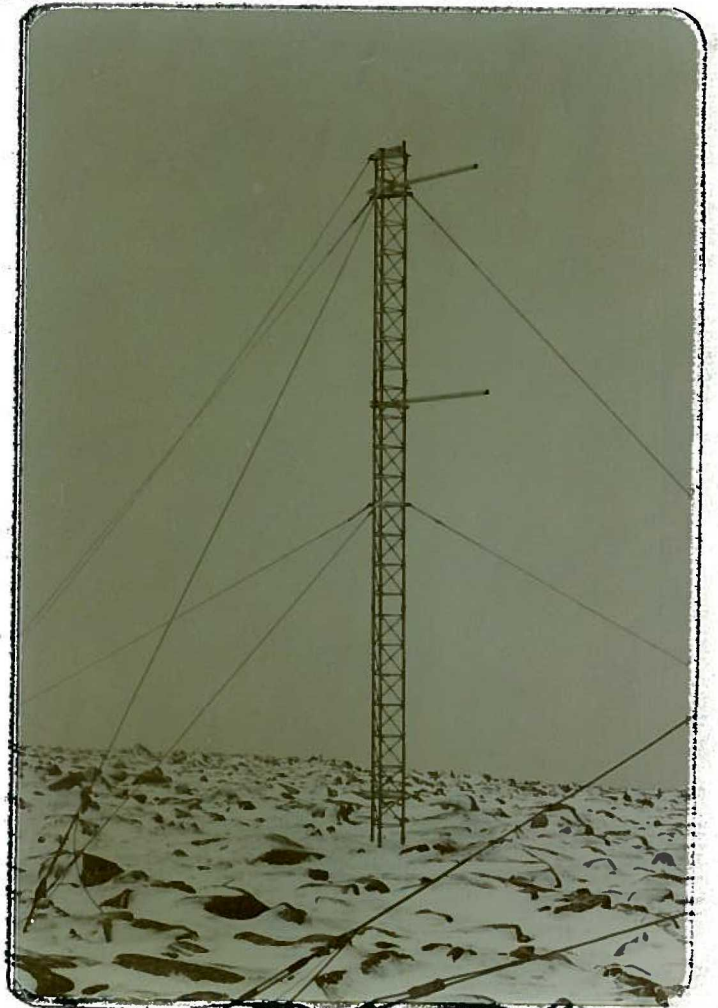
Photo VI - Original - Modified Test Site

Two of the sites were modified, #2 and #4, by attaching 2-inch aluminum rods to the 20-foot and 30-foot levels of the towers. These rods were installed in N-S and E-W directions so that the effects of prevailing winds on ice accretion might be noted and to simulate the 2" conductor envisaged for the DC line.

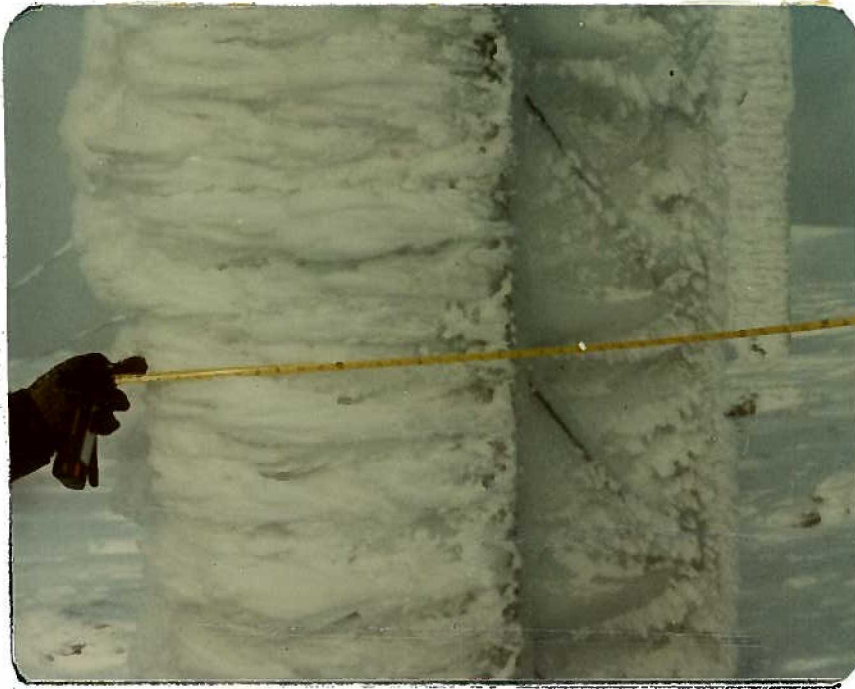
Photo VII Site #2. Portland Creek - December 1976

During the winter of 1976/77 ice accumulations at the four (4) initial sites (#1, #2, #3 and #4) was phenomenal. . . . At Site #2 - Portland Creek Head, in December 1976, accumulations of 14" were noted on the 1/4" guy wire with 3' to 4' on the 18" mast. (Photo VII ) At Site #4 - Labrador coast, in February 1977, accumulations of 13" of glaze were noted on the 1/4" guy wire with 28" to 36" of glaze on the 18" mast. (Photo VIII).

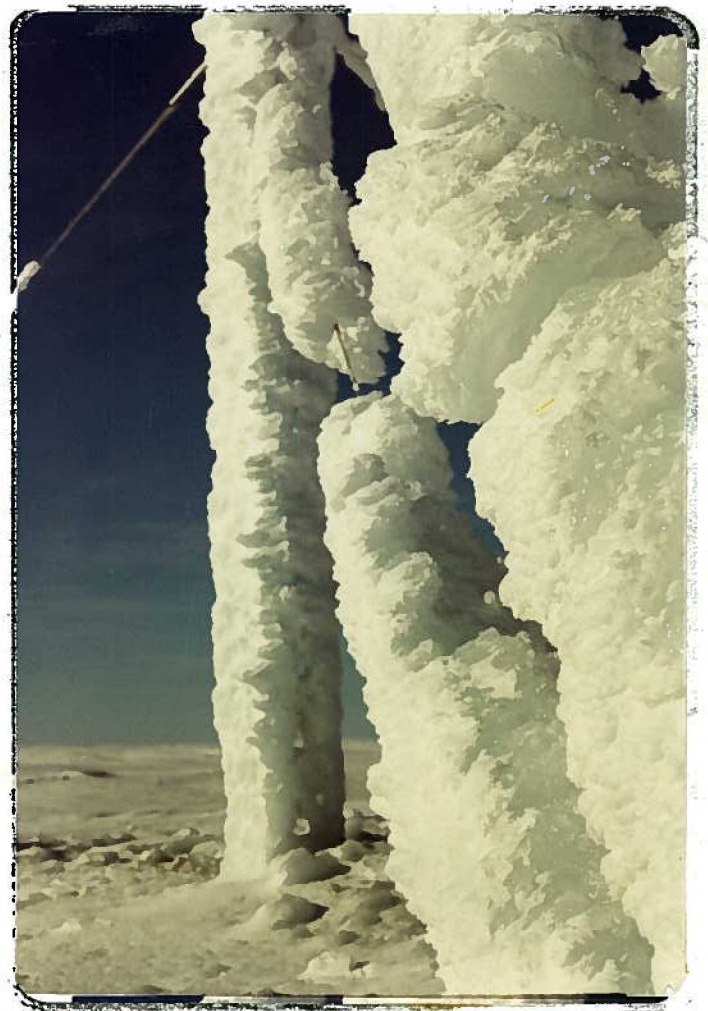
Photo VIII - Site #4.

Labrador - February 1977
