NEWFOUNDLAND AND LABRADOR HYDRO
REPORT ON
1978/79 CLIMATOLOGICAL MONITORING
PROGRAM

YEAR 2

PREPARED BY: Newfoundland and Labrador Hydro
Engineering & Construction Division
Transmission Line Design Group

DATE: 1979 June 29

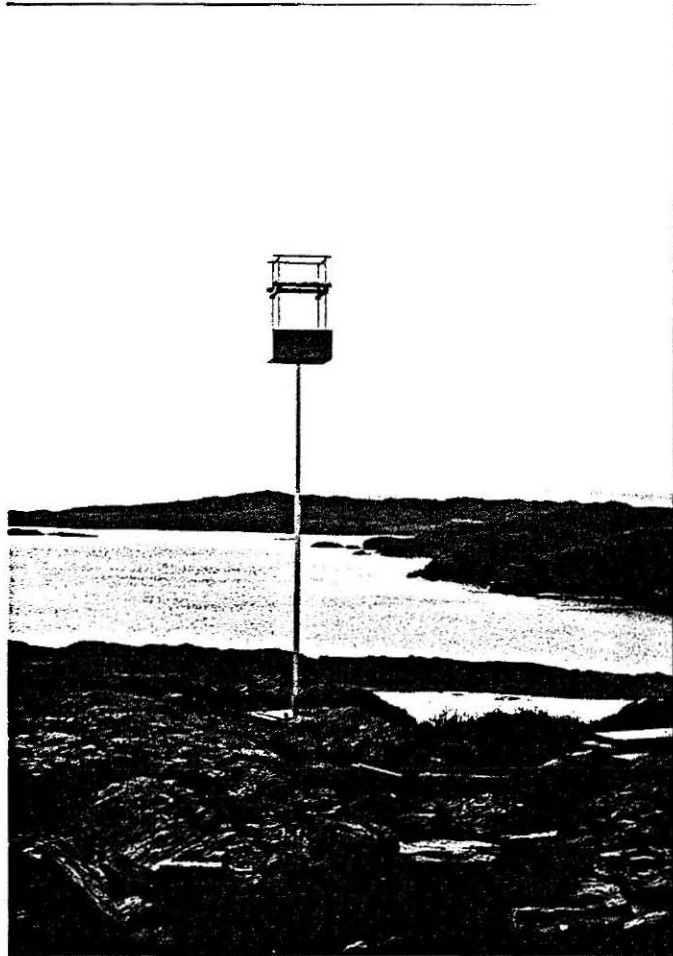
PHOTO I - Passive Ice Meter

A summation of the observed icing is tabulated in Appendix I - Summary of Passive Ice Meter Reports. Photograph I shows typical PIM installation.

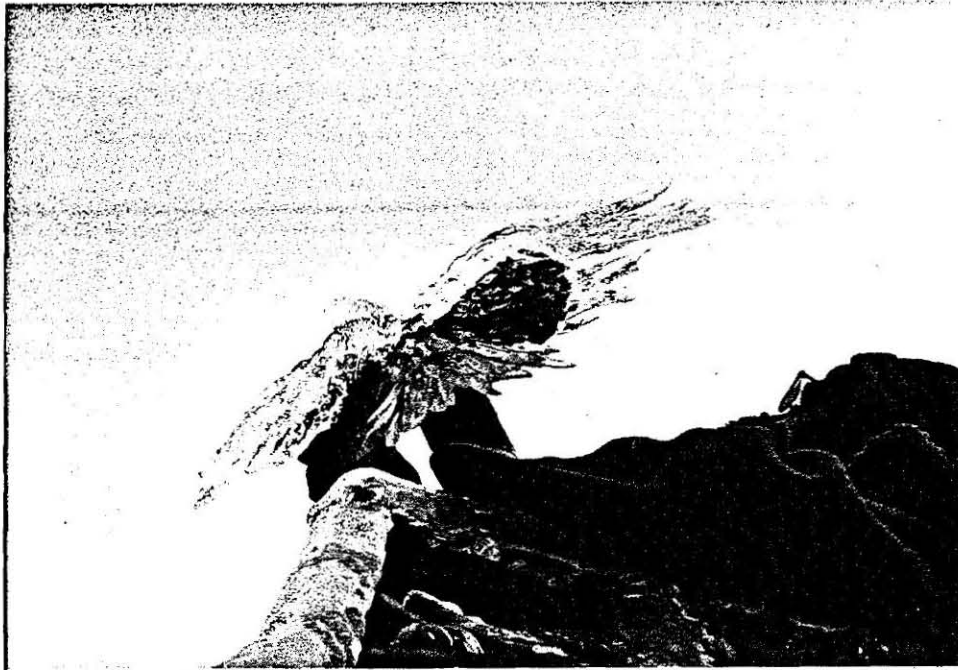
PHOTO II - Anemometer

Photograph II shows the Anemometer at 4 Mile Pond - Holyrood after a wind and freezing rain storm. Similar conditions were documented at this site twice during the season, and a third case was reported by Newfoundland Telephone Company Personnel during which the anemometer was frozen inside solid ice. These icing conditions in conjunction with the high winds documented for this site helps us to understand why this anemometer has been severely damaged twice in the last two seasons with a resultant loss of valuable information. CEA presently has a research and development program underway for an ice-free anemometer but to-date the technology has not been perfected.

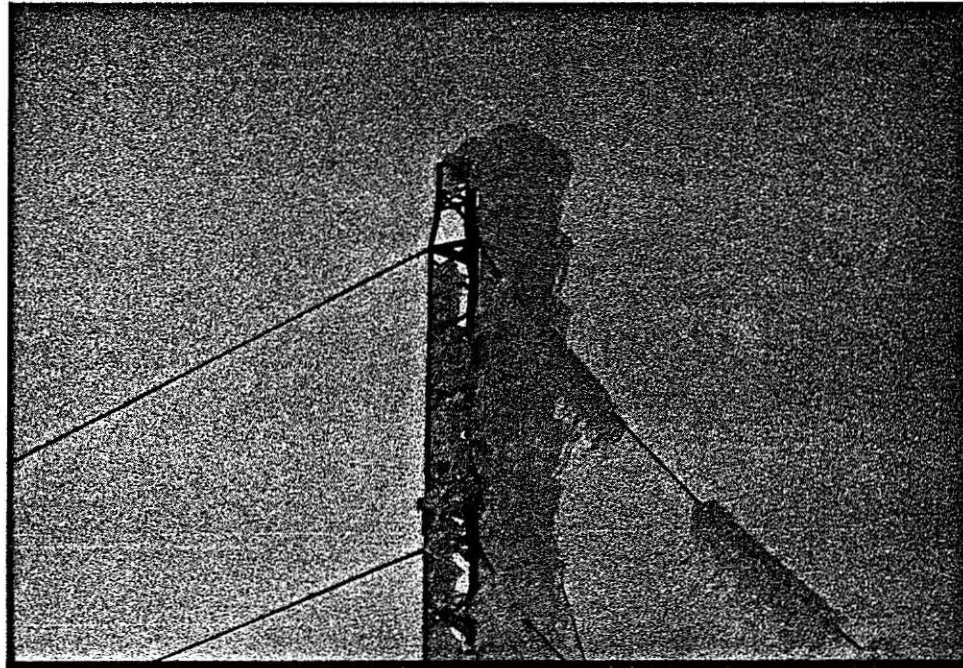
PHOTO IV - Icing at Site 5

Sites on the eastern side of the Great Northern Peninsula, which had been subjected to large glaze deposits during the 1977/78 season, received massive accumulations of glaze again in 1978/79. In particular, Site 5, near Little Harbour Deep, received up to 30" diameter of glaze ice which caused severe damage to the Tower, see Photographs IV and V.
