Twenty Years of Ice Monitoring Experience On Overhead Lines In Newfoundland and Labrador

Asim Haldar

Newfoundland and Labrador Hydro
St. John's, NL, Canada ahaldar@nlh.nl.ca

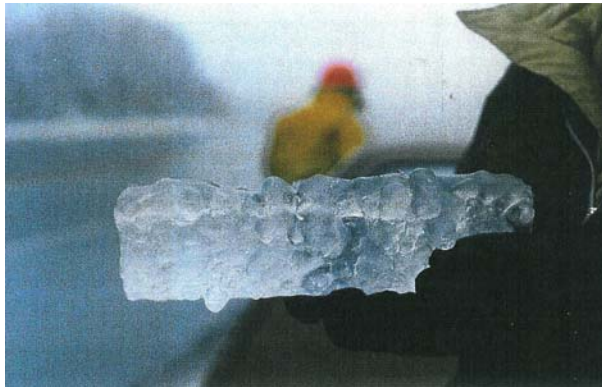
Fig. 2 Glaze ice sample from conductor (1984 storm)

The line failures on the Avalon Peninsula occurred in 1970, 1984, 1988 and 1994 (Haldar, 1995). Figure 2 depicts the observed glaze ice sample on conductor during the 1984

failure. The ice sample weighed approximately 7.8 kg/meter. Figure 3 depicts the bridge failure of a 230 kV suspension tower (guyed-V) under vertical ice load in 1988. In 1994, one 230 kV wood pole line on the Avalon Peninsula failed causing a forced outage in the system. In all cases, the lines experienced conductor/hardware failures due to ice overload. In many cases, this led to moderate to severe cascades indicating an inherent weakness in the design with regard to coordination of strength (Haldar, 2006). The ice load was also significantly underestimated in certain sections of these lines on the Avalon Peninsula and on the Buchans Plain (Figure 1).

for the entire Avalon region. In reviewing the observed ice load on conductors (Figures 2 and 5), it is noted that 38 mm to 50 mm of equivalent radial glaze ice was found to be on the conductors and /or on guy wires in many instances. This information was used later to revise the original design ice load (Normal Zone) to 63 mm radial glaze ice thickness for the upgrading of the existing transmission line system (Haldar,1995, 2006).

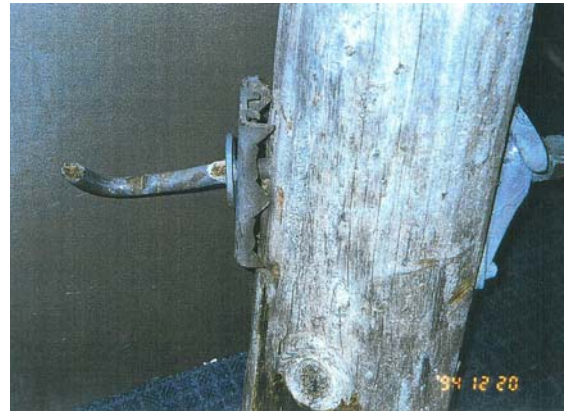
Fig. 4 Failure of a forged eye bolt in 1994

The 1994 line failure caused a cascading event in which seven (7) H-frame wood pole structures (230 kV) were lost due to the failure of a forged eye bolt on a dead end structure (Figure 4). The replacement cost of the failed section of this line alone was approximately \$500,000 dollars. In 1970 and in 1984, NLH incurred several million dollars in repair costs and a long forced outage time before the system was brought back into operation.

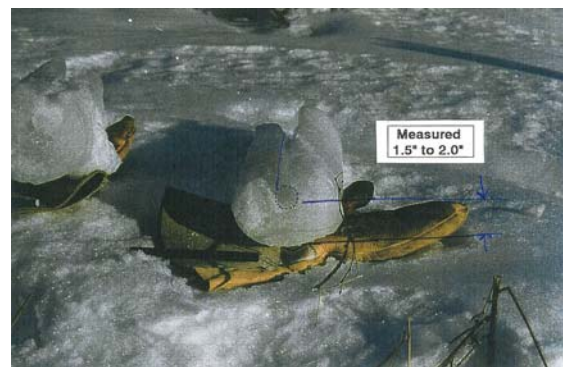
Fig. 5 Glaze ice observed during 1994 line failure

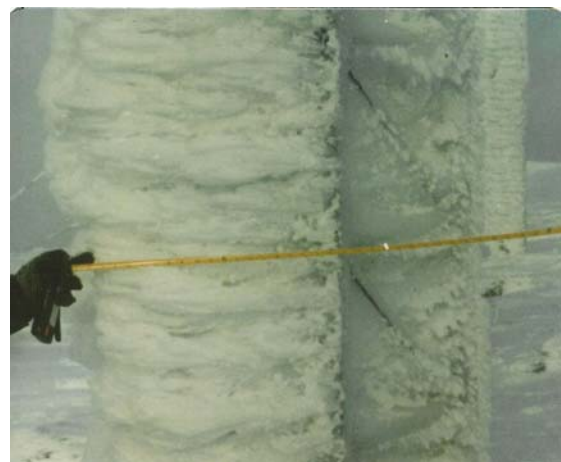
Fig. 7 Observed rime icing event on the Long Range Mountains

To study the icing phenomenon along the proposed DC transmission line route, NLH installed a number of ice monitoring test stations (test spans and guyed towers at specific locations along the route) and operated these stations from 1979-87. Initially, the ice load on the proposed line was estimated using an ice accretion model with a limited data set obtained from the nearby airport and/or weather stations along the proposed line route. The model predicted ice loads were later revised based on the observed ice data from the various test sites located along the route. Figure 7 depicts a typical icing event that was observed on a test tower located on the top of the Long Range Mountains (Figure 1).

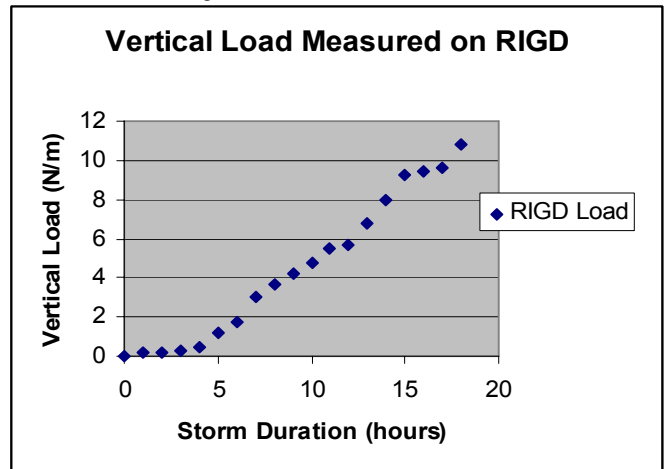
Fig. 10 Measured time history of load during March 31, 1997 event

Figure 9 depicts the ice accretion captured on RIGD beam due to an icing event in 1997. Figure 10 presents the time history of measured load during the icing event.

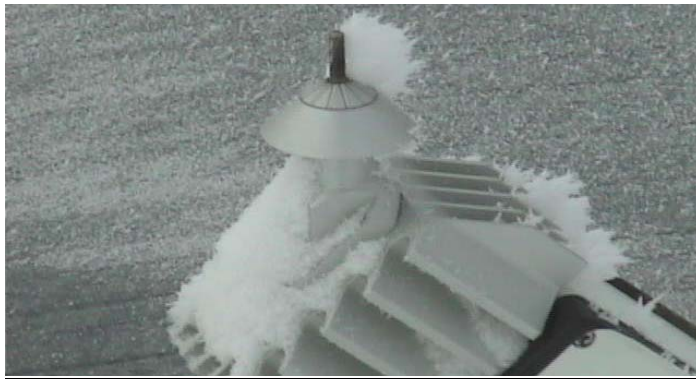
Fig. 11 Ice Detector

The test site also has an ice detector (Figure 11) which provides the accumulated ice mass based on frequency shift. The initial rest frequency is set as 40 kHz and a 500 Hz shift in frequency is used to estimate a predetermined amount of ice

The duration of the analysis is restricted to fourteen hours because of the malfunction of the ice detector after this period (Figure 11). The results of the comparison show clearly that the measured load on the RIGD beam can be captured reasonably assuming a droplet radius of 20 micron. However, the same conclusion can not be drawn for the conductor load. In this case, the model is under predicting the load considerably. The model prediction can be improved by including i) the torsional rigidity of the cable in the formulation and ii) the time history of the LWC during the

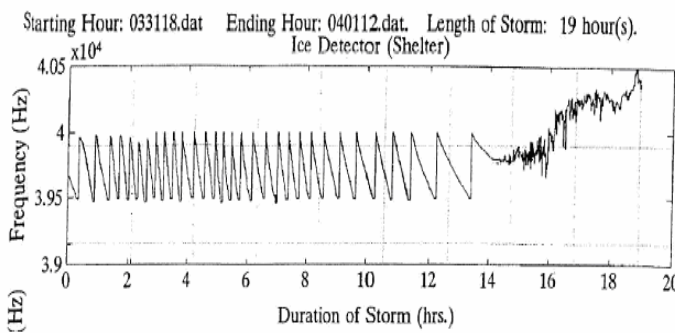
Fig. 12 Frequency response time history during March 31, 1997 storm

accretion with known thickness. As soon as this frequency is reached, the heater is activated to de-ice the sensor. A new cycle begins and the probe starts accumulating ice. A frequency time history during the March 31, 2007 storm event is shown in Figure 12. A problem is noted in Figure 12 in recording the data beyond the 14th hour because of the malfunction of the ice detector. The frequency time history can be used to estimate the cumulative mass on the probe. This icing mass can also be used to calibrate against the conductor load based on a long term data.

The liquid water content (LWC) during the icing event is estimated from Figure 12 based on the average accreted ice mass per hour, wind speed and the exposed surface area of the probe (ice-detector) facing the wind. A calibration factor is used to convert the average cumulative frequency (Hz) to accreted mass (gm) following Laforte and Allaire (1993).

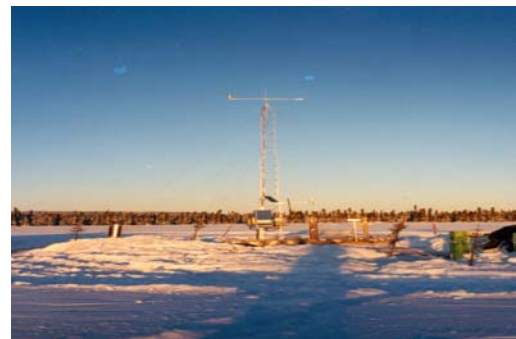
Fig. 15 Typical test tower installed at the Gull Island site (Labrador, Figure 1)

As part of the proposed power development in Labrador, NLH installed one ice monitoring test site at Gull Island) in 1999 (Figure 1). The site operated for three years. It was a remote test site where the instrumentation was done on a test tower. Figure 15 presents the instrumented tower. The instrumentation set up included: (1) a heated anemometer to measure wind speed and direction, (2) temperature and humidity probe, (3) a RIGD ice beam and (4) a precipitation gauge. The power was supplied by battery bank with a solar panel. The data was collected via a data logger and transmitted to an office computer via satellite communication.

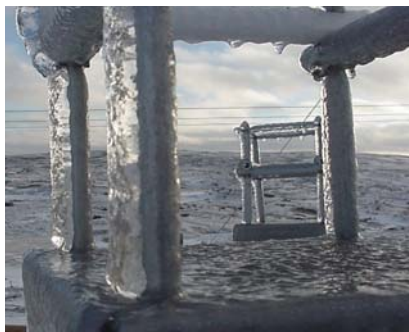
Fig. 13 Passive ice meter (PIM)

The site is also equipped with a passive ice meter (Figure 13), which consists of a vertical stand with four faces; each face consists of several rods interconnected to represent various conductor sizes. The ice thicknesses on these rods are measured manually.

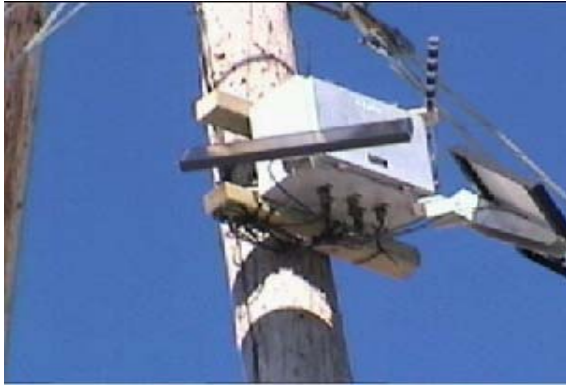
Fig. 16 CAT1 system installed on a 230 kV dead end structure

In 2000, NLH installed a CAT1 system on a 230 kV H-Frame wood pole dead end structure, located a few kilometers west of the Hawke Hill test site. This site is at a lower elevation than the Hawke Hill test site. The CAT1 system presented in Figure 16 is primarily used to measure ampacity of a line based on change in line tension due to increase/decrease in temperature but can also be used in the winter months to detect an icing event and to estimate ice load. The change in the line tension can be used to estimate the ice load and Figure 17 presents an icing event where the data from the RIGD at the Hawke Hill test site is compared with that measured by the CAT1 system.

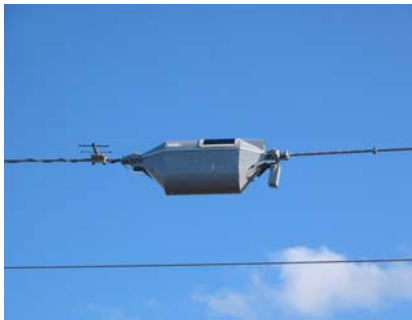
Fig. 18 Automatic ice control device installed on a 230kV line near St. John's

In 2004, NLH in cooperation with the CEATI Wind and Ice Storm Mitigation Interest Group, a consortium of 19 electric utilities from around the world (see <http://www.ceati.com>) installed an automatic ice control (AIC) device on a 230 kV wood pole line located next to the test line. The ice control device operates as a shaker to remove any ice from an energized line and is effective for one or two spans on either side of the span where the device is installed. The device operates using the line current as the main power source and uses advanced communication protocol not only to transmit data but also provide a picture of accreted ice on the span and removal of this ice by the shaker. Data is transmitted directly to the NLH control center.

During its operation in NLH's system, the device only worked for a limited period during the non-icing season and experienced major problems ranging from sensor malfunction

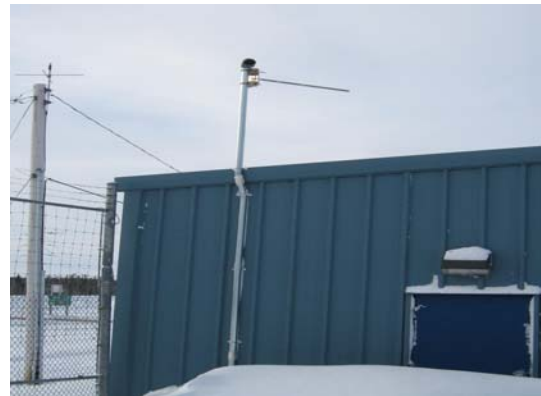
Fig. 19 RIGD beam installed at a terminal station

In 2005, the author initiated the implementation of a remote ice monitoring program by networking a number of RIGD ice monitoring sensors (Figure 9) installed at 15 selected terminal stations (TS) across the island (Figure 1). Under a three year capital program, each terminal station will have one RIGD beam and the ice data will be transferred to the Energy Control Center (ECC) via RTU (remote terminal unit). The specific locations are depicted in Figure 1. Figure 19 depicts a typical installation at a terminal station on the Northern Peninsula. Figure 20 presents a typical time history of ice load measured during an ice storm in the same area in 2007.

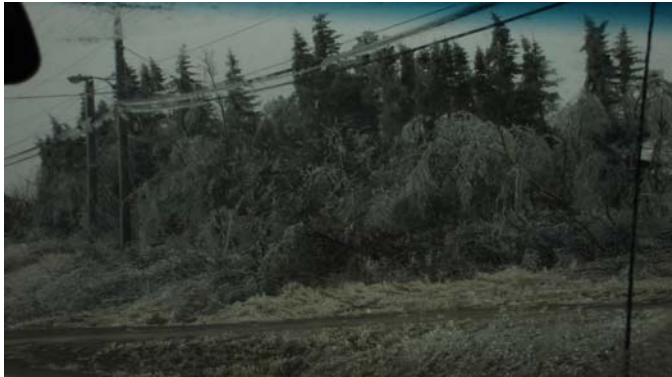
Fig. 21 Photograph showing the icing on distribution cable

The analysis of the loading time history indicated that the actual ice load was 10 N/m, which translates to an equivalent ice thickness of 10 mm radial glaze ice on a 25.4 mm diameter rod. Figure 21 presents a photograph of ice accretion on distribution cables during the event.

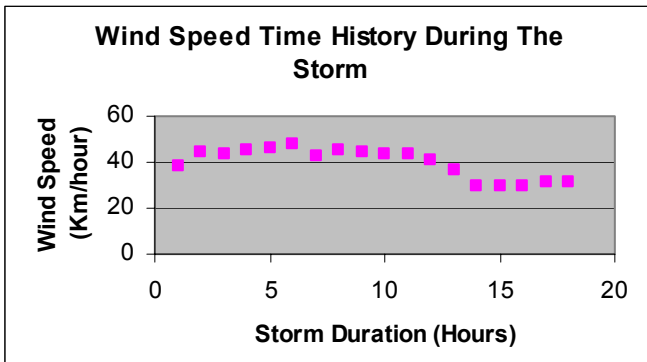
Fig. 22 Wind speed perpendicular to the test line (km/hour)

event was primarily in-cloud icing. The nearby weather station at the St. John's International Airport recorded drizzle in the early evening followed by only a trace amount of precipitation throughout the night into the morning hours. The cloud ceiling was low and there was a persistent fog condition throughout the night with very low visibility. The RIGD beam shown in Figure 9 measured a significant amount of icing and the accreted ice shape formed from one side of the beam indicating the prevailing wind direction. Figure 22 presents the wind data perpendicular to the test line while Figure 23 presents the temperature profile.

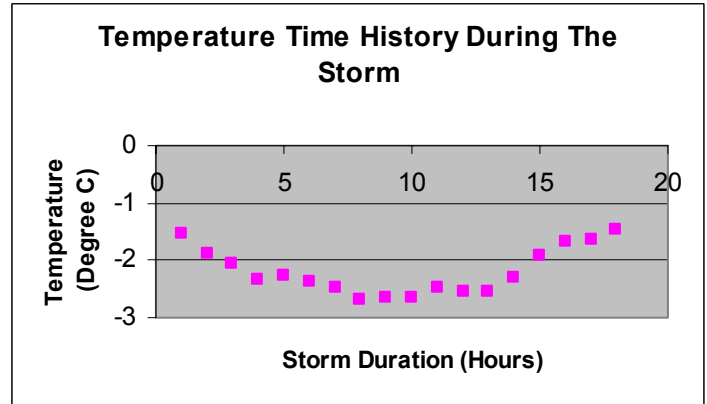
Fig. 23 Temperature profile during the icing event

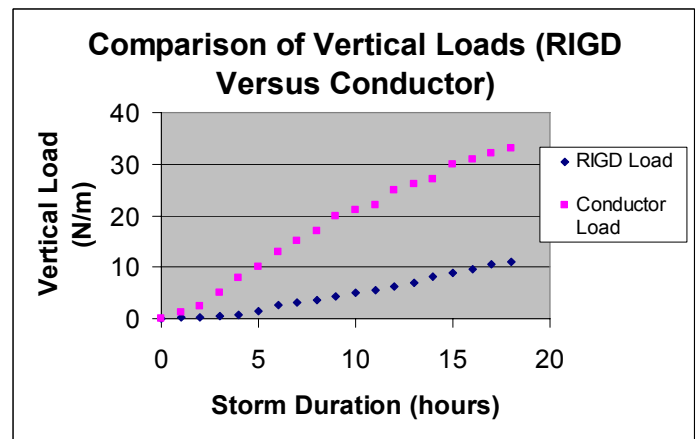
Fig. 24 Correlation of RIGD Load versus Vertical Conductor Load on Main Tower

Figure 24 presents the correlation of vertical ice loads measured on RIGD beam and on the conductor. The ratio is almost 1:3.3. The two possible explanations are: (1) the height effect and (2) the torsional rigidity of the conductor. It is well known that the rate of ice accretion increases as the cable rotates due to eccentric ice weight thus increasing the effective cross section of the iced conductor.

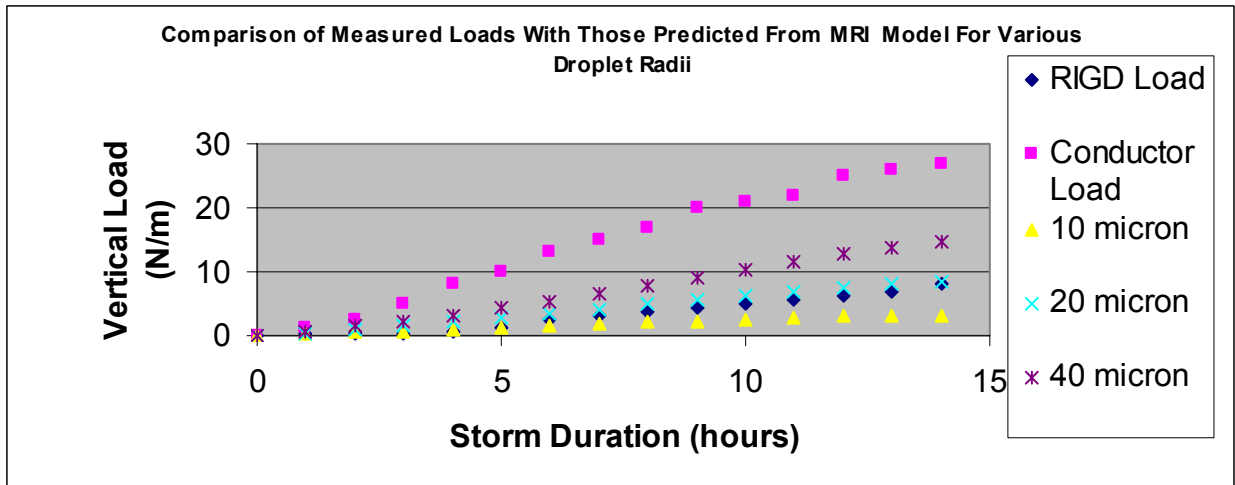
Fig. 25 Predicted load from MRI model (on RIGD & on Conductor)

The last two parameters, the pressure and the droplet radius were not measured at the test site but the input data on pressure was taken from the nearby weather station located at the St. John's International Airport. The droplet radius is rarely available and is normally not measured. The model is sensitive to this parameter. Initially, a cloud droplet radius of 20 micron was assumed in the analysis with two other values (10 micron and 40 micron) used to study the sensitivity of this parameter. Figure 25 compares the measured vertical loads (N/m) on the RIGD beam and on the conductor with those obtained from the model for various droplet radii.
