HVDC Labrador – Island Transmission Link Review of in-cloud icing on the Long Range Mountain Ridge

Title: HVDC Labrador - Island transmission Link, Review on incloud icing on the Long Range Mountain

Authors/Company: Landsvirkjun Power, EFLA Engineering

Prepared for: Nalcor Energy, St. Johns., Newfoundland and Labrador, Canada

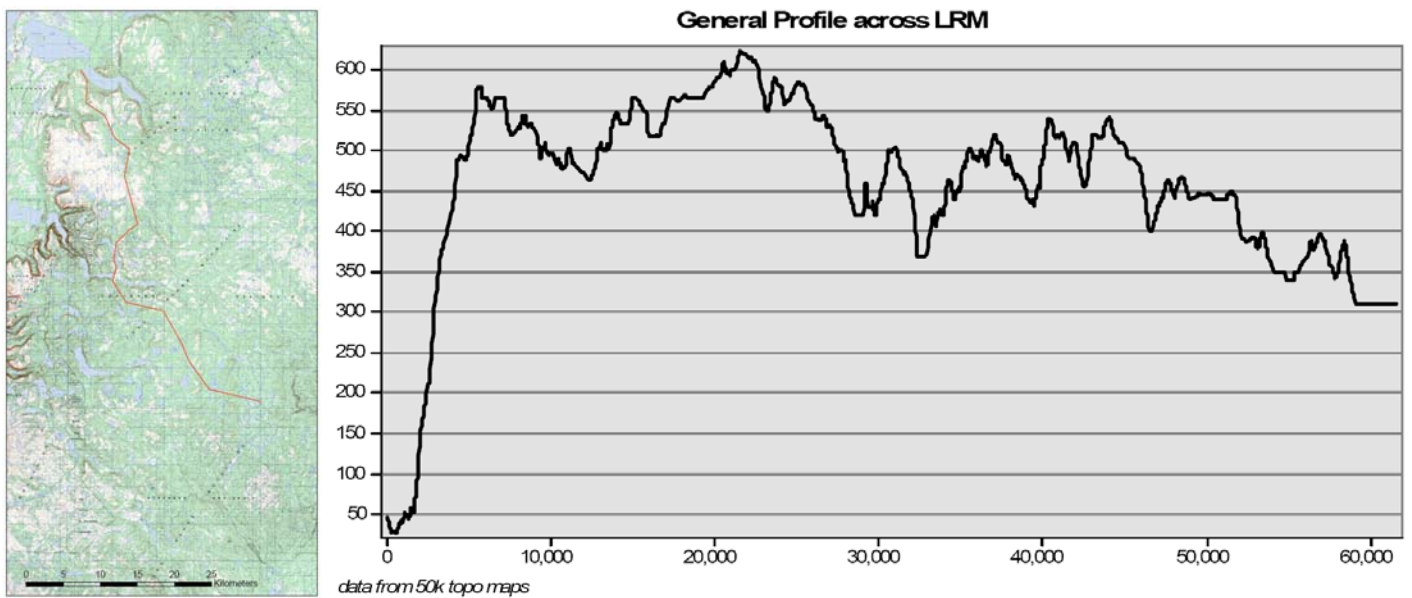
Figure 3. Profile of possible line route across the Long Range Mountain, m above sea level.

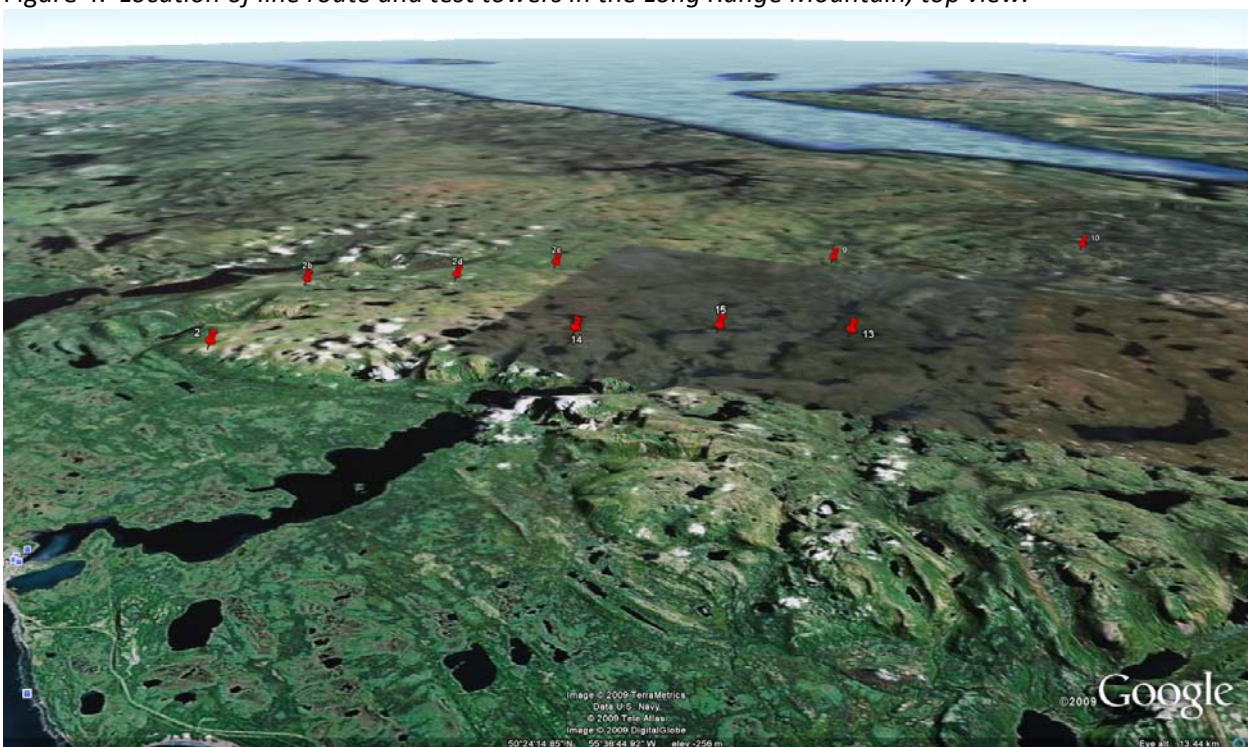
Figure 5. Location of line route and test towers in the Long Range Mountain, 3D view

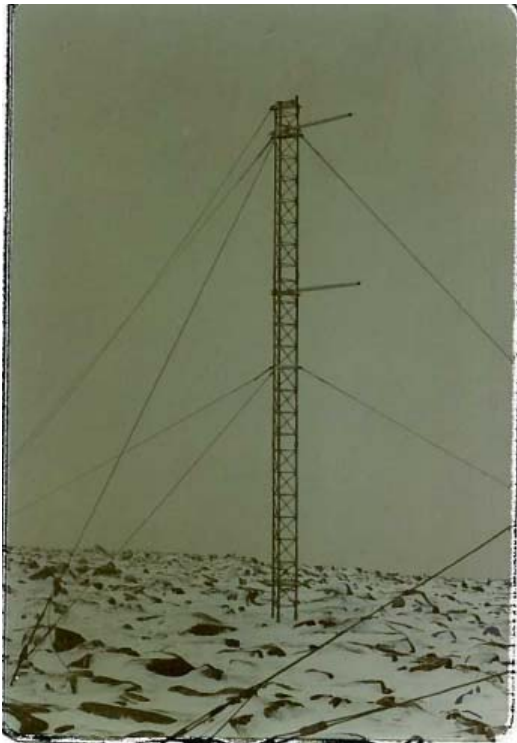
Figure 7. Test tower. Only few towers had two horizontal rods (50 mm) as this tower

Two of the towers (#2 and #4³) were modified by attaching two horizontal aluminum rods 50 mm in diameter and 1.5 m long to simulate the conductor proposed for the Gull Island Project. The rods were installed in N-S and WE-W directions to examine the effects of wind direction as well as height above ground on ice accretion.

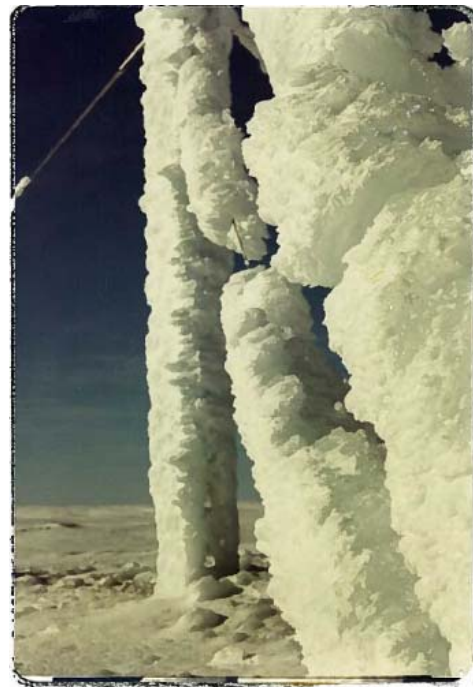
Figure 11. Site #4. In Labrador – Feb. 1977.

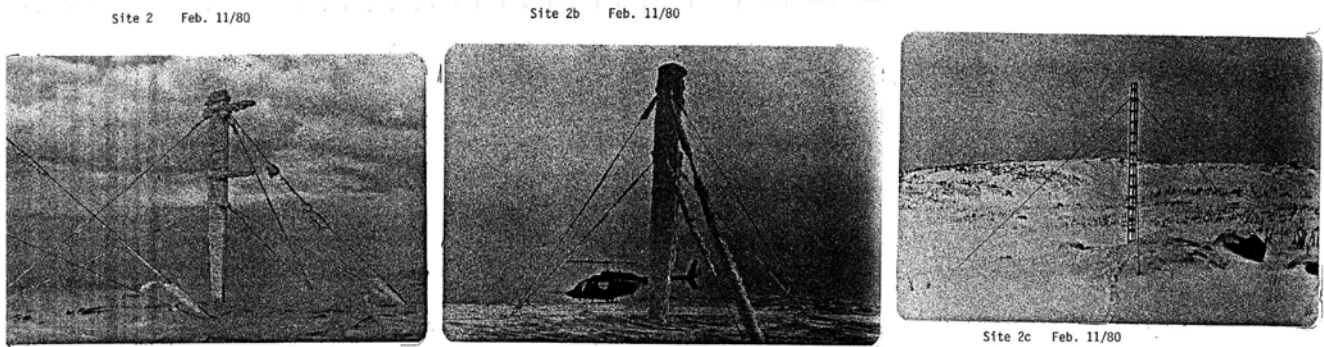
Figure 12. Observation at same time shows tremendous difference in ice accumulation in sheltered areas.

Observations made at the same time at exposed and sheltered sites along the route showed tremendous differences in ice accumulations. The effect of shelter in rime ice situations cannot be emphasized too strongly. Typical examples are shown in following photos of sites #2, #2b and #2c.

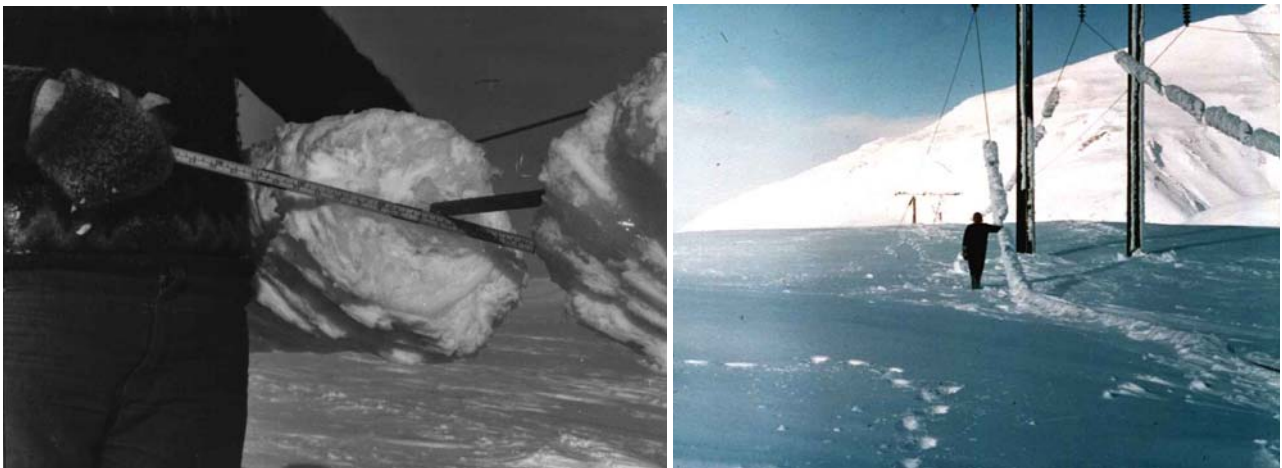
Figure 22. Icing at Hallsteinsvarp 28.02.1978. Ice weight 29.4 kg/m. Density 420 kg/m³.

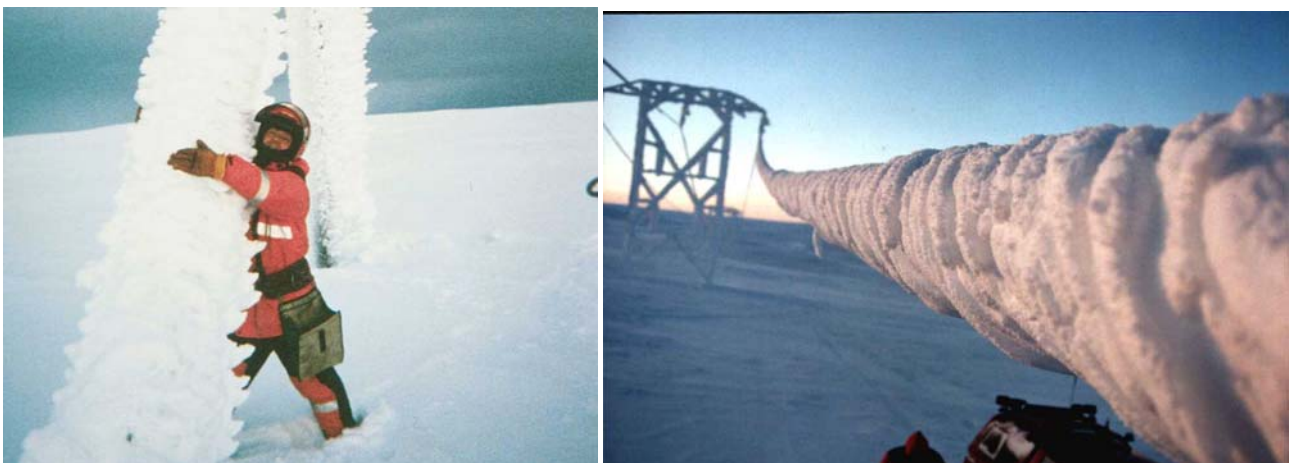
Figure 23. In-cloud icing on a guy wire.

Figure 24. In-cloud icing on a 132 kV OHTL at Hallormsstadarhals.

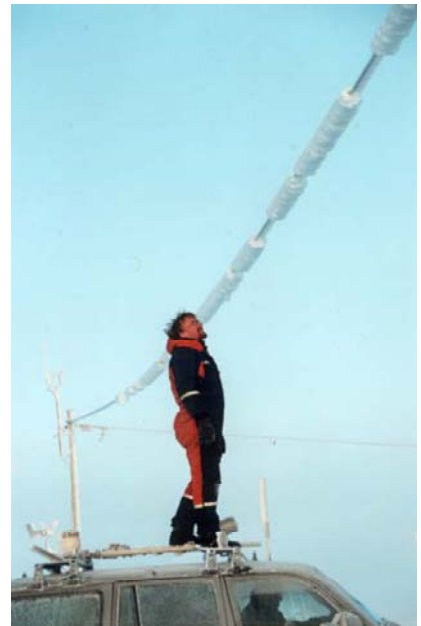
Figure 26. Icing in a test span (80m)

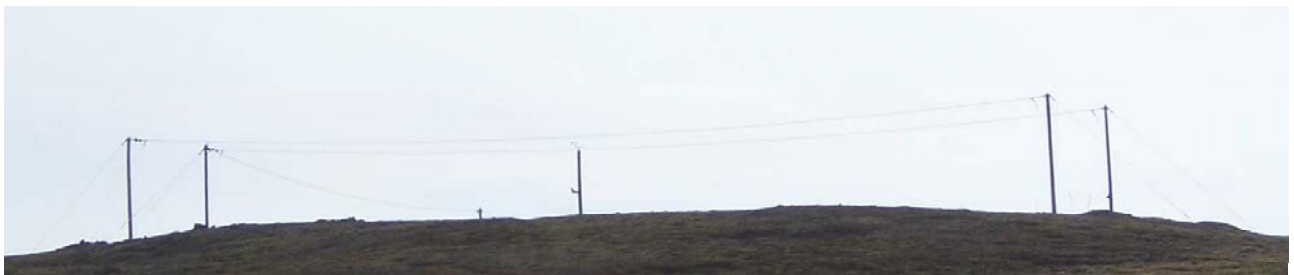
Figure 27. Test spans (3 spans) at Hallormsstadarhals (83-1).

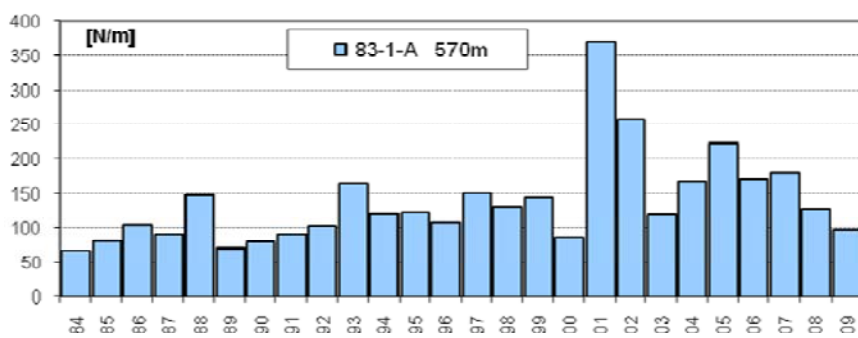
Figure 28. Yearly maximum loading in test span (83-1-A).

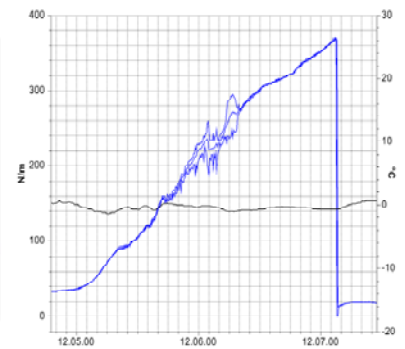
Figure 29. Highest loading in test span 83-1-A.

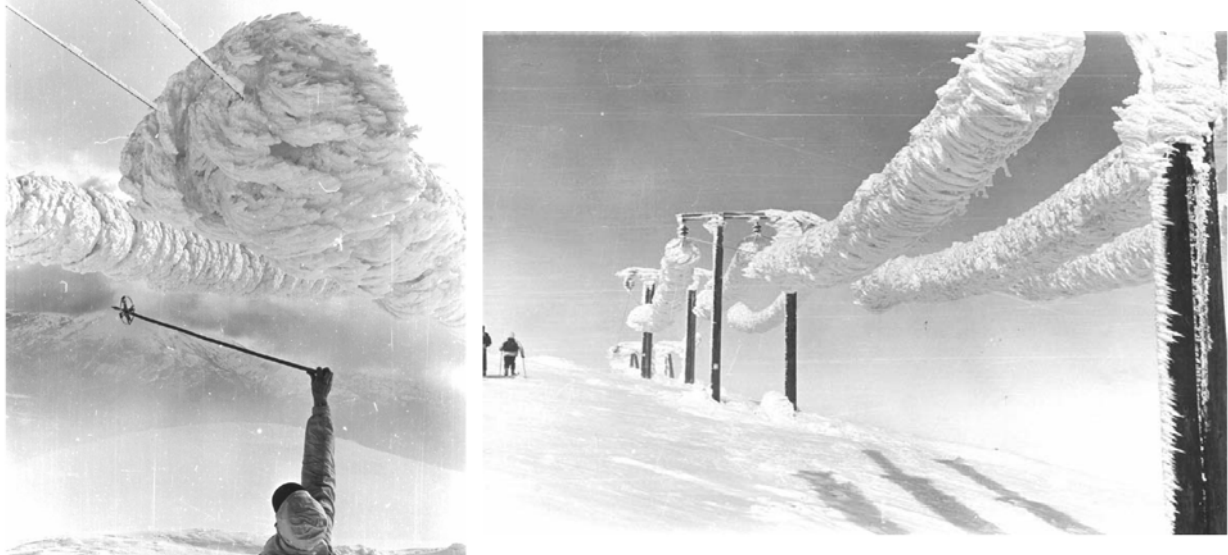
Figure 31. Photo: O. Wist. The most famous photos of in-cloud icing. Ice load 305 kg/m.

- The biggest ice load ever recorded on an OHTL occurred in Norway 1961, 1400m above sea level. The accretion had an elliptic shape with the longer diameter of 1,4m and the shorter as 0.95 m. Accretion weighted 305 kg/m. It was a 22 kV wooden pole line
- The great dependence of in-cloud icing on topography results in that the main grid of Norway is designed span by span to the expected ice load.

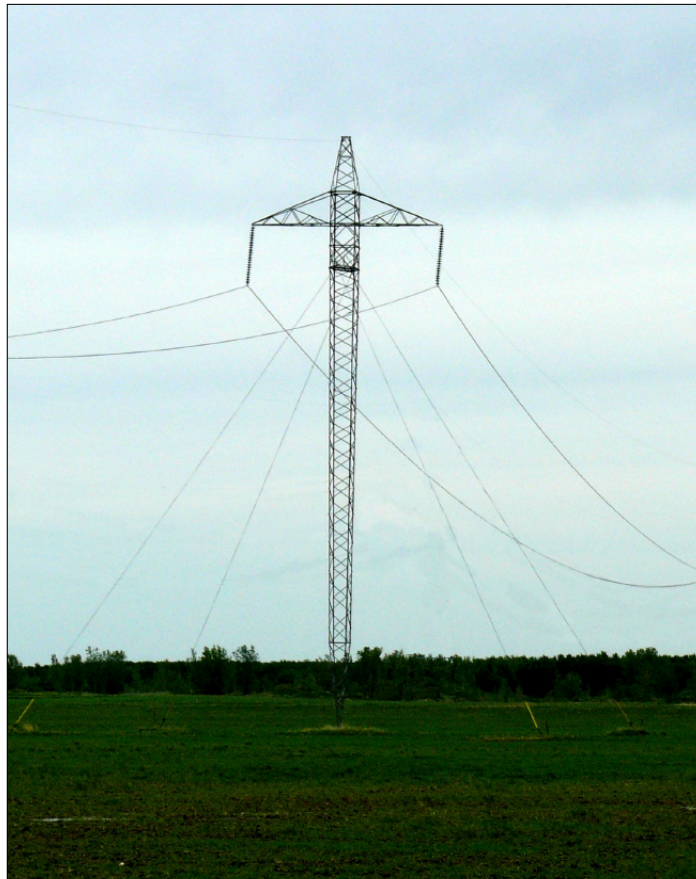
- Tower will carry three wires, i.e. two conductors and one ground wire, with/without fiber optic cable.
- Phase conductor is planned to be simplex conductor approx. 58mm in diameter. The reason for using single conductor instead of bundle conductor is due to significant icing issues along sections of the HVdc corridor.
- Tower height will generally be in range of 38-49m with average approx. 43 m in height
- Span length will vary. It is assumed that ruling span will be around 375 m in normal loading zone and 285 m in higher loading zones.
- There will be approx. 3600 towers in the whole line, length approximately 1300 km.
- Design will comply with Standard C22.3 No.1 – Overhead Systems and Standard C22.3 No. 60826 – Design Criteria of Overhead Transmission Lines.
- Right of way will be cleared on average with 60m and up to 80 m.
- Foundation will consist of steel grillage structures.

Figure 38. A typical tower in a HVdc line. Structurally the transmission line will be similar to other transmission lines in Newfoundland and Labrador and elsewhere.

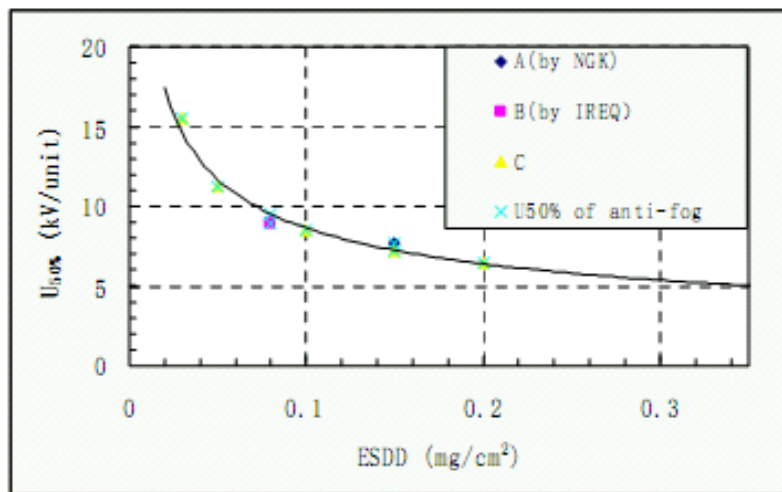
Figure 39. Contamination flashover voltage of suspension insulators at different ESDD.

Accumulation of contaminants on insulation surfaces is more severe under DC than AC and for the same level of contamination, the withstand strength of DC insulation is lower than of AC. The following figure shows the flashover voltage of suspension insulators for different ESDD [Li Wufeng et al; "Contamination flashover Performance of Insulator Strings and Post Insulators used for ± 500 kV HVdc System", 2005]

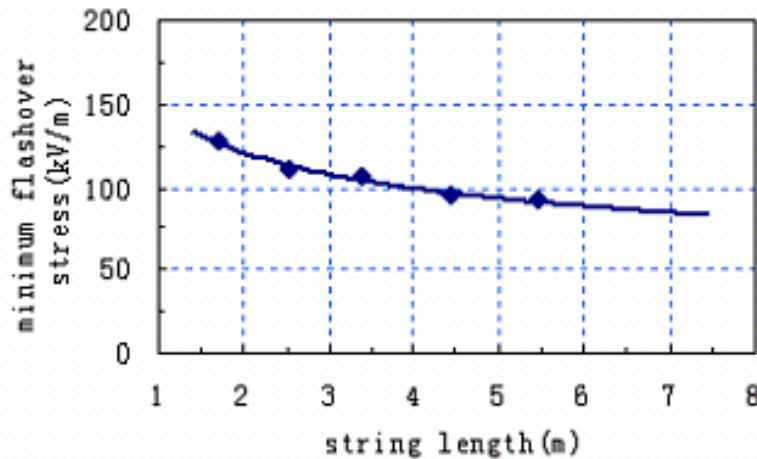
Figure 41. Minimum flashover stress of DC icing insulator string under different string length.

It is known that icing on insulator strings reduces the flashover strength. For moderate icing the shape of insulator units and the sheds can affect the withstand strength but for extreme ice the withstand strength is more related to the length. The withstand strength per unit length is also reduced with increased length, i.e. the withstand strength is not proportional to the length. This is shown on a figure below [Li Peng; "DC flashover performance of long insulator strings coated with ice"];

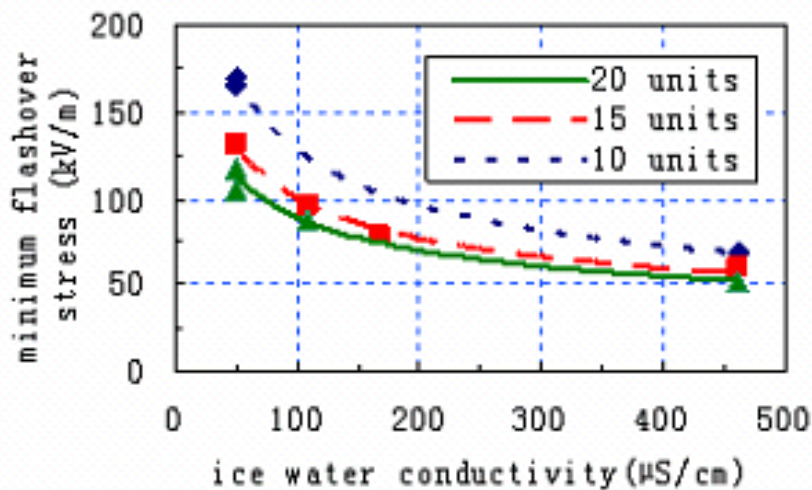
Figure 42. Curves of DC insulator strings, icing flashover stress against water conductivity under different string length

The icing flashover voltage is also relative to the water conductivity. With increasing conductivity of the water making up the ice, the flashover voltage decreases. This is shown below [Li Peng; "DC flashover performance of long insulator strings coated with ice"]. The figure also shows how the withstand strength per unit length is less with long strings than shorter strings.

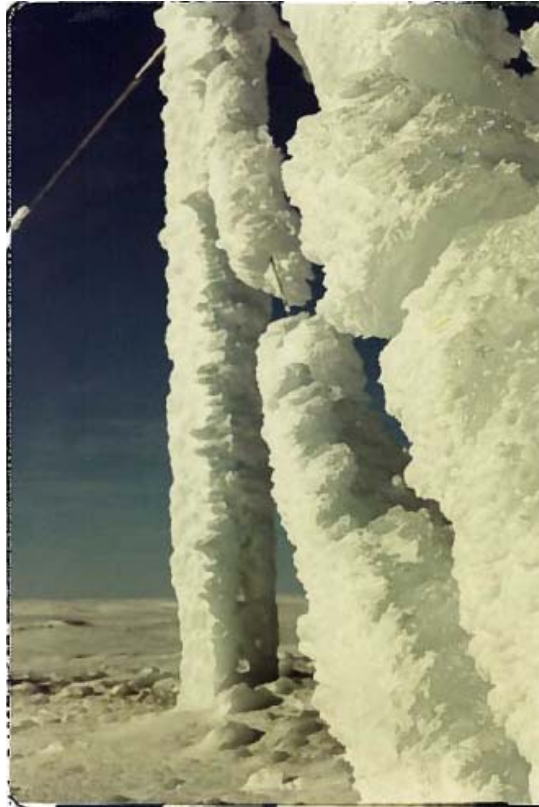
Figure 47. Site #4 (in Labrador). February 1977. Description was:

Tower and guys were completely encased in glaze covered by a little rime. Guys were covered by 8"-10" of solid ice. Lower portion of 18" tower was covered by ice measuring 28" across the face. The top measurements were estimated at 36" across the face. Direction East.

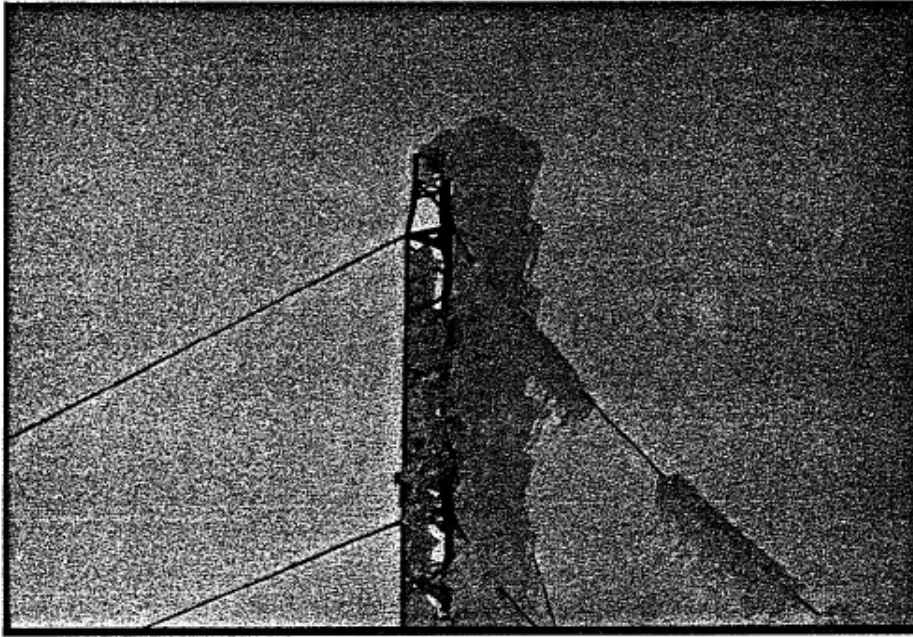
Figure 49. Site #5. 14-02-79. Description was:

Massive accumulation glaze on tower and guys. Approximately 30" thick on tower and 12" thick by 40" wide between guys and ground. Severe damage to tower. Direction of accumulation East-Northeast.
