Muskrat Falls Project - Exhibit 39 Page 1 of 122

July 2008

MF1260 - Assessment of Existing Pumpwell System

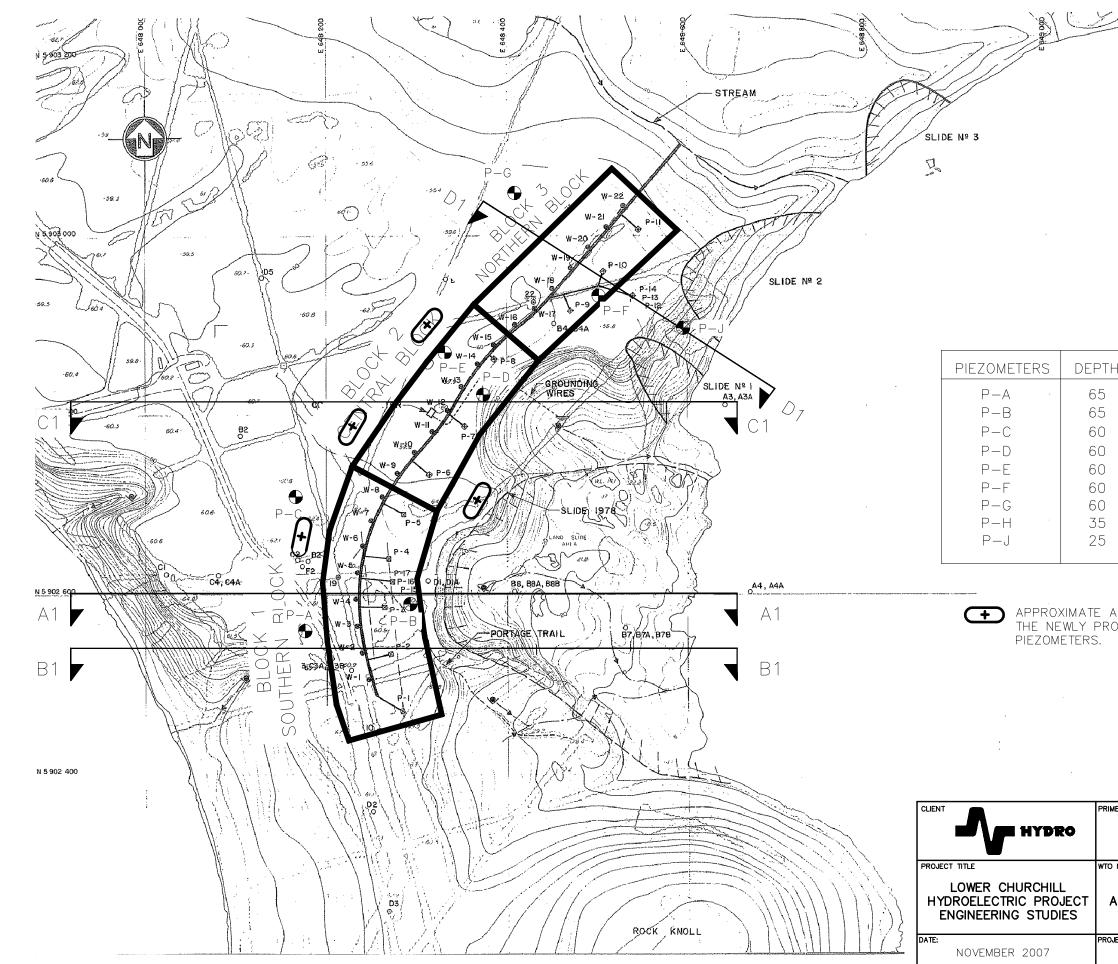
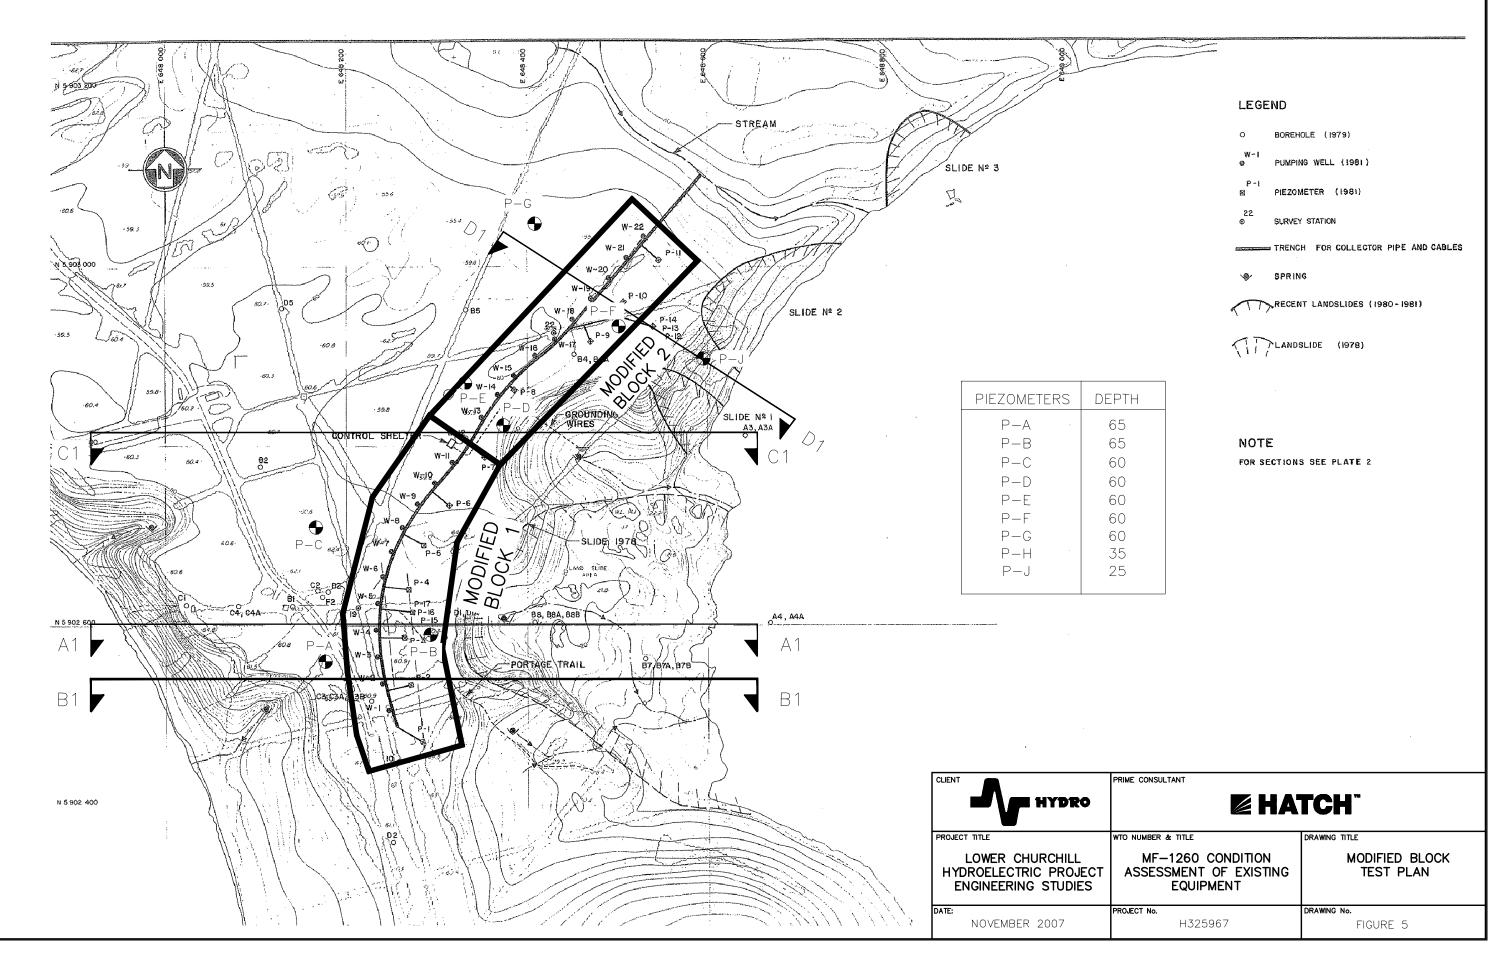
Initially, it was intended to divide the wells into three main blocks as shown in Figure 4. These test blocks were to consist of the following wells and piezometers:

- In order to develop a more complete understanding of the phreatic surface and to assist in the creation of hydrogeological cross sections, such as those presented in Section 4.4, and in other sections to be developed in the future, it is suggested to install 4 new double standpipe piezometers. It is estimated that this will cost in the order of \$120,000 plus engineering and management fees (Details are provided in Appendix E). The locations of the new piezometers are suggested as follows as shown in Figure 4:

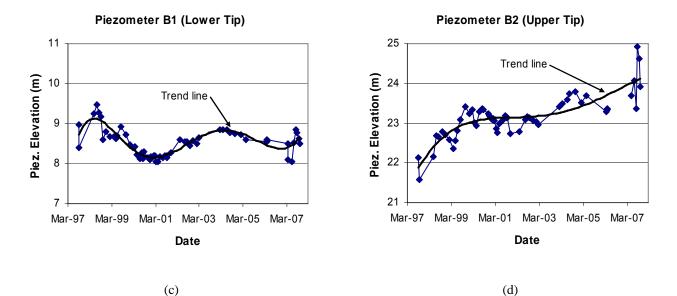
Figure 7 - Piezometer water level variations from 1997 to 2007: (a) P-A1 lower tip, (b) P-A2 upper tip, (c) P-B1 lower tip, (d) P-B2 upper tip

Figures 7 to 10 plot the variation of piezometer water elevation for the last 10 years. Out of 12 observed tips, the readings of four tips are not consistent with the other installations or historic data. These are: P-A2, P-B2, P-C, and P-D2. In the piezometers which have two tips, the suffixes 1 and 2 refer to lower and higher tips, respectively.

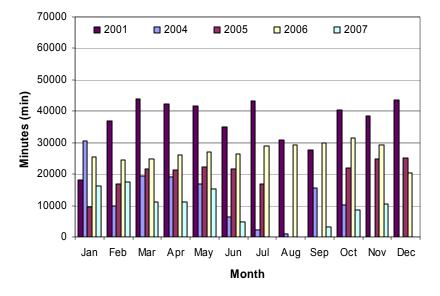
Figure 21 - Total monthly on-time for Block-1 (Southern Block)

Figure 21 depicts the total monthly on-time for the block 1 (Southern Block). The block experienced its most active time during year 2006, as a result of high pump no.4 activity; however, the on-time values are much less than the year of 2001.

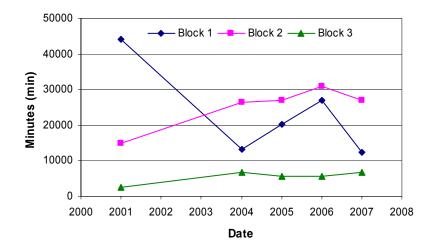
Figure 24 - Average monthly on-time for different blocks

Figure 24 shows the average monthly on-time for different blocks for the last four years. This figure shows that Block-2 (Central Block) is the most active block in the recent years followed by Block-1. While the on-time of Block-3 has been almost constant over the years, the other two blocks experienced the most active years in 2006 (other than 2001).

- Considering all the uncertainties in the dewatering system data recording and transmission as mentioned in Section 4.6, historical pump operation data indicates that the pumps in the northern block are generally inactive (Figure 24). The average monthly on-time of the northern block is significantly lower than the other two blocks. This observation is to be compared within an observed rise in groundwater levels in piezometers within this block. Despite the increase in the on-time hours in recent years in comparison to 2001, it is clear that pumping in the north block is inefficient.

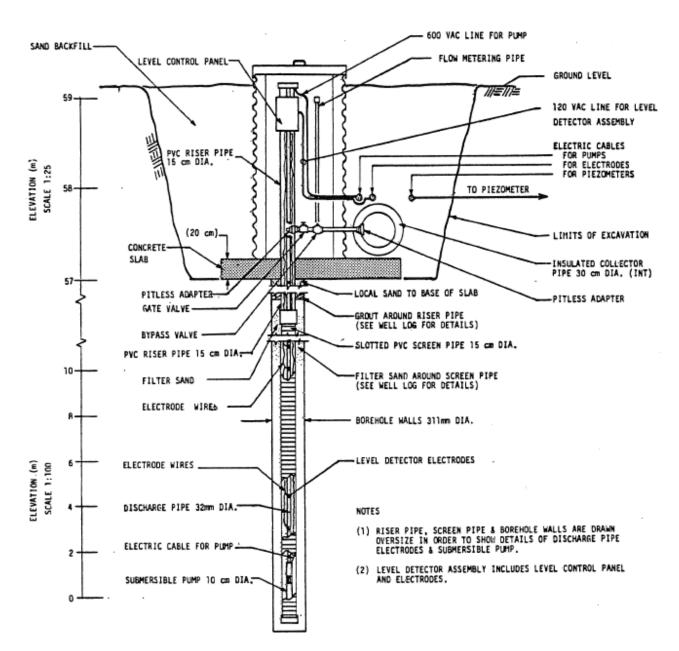
Figure 25 – Typical pump and well as-built detail provided by SNC-Lavalin (1982)

A description of the Muskrat Falls system is presented in Section 2. It is to be noted that no record of the materials used in the well screens was found, only that the riser pipes are polyvinyl chloride (PVC). Similarly, no record is available indicating the slot size or well screen opening. Figure 25 shows a typical pump and well as-built detail as provided by SNC-Lavalin (1982).

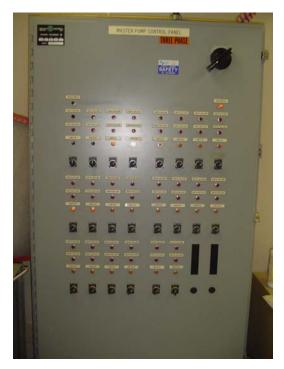
Common pump operation before the replacement of pump at W4 (Site Visit -1)
