Geotechnical Site Investigation Proposed Island Pond Hydro Electric Development (as prepared by AMEC)

**Geotechnical Site Investigation
Proposed Island Pond Hydro Electric
Development
South Central Newfoundland
Date: January 03, 2007
Final Report
Submitted by:
AMEC Earth & Environmental**

**GEOTECHNICAL INVESTIGATION
PROPOSED ISLAND POND
HYDROELECTRIC DEVELOPMENT
SOUTH CENTRAL NEWFOUNDLAND**

January 2007
TF6316540

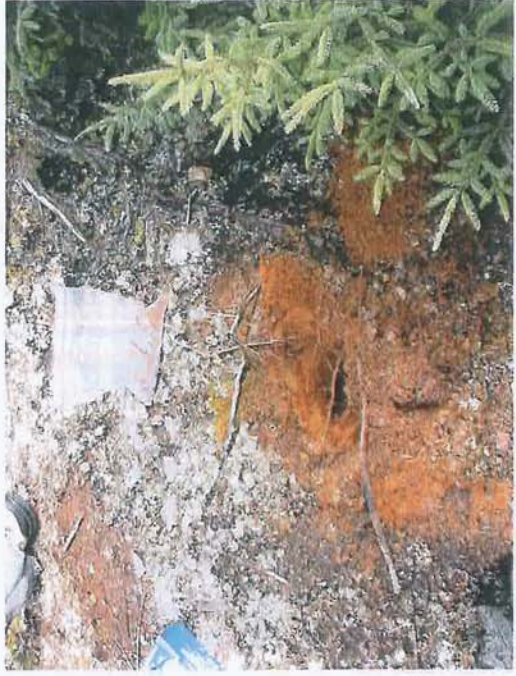
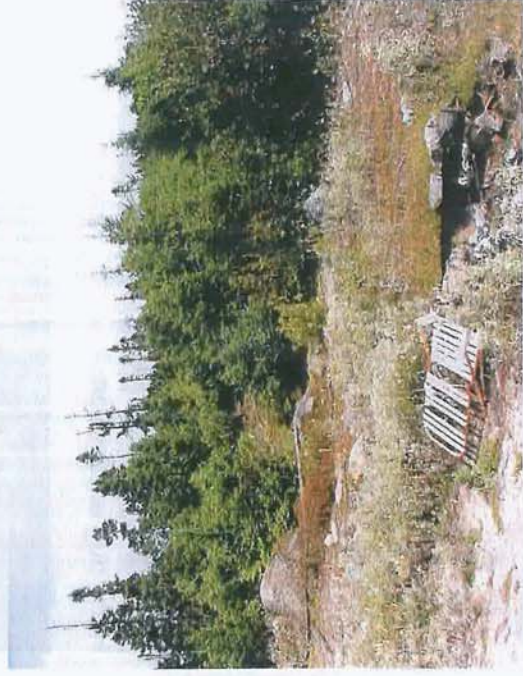
Test Pit Number	Depth (m) From - To	Description
TP-06-001	0.0 - 0.2	ROOTMAT - Black, organic silt with roots and organic matter, moist, loose, compressible.
5,346,929 N 557,277 E Zone 21 UTM NAD 83	0.2 - 0.5	GLACIAL TILL - Reddish brown, fine to medium grained sand with some gravel and fines, and occasional cobbles, compact, moist.
	0.5	Test pit terminated in native soil.
		Note: 1) Test pit hand dug with a shovel. 2) Groundwater not encountered.

Location: Borrow, east side of Burnt Lake Diversion Canal.
 Date: September 5, 2006
 Notes: Hand dug test pit

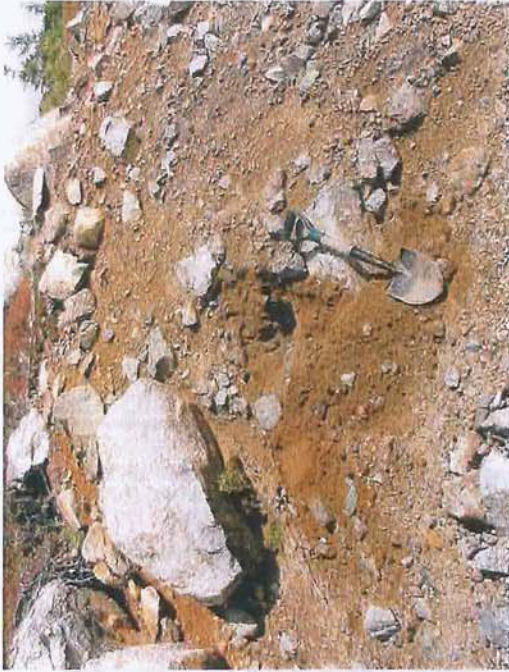
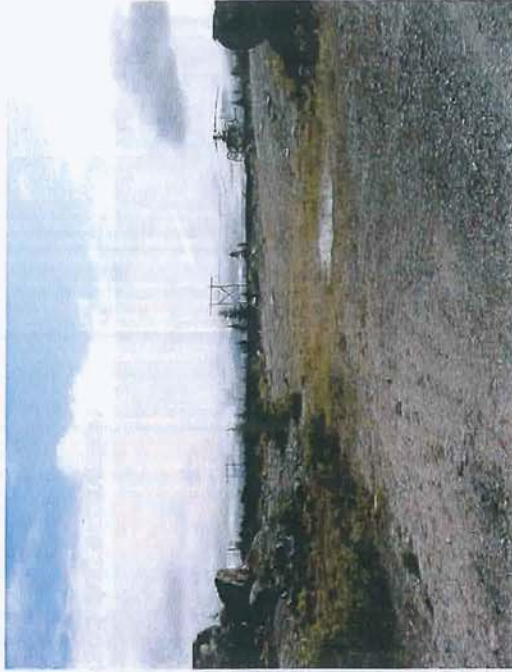
Test Pit Number	Depth (m) From – To	Description
TP-06-002 5,346,717 N 556,924 E Zone 21 UTM NAD 83	0.0 – 0.5 0.5	GLACIAL TILL – Brownish grey, fine to medium grained sand with some gravel, trace of fines, and occasional cobbles, compact, moist. Test pit terminated in native soil. Note: 1) Test pit hand dug with a shovel. 2) Groundwater not encountered.

Location: Existing borrow, east side of Burnt Lake Diversion Canal.
Date: September 5, 2006
Notes: Hand dug test pit
 Sieve analysis conducted on Glacial Till soil.

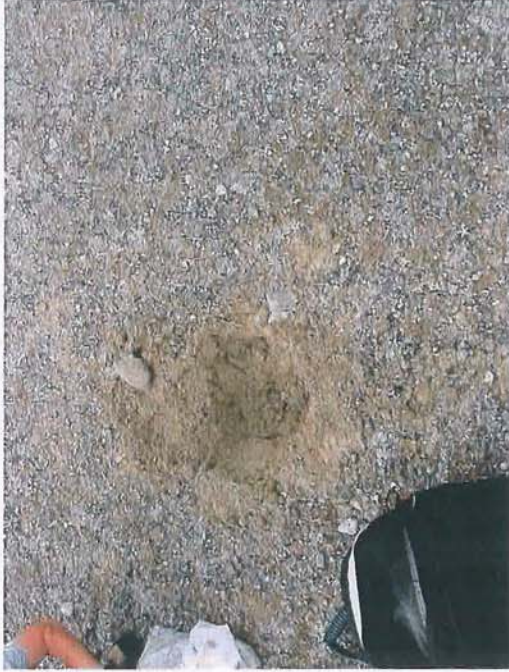
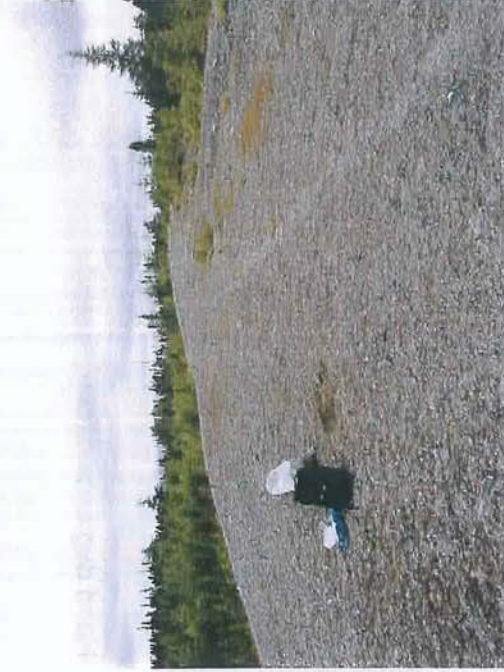
Test Pit Number	Depth (m) From - To	Description
TP-06-003 5,346,438 N 555,761 E Zone 21 UTM NAD 83	0.0 - 0.5 0.5	GLACIAL TILL - Grey, fine to medium grained sand with some gravel and fines, occasional cobbles, compact, moist. Test pit terminated in native soil. Note: 1) Test pit hand dug with a shovel. 2) Groundwater not encountered.

Location: Borrow, west side of Burnt Lake Diversion Canal.
Date: September 5, 2006
Notes: Hand dug test pit
 Sieve analysis conducted on Glacial Till soil.

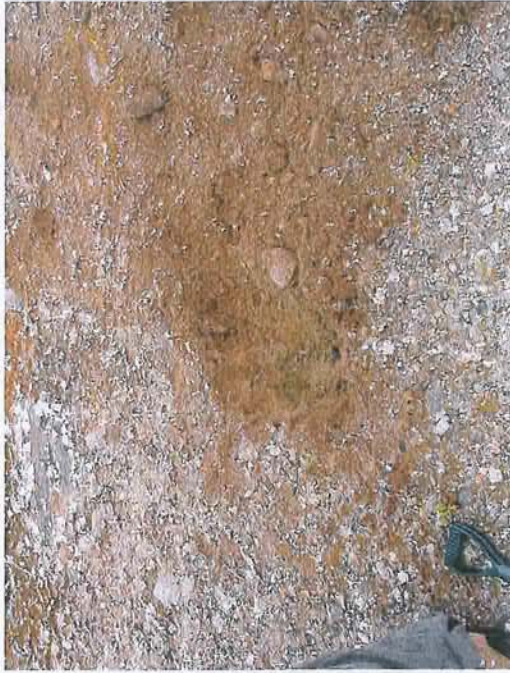
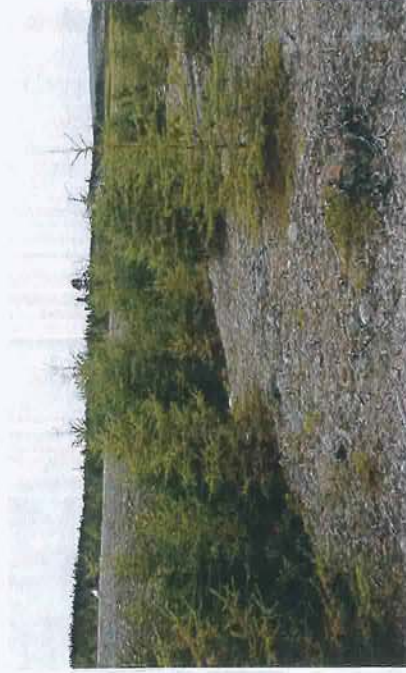
Test Pit Number	Depth (m) From – To	Description
TP-06-004 5,346,386 N 555,772 E Zone 21 UTM NAD 83	0.0 – 0.5 0.5	GLACIAL TILL – Brownish grey, fine to medium grained sand with some gravel and fines, occasional cobbles, compact, moist. Test pit terminated in native soil. Note: 1) Test pit hand dug with a shovel. 2) Groundwater not encountered.

Location: Borrow, west side of Burnt Lake Diversion Canal.
 Date: September 5, 2006
 Notes: Hand dug test pit
 Sieve analysis conducted on Glacial Till soil.

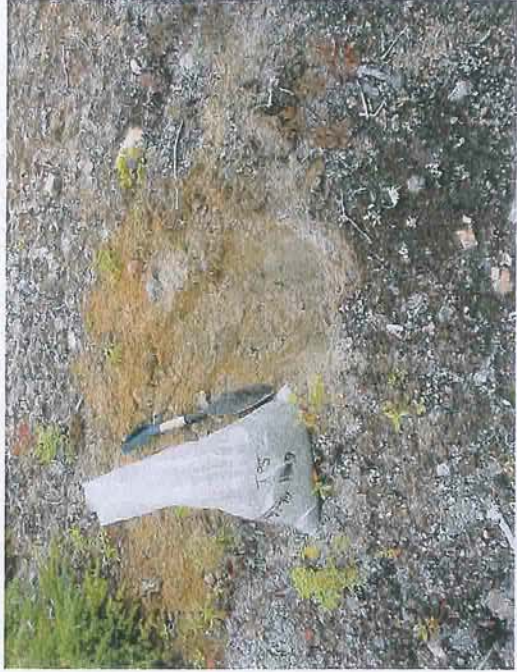
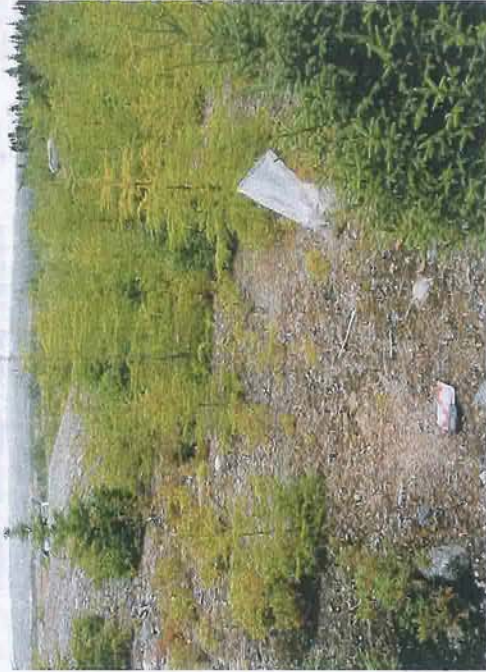
Test Pit Number	Depth (m) From - To	Description
TP-06-005 5,346,407 N 555,702 E Zone 21 UTM NAD 83	0.0 - 0.5 0.5	GLACIAL TILL - Grey, fine to medium grained sand with some gravel and fines, occasional cobbles, compact, moist. (50 mm of rootmat located on the ground surface) Test pit terminated in native soil. Note: 1) Test pit hand dug with a shovel. 2) Groundwater not encountered.

Location: Borrow, west side of Burnt Lake Diversion Canal.
 Date: September 5, 2006
 Notes: Hand dug test pit
 Sieve analysis conducted on Glacial Till soil.

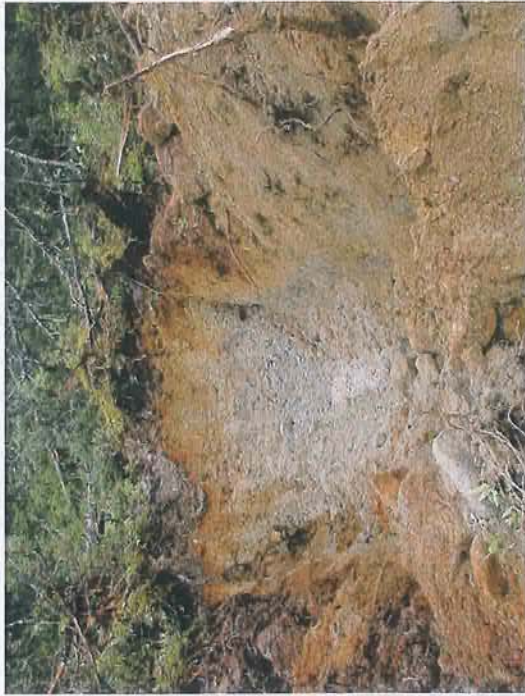
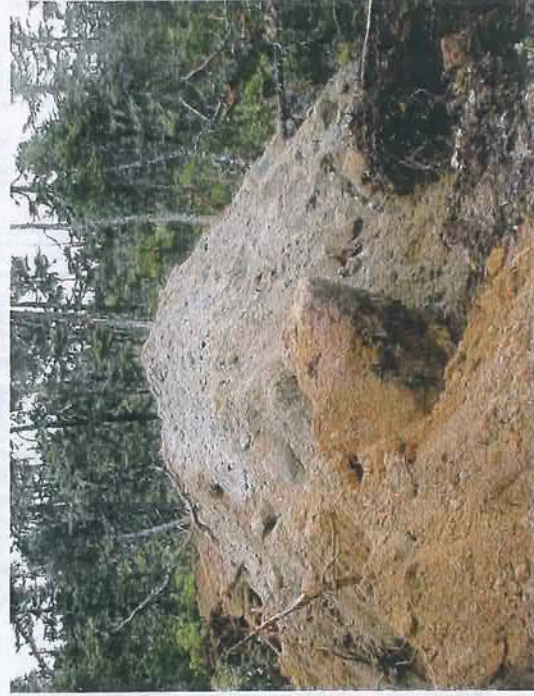
Test Pit Number	Depth (m) From - To	Description
TP-06-006 5,358,035 N 545,274 E Zone 21 UTM NAD 83	0.0 - 0.2	ROOTMAT - Black, organic silt with roots and organic matter, loose, moist, compressible.
	0.2 - 0.5	WEATHERED GLACIAL TILL - Reddish brown, silty sand and gravel with occasional cobbles and small boulders, compact, moist.
	0.5 - 1.5	GLACIAL TILL - Grey, gravelly, sand with some fines, occasional cobbles and boulders, dense to very dense, moist.
	1.5	Test pit terminated in glacial till.
		Note: 1) Test pit excavated using a CAT 220 excavator. 2) Groundwater not encountered.

Location: Test pit excavated approximately 900 m south west of the river along the proposed access road. Borrow "A"
Date: September 6, 2006
Notes: Sieve analysis conducted on Glacial Till soil from excavation spoilage.

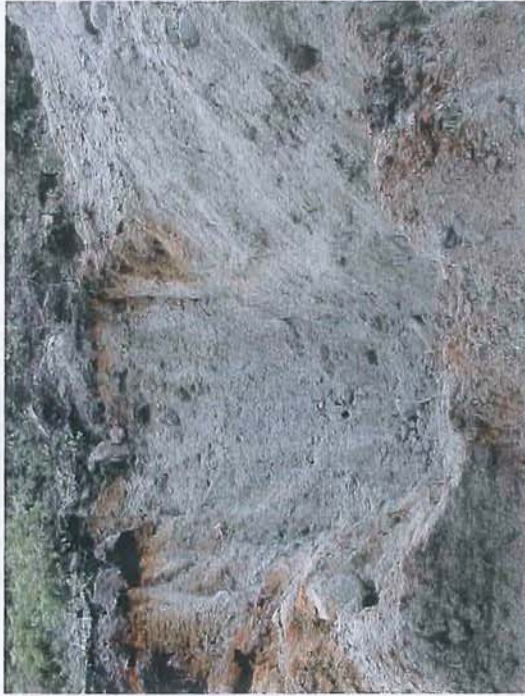
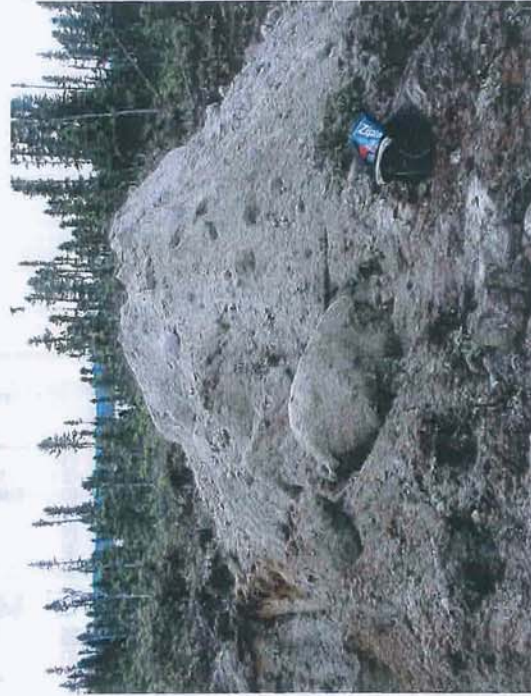
Test Pit Number	Depth (m) From - To	Description
TP-06-007	0.0 - 0.2	ROOTMAT - Black, organic silt with roots and organic matter, loose, moist, compressible.
5,358,022 N 545,275 E Zone 21 UTM NAD 83	0.2 - 0.5	WEATHERED GLACIAL TILL - Reddish brown, silty sand and gravel with occasional cobbles and small boulders, compact, moist.
	0.5 - 2.5	GLACIAL TILL - Grey, sand with some gravel and fines, occasional cobbles and boulders, dense to very dense, moist.
	2.5	Test pit terminated in glacial till. Note: 1) Test pit excavated using a CAT 220 excavator. 2) Groundwater not encountered.

Location: Test pit excavated approximately 900 m south west of the river along the proposed access road. Borrow "A"

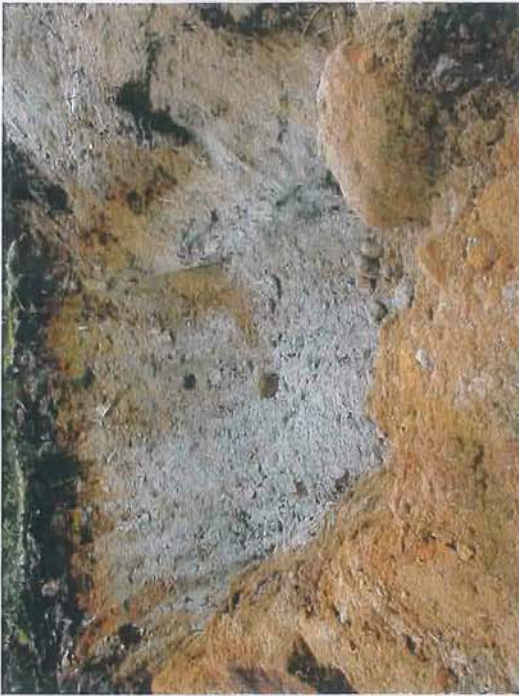
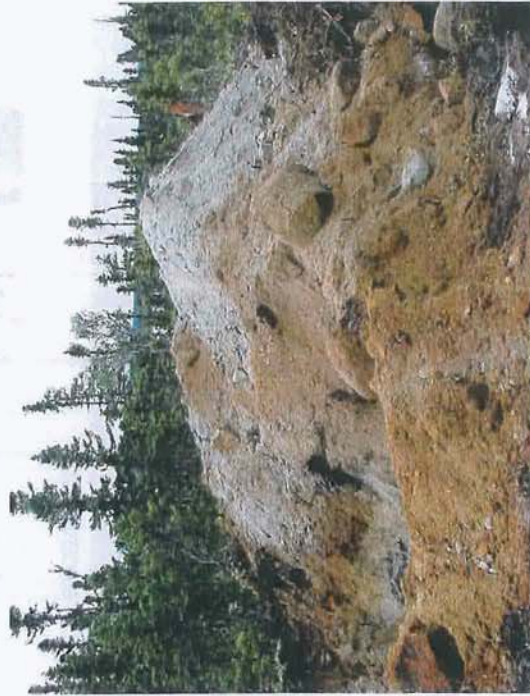
Test Pit Number	Depth (m) From - To	Description
TP-06-008 5,357,999 N 545,254 E Zone 21 UTM NAD 83	0.0 - 0.2 0.2 - 0.5 0.5 - 2.0 2.0	<p>ROOTMAT - Black, organic silt with roots and organic matter, loose, moist, compressible.</p> <p>WEATHERED GLACIAL TILL - Reddish brown, silty sand and gravel with occasional cobbles and small boulders, compact, moist.</p> <p>GLACIAL TILL - Grey, sand with some gravel and fines, occasional cobbles and boulders, dense to very dense, moist.</p> <p>Test pit terminated in glacial till.</p> <p>Note: 1) Test pit excavated using a CAT 220 excavator. 2) Groundwater not encountered.</p>

Location: Test pit excavated approximately 950 m south west of the river along the proposed access road. Borrow "A"
 Date: September 6, 2006
 Notes:

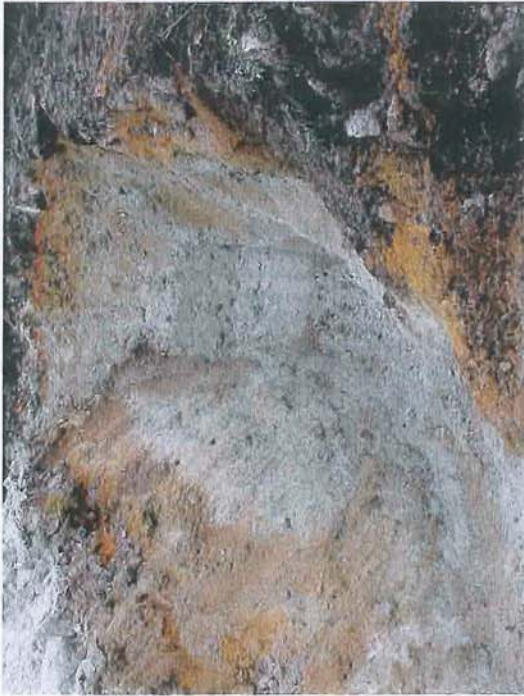
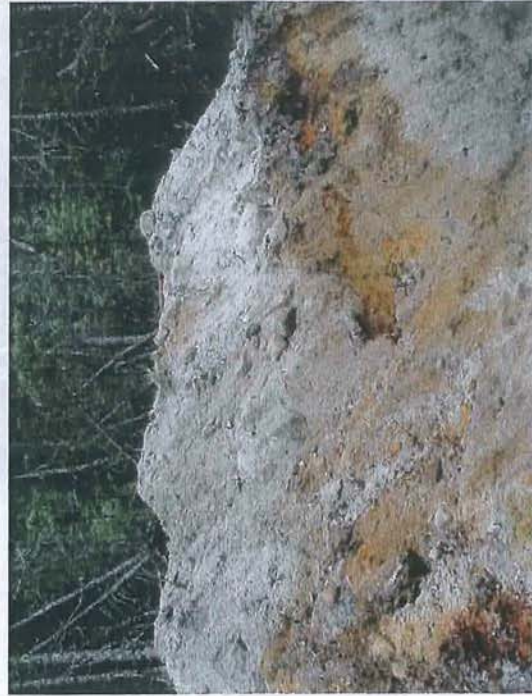
Test Pit Number	Depth (m) From - To	Description
TP-06-009 5,358,004 N 545,245 E Zone 21 UTM NAD 83	0.0 - 0.2	ROOTMAT - Black, organic silt with roots and organic matter, loose, moist, compressible.
	0.2 - 0.5	WEATHERED GLACIAL TILL - Reddish brown, silty sand and gravel with occasional cobbles and small boulders, compact, moist.
	0.5 - 3.0	GLACIAL TILL - Grey, sand with some gravel and fines, occasional cobbles and boulders, dense to very dense, moist.
	3.0	Test pit terminated in glacial till.
Note: 1) Test pit excavated using a CAT 220 excavator. 2) Groundwater not encountered.

Location: Test pit excavated approximately 950 m south west of the river along the proposed access road. Borrow "A"

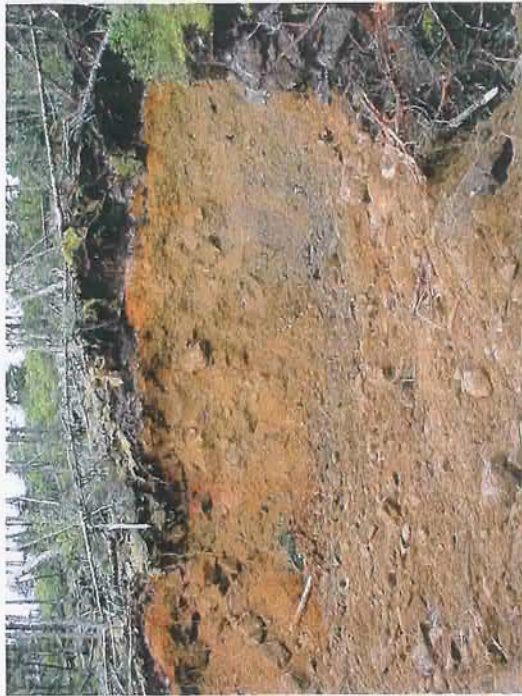
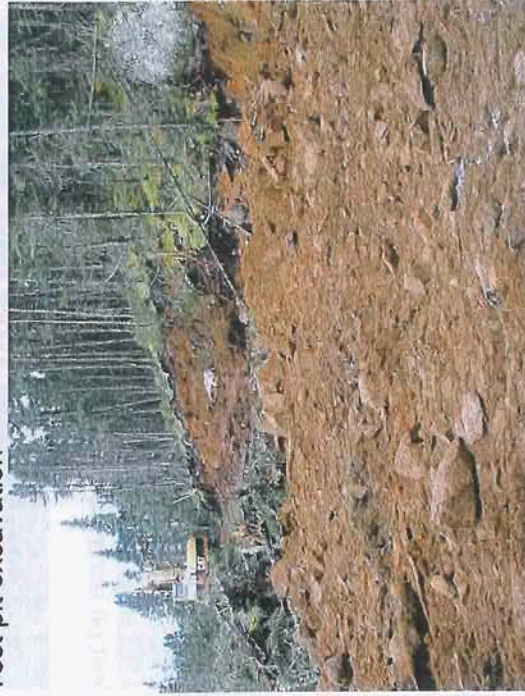
Test Pit Number	Depth (m) From – To	Description
TP-06-010 5,358,884 N 545,813 E Zone 21 UTM NAD 83	0.0 – 0.3	ROOTMAT – Black, organic silt with roots and organic matter, loose, moist, compressible.
	0.3 – 0.6	WEATHERED GLACIAL TILL – Reddish brown, silty sand and gravel with occasional cobbles and small boulders, compact, moist.
	0.6 – 3.0	GLACIAL TILL – Brown, sandy gravel, some fines, cobbles and small boulders, dense to very dense, moist.
	3.0	Test pit terminated in glacial till.

Location: Test pit excavated along centre line of proposed dam approximately 20 m east of the river.
Date: September 7, 2006
Notes: Sieve analysis conducted on Glacial Till soil from excavation spoilage.

Test pit excavation material used to build helicopter pad.

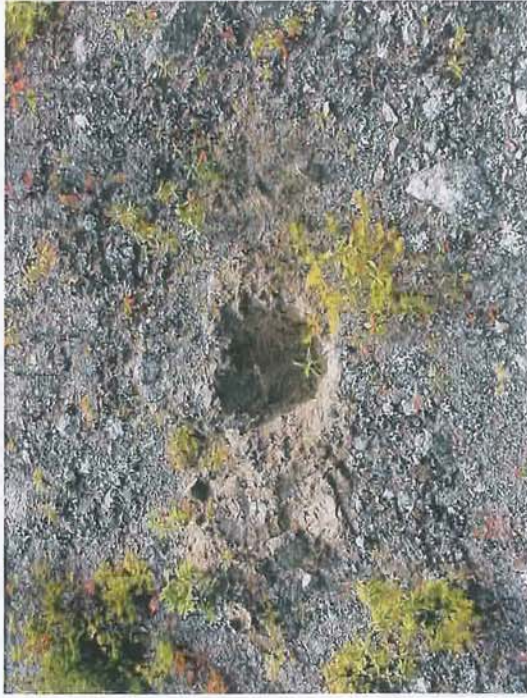
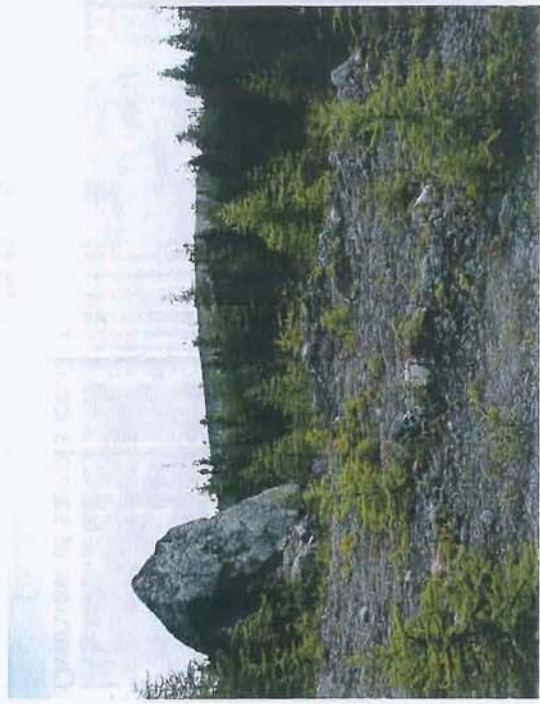
Test Pit Number	Depth (m) From - To	Description
TP-06-011 5,353,387 N 541,957 E Zone 21 UTM NAD 83	0.0 - 0.3 0.3	GLACIAL TILL - Tan/grey, fine to medium grained sand with some gravel, trace of fines, and occasional cobbles, dense, moist. Test pit terminated in native soil. Note: 1) Test pit hand dug with a shovel. 2) Groundwater not encountered.

Location: Existing borrow, main access road.
 Date: September 7, 2006
 Notes: Hand dug test pit.
 Sieve analysis conducted on Glacial Till soil.

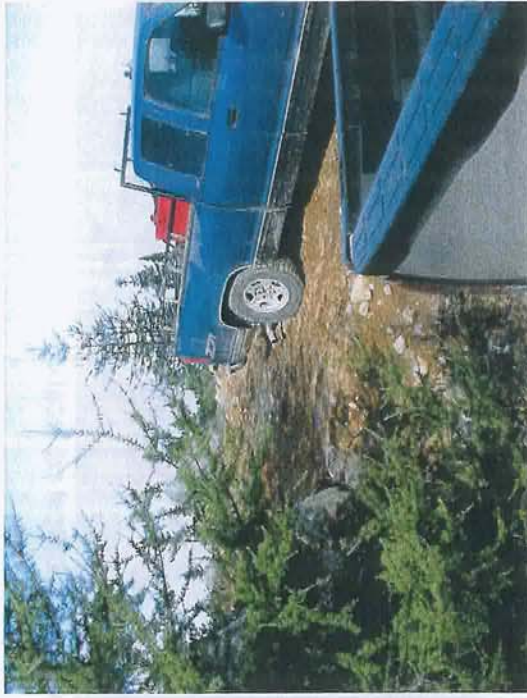
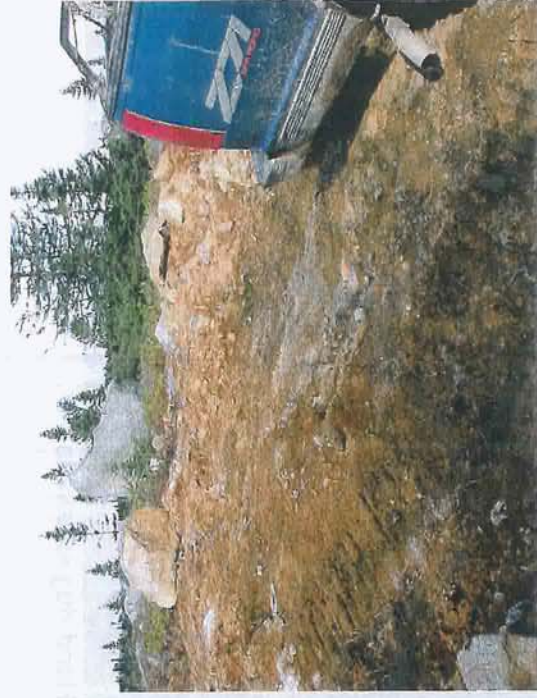
Test Pit Number	Depth (m) From - To	Description
TP-06-012 5,353,075 N 542,309 E Zone 21 UTM NAD 83	0.0 - 0.3 0.3	GLACIAL TILL - Brown, sand and gravel, some fines, and occasional cobbles, boulders on the ground surface, dense, moist. Test pit terminated in native soil. Note: 1) Test pit hand dug with a shovel. 2) Groundwater not encountered.

Location: Intersection of main access road and proposed permanent access to site. Borrow "C"
Date: September 7, 2006
Notes: Hand dug test pit
 Sieve analysis conducted on Glacial Till soil.

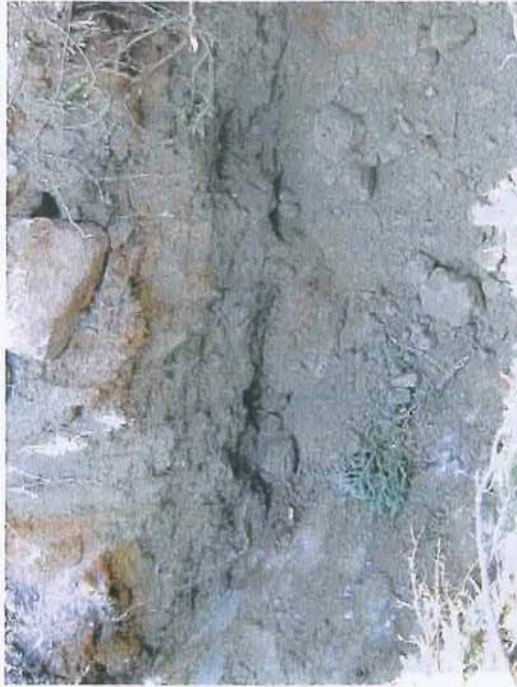
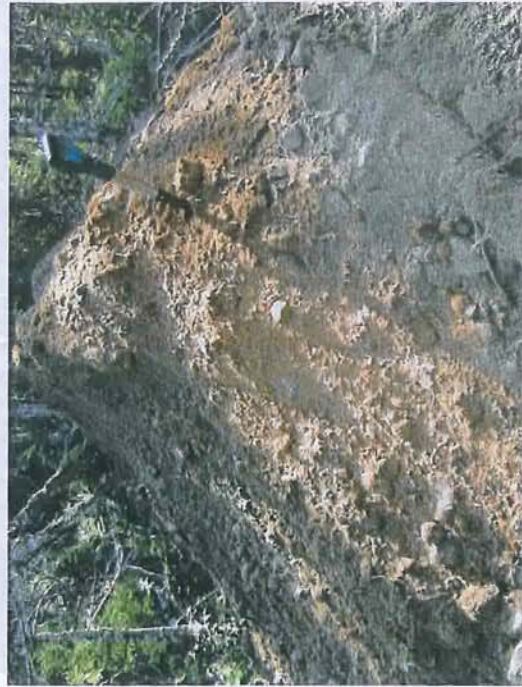
Test Pit Number	Depth (m) From - To	Description
TP-06-013 5,356,620 N 543,606 E Zone 21 UTM NAD 83	0.0 - 0.2	ROOTMAT - Black, organic silt with roots and organic matter, loose, moist, compressible.
	0.2 - 0.5	WEATHERED GLACIAL TILL - Reddish brown, silty sand and gravel with occasional cobbles and small boulders, compact, moist.
	0.5 - 2.3	GLACIAL TILL - Grey, sand and gravel, some fines, occasional cobbles and boulders, dense to very dense, moist. Test pit terminated in glacial till.
	2.3	Note: 1) Test pit excavated using a Daewoo 225LCX excavator. 2) Groundwater not encountered.

Location: Test pit excavated approximately 3100 m south west of the river along the proposed access road. Proposed Campsite.
Date: September 8, 2006
Notes: Sieve analysis conducted on Glacial Till soil from excavation spoilage.

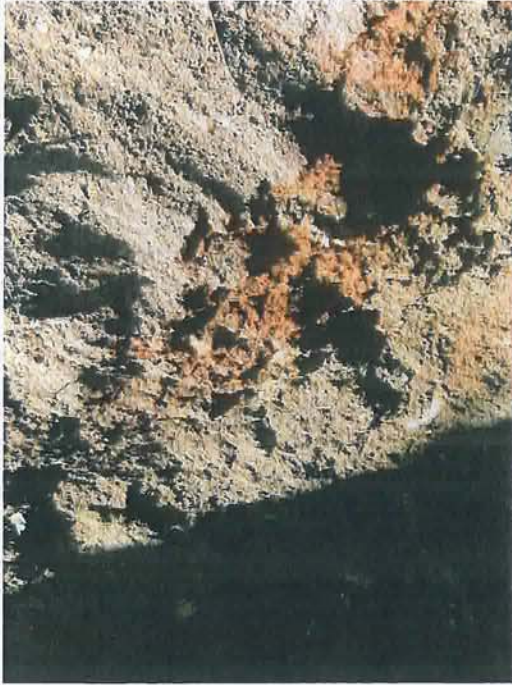
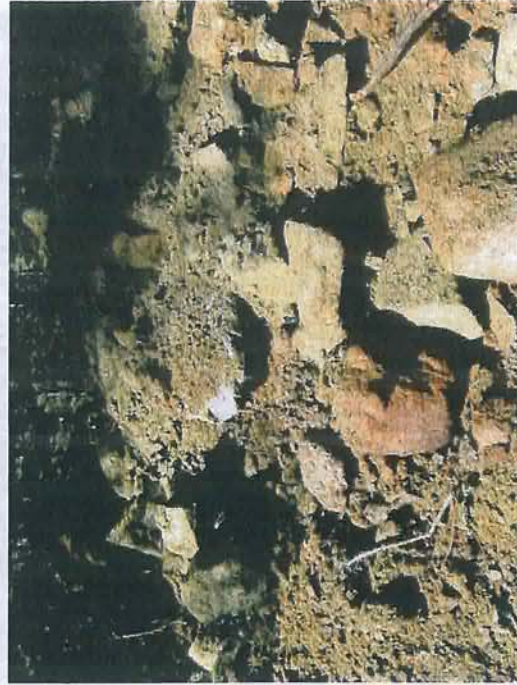
Test Pit Number	Depth (m) From – To	Description
TP-06-014 5,356,710 N 543,652 E Zone 21 UTM NAD 83	0.0 – 0.2	ROOTMAT – Black, organic silt with roots and organic matter, loose, moist, compressible.
	0.2 – 0.5	WEATHERED GLACIAL TILL – Reddish brown, silty sand and gravel with occasional cobbles and small boulders, compact, moist.
	0.5 – 2.0	GLACIAL TILL – Grey, sand and gravel, some fines and boulders, occasional cobbles, dense to very dense, moist.
	2.0	Test pit terminated in glacial till.
		Note: 1) Test pit excavated using a Daewoo 225LCX excavator. 2) Groundwater not encountered.

Location: Test pit excavated approximately 2900 m south west of the river along the proposed access road. Proposed Campsite.
Date: September 8, 2006
Notes: Sieve analysis conducted on Glacial Till soil from excavation spoilage.

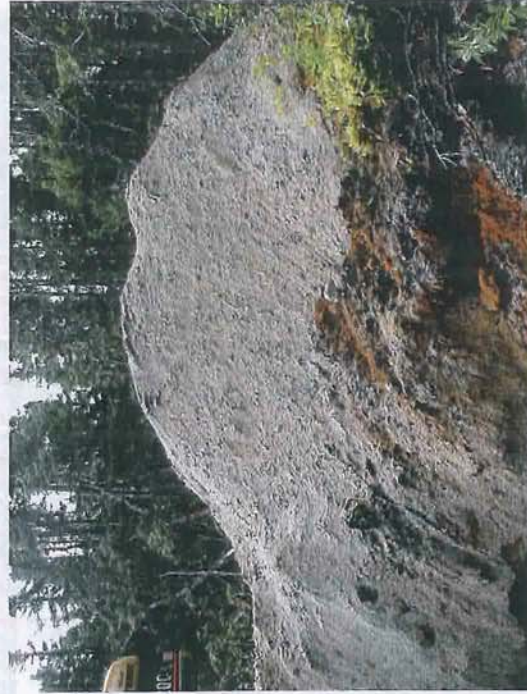
Spoilage from the test pit excavation

Location: Test pit excavated approximately 150 m south west of the river along the proposed access road. Borrow "B"
Date: September 9, 2006
Notes: Sieve analysis conducted on Glacial Till soil from excavation spoilage.

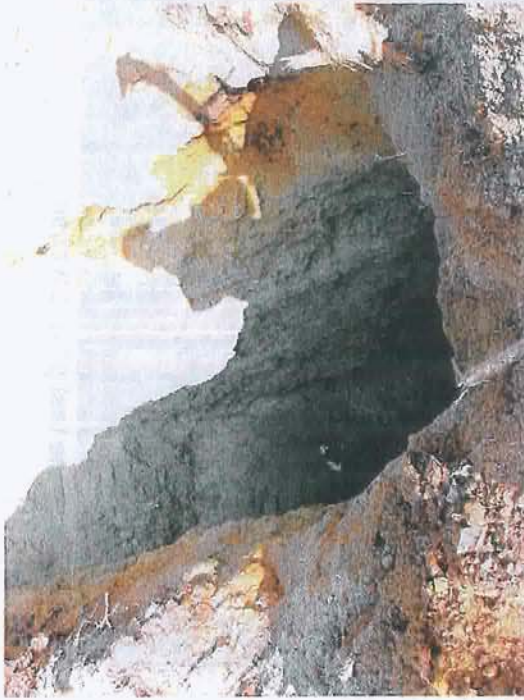
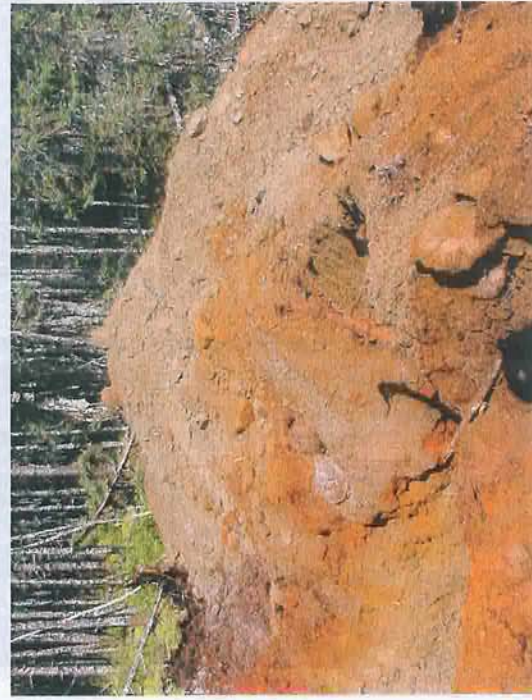
Test Pit Number	Depth (m) From – To	Description
TP-06-035 5,358,542 N 545,779 E Zone 21 UTM NAD 83	0.0 – 0.2 0.2 – 0.4 0.4 – 6.0 6.0	<p>ROOTMAT – Black, organic silt with roots and organic matter, loose, moist, compressible.</p> <p>WEATHERED GLACIOFLUVIAL SOIL – Reddish brown, silty sand and gravel with occasional cobbles and small boulders, compact, moist.</p> <p>GLACIOFLUVIAL SOIL – Grey, sand and gravel, trace fines, occasional cobbles and boulders, dense to very dense, moist.</p> <p>Test pit terminated in glaciofluvial soil.</p> <p>Note: 1) Test pit excavated using a CAT 320 excavator. 2) Groundwater not encountered. 3) Stratified with 100 mm gravel seams.</p>

Test pit excavation

Spoilage from the test pit excavation

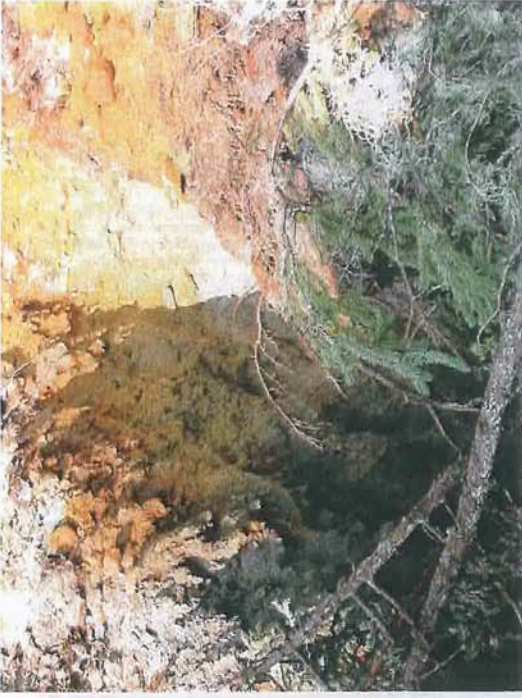
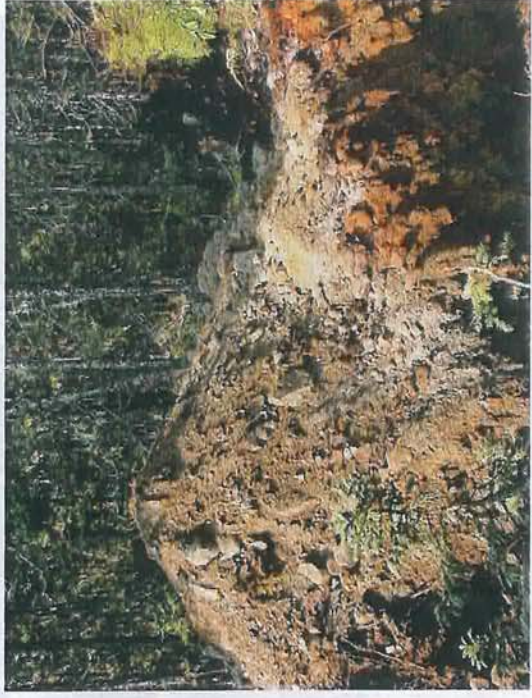
Test Pit Number	Depth (m) From - To	Description
TP-06-036	0.0 - 0.2	ROOTMAT - Black, organic silt with roots and organic matter, loose, moist, compressible.
5,358,514 N 545,778 E Zone 21 UTM NAD 83	0.2 - 0.5	WEATHERED GLACIOFLUVIAL SOIL - Reddish brown, silty sand and gravel with occasional cobbles and small boulders, compact, moist.
	0.5 - 4.0	GLACIOFLUVIAL SOIL - Grey, sand and gravel, some fines and cobbles, occasional boulders, dense to very dense, moist.
	4.0	Test pit terminated on bedrock.
		Note: 1) Test pit excavated using a CAT 320 excavator. 2) Groundwater not encountered.

Test pit excavation

Spoilage from the test pit excavation

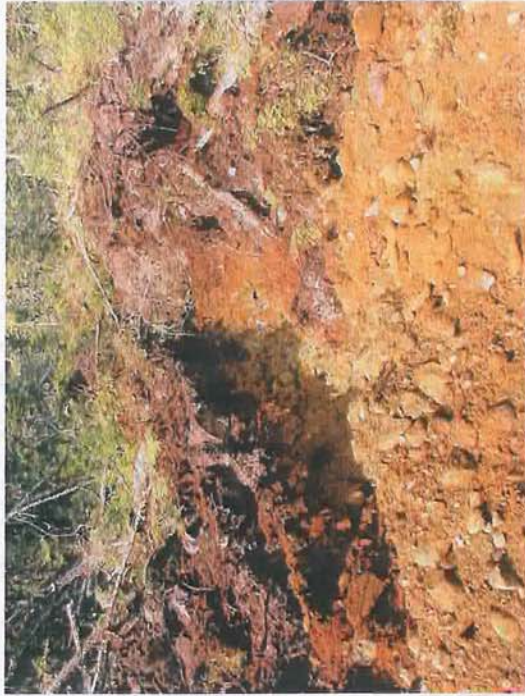
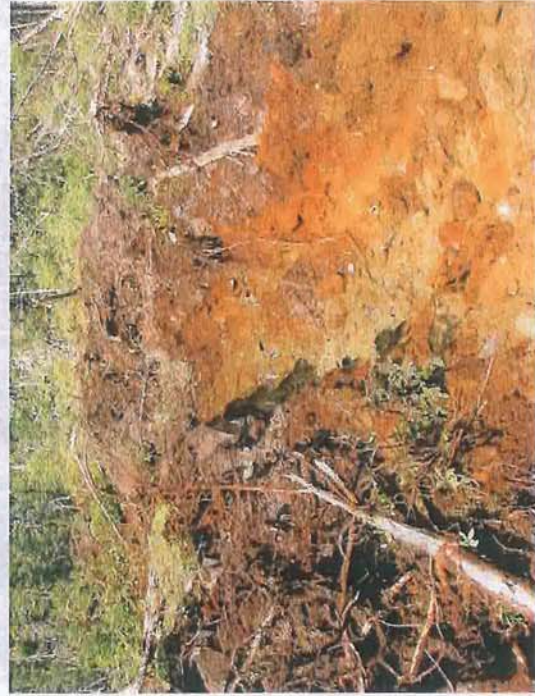
Test Pit Number	Depth (m) From - To	Description
TP-06-037 5,358,547 N 545,763 E Zone 21 UTM NAD 83	0.0 - 0.2 0.2 - 0.5	ROOTMAT - Black, organic silt with roots and organic matter, loose, moist, compressible. WEATHERED GLACIOFLUVIAL SOIL - Reddish brown, silty sand and gravel with occasional cobbles and small boulders, compact, moist.
	0.5 - 1.5 1.5	GLACIOFLUVIAL SOIL - Brownish grey, sand and gravel, trace to some fines and cobbles, occasional boulders, dense to very dense, moist. Test pit terminated on bedrock. Note: 1) Test pit excavated using a CAT 320 excavator. 2) Groundwater not encountered. 3) Test pit excavated as a trench.

Location: Test pit excavated approximately 200 m south west of the river along the proposed access road. Borrow "B"
 Date: September 9, 2006
 Notes:

Trench excavation

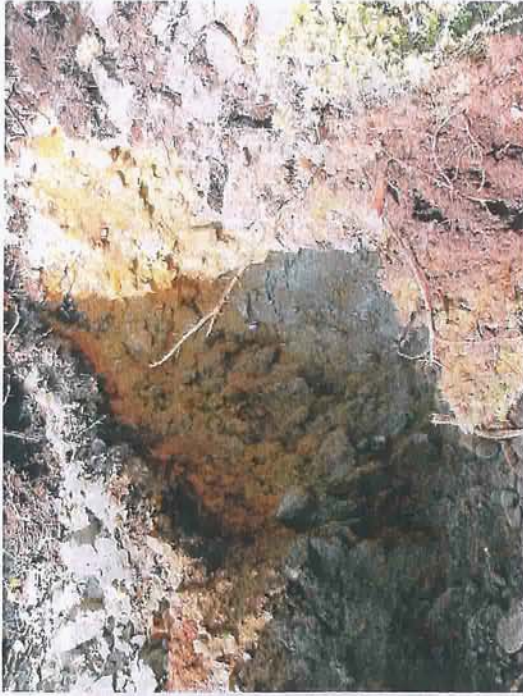
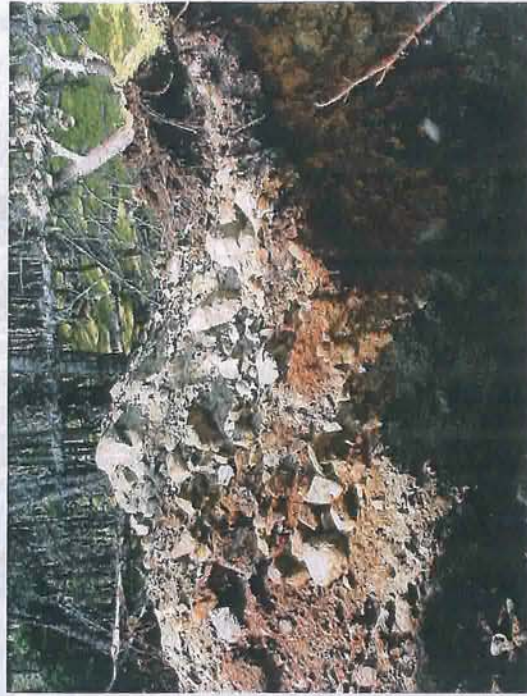
Test Pit Number	Depth (m) From - To	Description
TP-06-038 5,358,530 N 545,779 E Zone 21 UTM NAD 83	0.0 - 0.2 0.2 - 0.5 0.5 - 1.5 1.5	<p>ROOTMAT - Black, organic silt with roots and organic matter, loose, moist, compressible.</p> <p>WEATHERED GLACIOFLUVIAL SOIL - Reddish brown, silty sand and gravel with occasional cobbles and small boulders, compact, moist.</p> <p>GLACIOFLUVIAL SOIL - Grey, sand and gravel, some cobbles, trace fines, occasional boulders, dense to very dense, moist.</p> <p>Test pit terminated on bedrock.</p> <p>Note: 1) Test pit excavated using a CAT 320 excavator. 2) Groundwater not encountered.</p>

Test pit excavation

Spoilage from the test pit excavation

Location: Test pit excavated approximately 250 m south west of the river along the proposed access road. Borrow "B"

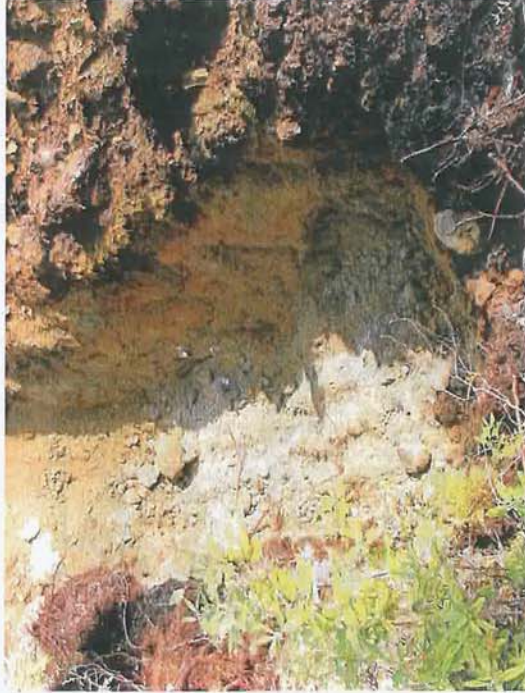
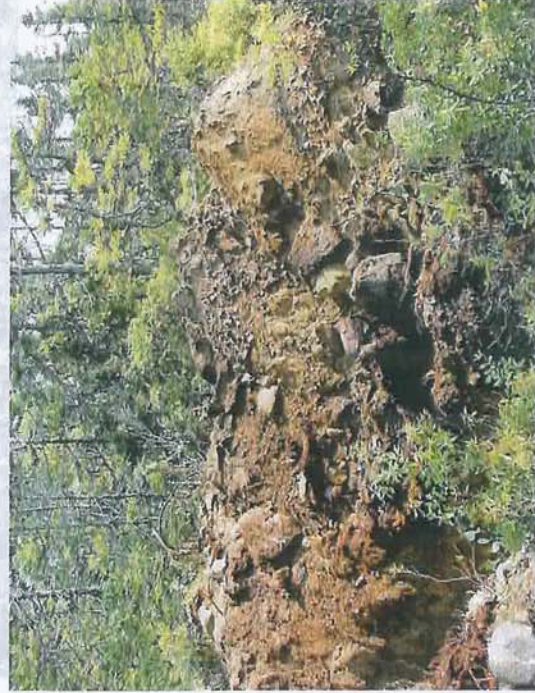
Test Pit Number	Depth (m) From - To	Description
TP-06-039 5,358,426 N 545,762 E Zone 21 UTM NAD 83	0.0 - 0.2 0.2 - 0.5 0.5 - 1.2 1.2	ROOTMAT - Black, organic silt with roots and organic matter, loose, moist, compressible. WEATHERED GLACIAL TILL - Reddish brown, silty sand and gravel with occasional cobbles and small boulders, compact, moist. GLACIAL TILL - Grey, sand and gravel, some cobbles and boulders, trace to some fines dense to very dense, moist. Test pit terminated on bedrock. Note: 1) Test pit excavated using a CAT 320 excavator. 2) Groundwater not encountered.

Location: Test pit excavated approximately 300 m south west of the river along the proposed access road. Borrow "A"
Date: September 9, 2006
Notes:

Test pit excavation

Spoilage from the test pit excavation

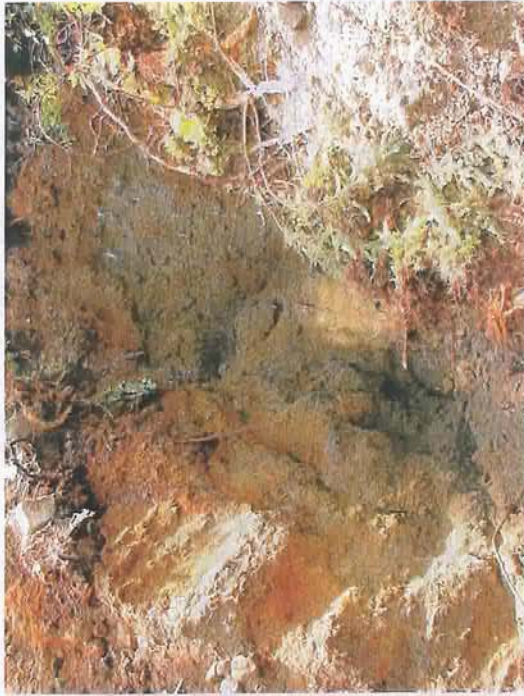
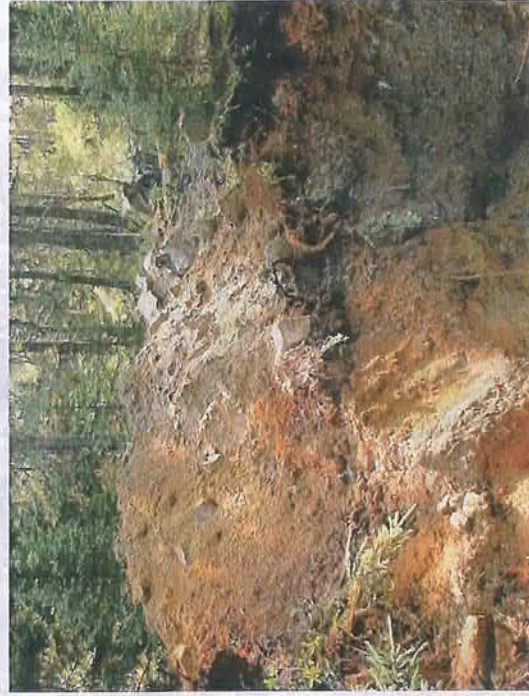
Test Pit Number	Depth (m) From - To	Description
TP-06-040 5,358,320 N 545,631 E Zone 21 UTM NAD 83	0.0 - 0.2	ROOTMAT - Black, organic silt with roots and organic matter, loose, moist, compressible.
	0.2 - 0.5	WEATHERED GLACIAL TILL - Reddish brown, silty sand and gravel with occasional cobbles and small boulders, compact, moist.
	0.5 - 2.2	GLACIAL TILL - Grey, sand and gravel, some fines and cobbles, occasional boulders, dense to very dense, moist.
	2.2	Test pit terminated on bedrock.
		Note: 1) Test pit excavated using a CAT 320 excavator. 2) Groundwater encountered at base of the excavation.

Test pit excavation

Spoilage from the test pit excavation

Location: Test pit excavated approximately 450 m south west of the river along the proposed access road. Borrow "A"

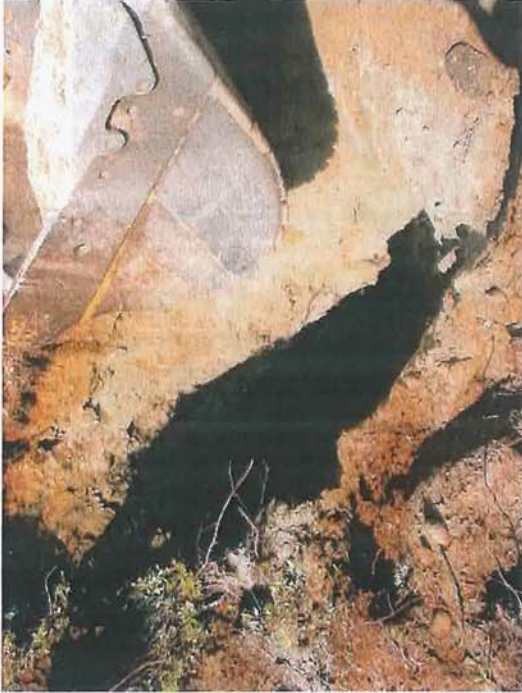
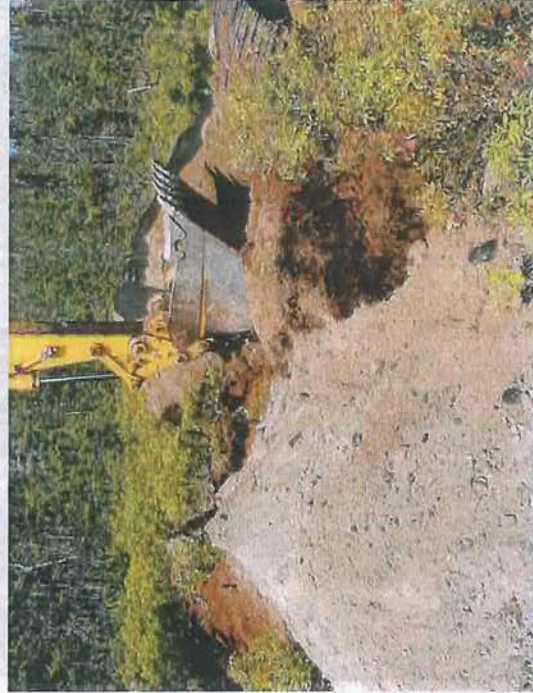
Test Pit Number	Depth (m) From - To	Description
TP-06-041	0.0 - 0.2	ROOTMAT - Black, organic silt with roots and organic matter, loose, moist, compressible.
5,358,210 N 545,541 E Zone 21 UTM NAD 83	0.2 - 0.5	WEATHERED GLACIAL TILL - Reddish brown, silty sand and gravel with occasional cobbles and small boulders, compact, moist.
	0.5 - 2.8	GLACIAL TILL - Grey, gravely sand, some fines, occasional cobbles, dense to very dense, moist.
	2.8	Test pit terminated on bedrock.
Note: 1) Test pit excavated using a CAT 320 excavator. 2) Groundwater not encountered.

Location: Test pit excavated approximately 600 m south west of the river along the proposed access road. Borrow "A"
Date: September 9, 2006
Notes: Sieve analysis conducted on Glacial Till soil from excavation spoilage.

Test pit excavation

Spoilage from the test pit excavation

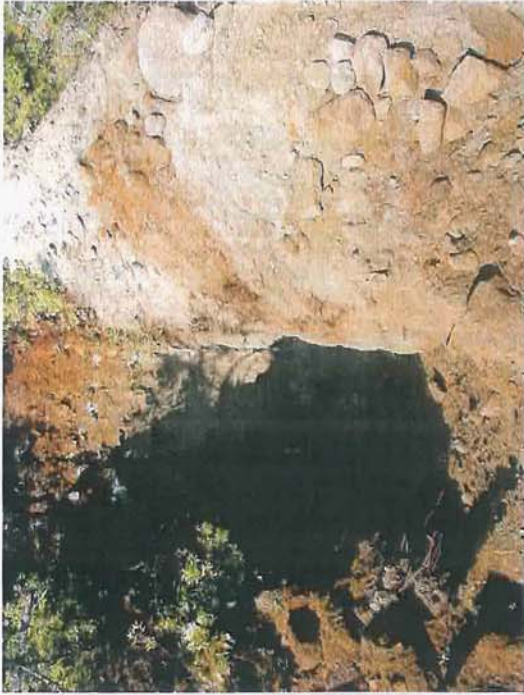
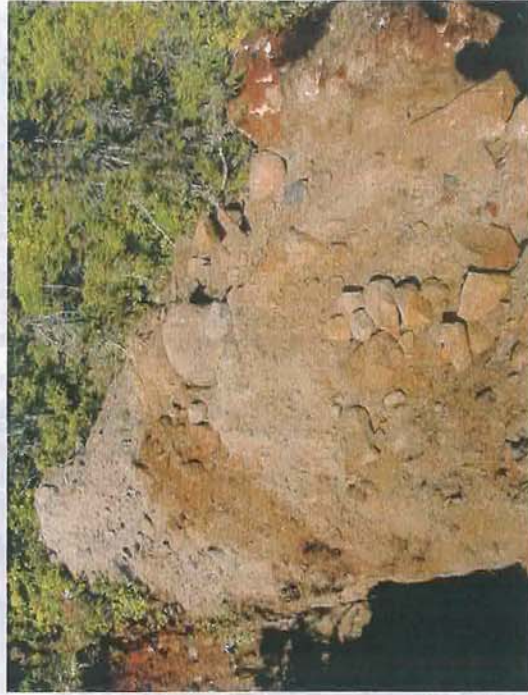
Test Pit Number	Depth (m) From - To	Description
TP-06-042 5,358,223 N 545,525 E Zone 21 UTM NAD 83	0.0 - 0.2	ROOTMAT - Black, organic silt with roots and organic matter, loose, moist, compressible.
	0.2 - 0.5	WEATHERED GLACIAL TILL - Reddish brown, silty sand and gravel with occasional cobbles and small boulders, compact, moist.
	0.5 - 3.0	GLACIAL TILL - Grey, sand and gravel, trace to some fines, cobbles, and boulders, dense to very dense, moist.
	3.0	Test pit terminated on bedrock.
Note: 1) Test pit excavated using a CAT 320 excavator. 2) Groundwater not encountered.

Test pit excavation

Spoilage from the test pit excavation

Location: Test pit excavated approximately 600 m south west of the river along the proposed access road. Borrow "A"

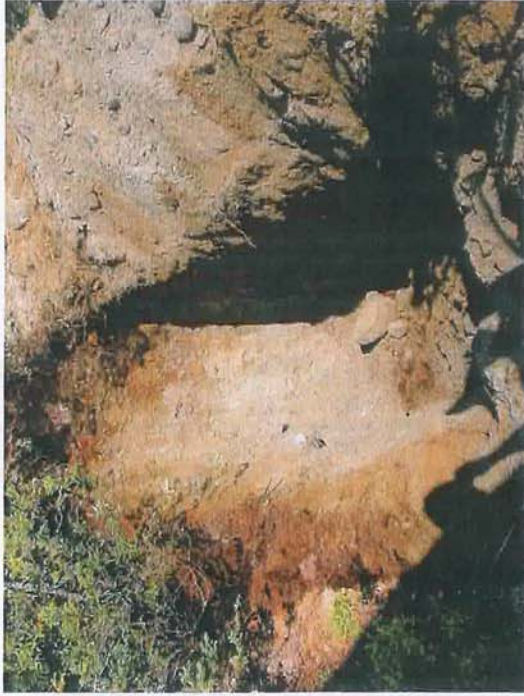
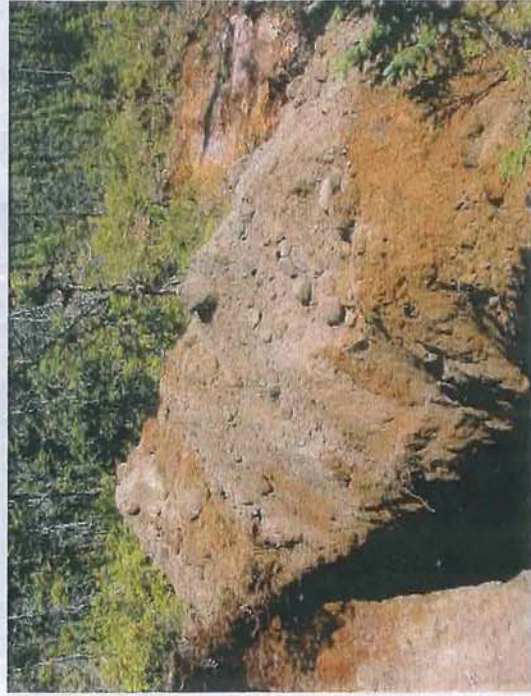
Test Pit Number	Depth (m) From - To	Description
TP-06-043	0.0 - 0.2	ROOTMAT - Black, organic silt with roots and organic matter, loose, moist, compressible.
5,358,171 N 545,492 E Zone 21 UTM NAD 83	0.2 - 0.5	WEATHERED GLACIAL TILL - Reddish brown, silty sand and gravel with occasional cobbles and small boulders, compact, moist.
	0.5 - 2.2	GLACIAL TILL - Grey, sand and gravel, some fines and cobbles, occasional boulders, dense to very dense, moist.
	2.2	Test pit terminated on bedrock.
		Note: 1) Test pit excavated using a CAT 320 excavator. 2) Groundwater not encountered.

Test pit excavation

Spoilage from the test pit excavation

Location: Test pit excavated approximately 700 m south west of the river along the proposed access road. Borrow "A"

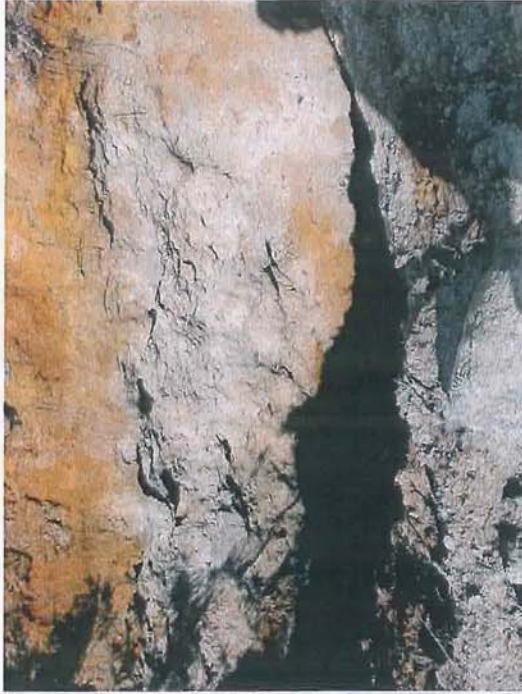
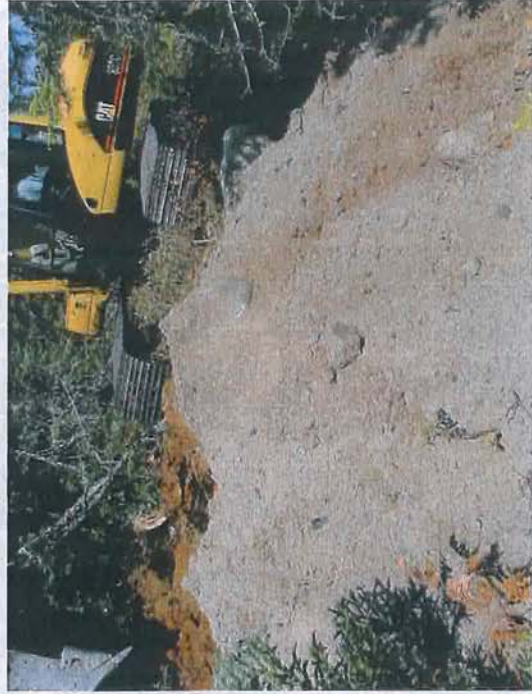
Test Pit Number	Depth (m) From - To	Description
TP-06-044 5,357,784 N 544,879 E Zone 21 UTM NAD 83	0.0 - 0.2	ROOTMAT - Black, organic silt with roots and organic matter, loose, moist, compressible.
	0.2 - 0.5	WEATHERED GLACIAL TILL - Reddish brown, silty sand and gravel with occasional cobbles and small boulders, compact, moist.
	0.5 - 2.1	GLACIAL TILL - Grey, gravely sand, some fines, occasional cobbles and boulders, dense to very dense, moist.
	2.1	Test pit terminated on bedrock.
		Note: 1) Test pit excavated using a CAT 320 excavator. 2) Groundwater not encountered.

Location: Test pit excavated approximately 1350 m south west of the river along the proposed access road. Borrow "A"
Date: September 9, 2006
Notes: Sieve analysis conducted on Glacial Till soil from excavation spoilage.

Test pit excavation

Spoilage from the test pit excavation
