Geotechnical Site Investigation Proposed Island Pond Hydro Electric Development (as prepared by AMEC)

**Geotechnical Site Investigation
Proposed Island Pond Hydro Electric
Development
South Central Newfoundland
Date: January 03, 2007
Final Report
Submitted by:
AMEC Earth & Environmental**

**GEOTECHNICAL INVESTIGATION
PROPOSED ISLAND POND
HYDROELECTRIC DEVELOPMENT
SOUTH CENTRAL NEWFOUNDLAND**

January 2007
TF6316540

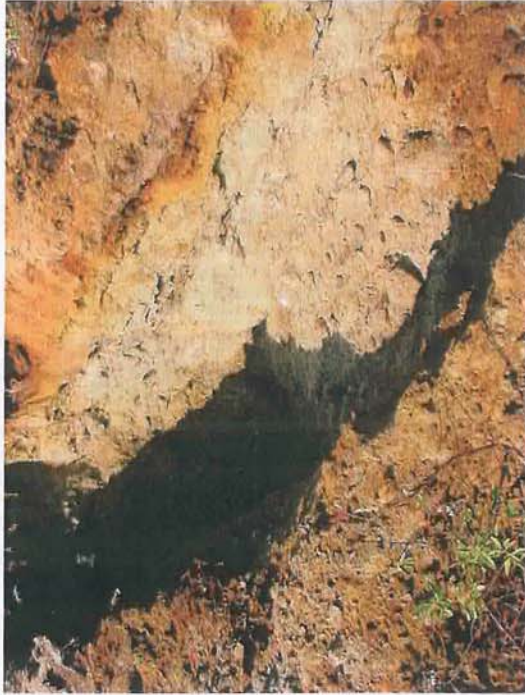
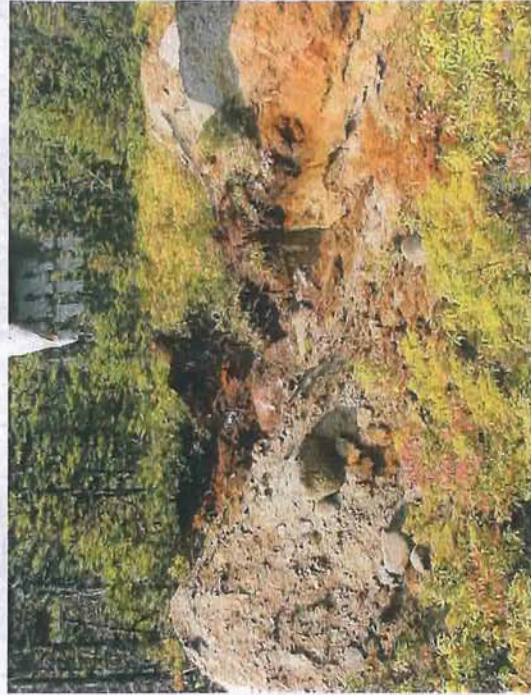
Test Pit Number	Depth (m) From - To	Description
TP-06-045 5,357,684 N 544,708 E Zone 21 UTM NAD 83	0.0 - 0.2 0.2 - 0.4 0.4 - 1.2 1.2	<p>ROOTMAT - Black, organic silt with roots and organic matter, loose, moist, compressible.</p> <p>WEATHERED GLACIAL TILL - Reddish brown, silty sand and gravel with occasional cobbles and small boulders, compact, moist.</p> <p>GLACIAL TILL - Grey, sand and gravel, trace to some fines and cobbles, occasional boulders, dense to very dense, moist.</p> <p>Test pit terminated on bedrock.</p> <p>Note: 1) Test pit excavated using a CAT 320 excavator. 2) Groundwater not encountered.</p>

Test pit excavation

Spoilage from the test pit excavation

Location: Test pit excavated approximately 1550 m south west of the river along the proposed access road. Borrow "A"
 Date: September 9, 2006
 Notes:

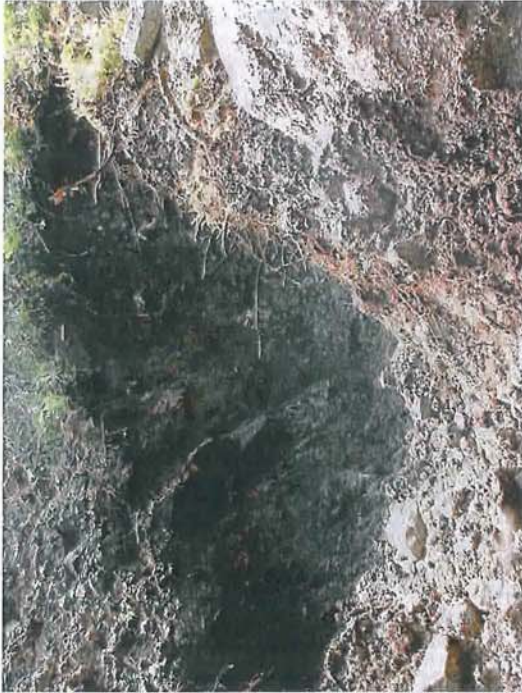
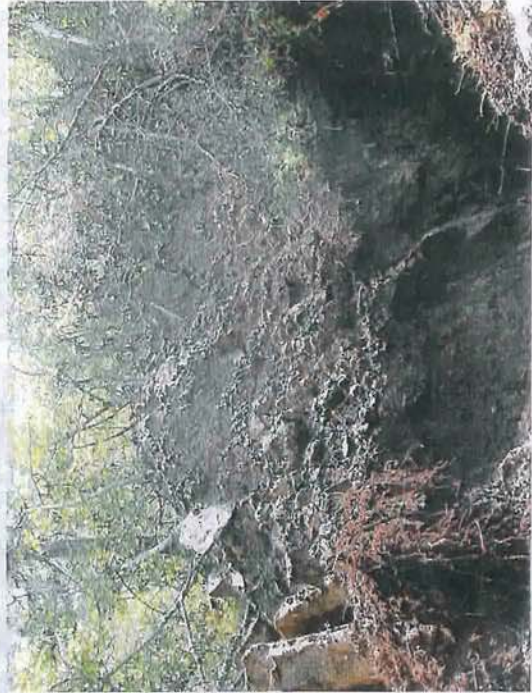
Test Pit Number	Depth (m) From - To	Description
TP-06-046 5,356,807 N 543,668 E Zone 21 UTM NAD 83	0.0 - 0.2	ROOTMAT - Black, organic silt with roots and organic matter, loose, moist, compressible.
	0.2 - 1.0	GLACIAL TILL - Dark grey, boulders and cobbles with sand and gravel and trace of fines, compact, moist.
	1.0 - 2.0	GLACIAL TILL - Grey, sand and gravel, trace to some fines and cobbles, occasional boulders, dense to very dense, moist.
	2.0	Test pit terminated on bedrock.

Location: Test pit excavated approximately 2900 m south west of the river along the proposed access road. Borrow "A"
 Date: September 9, 2006

Test pit excavation

Spoilage from the test pit excavation

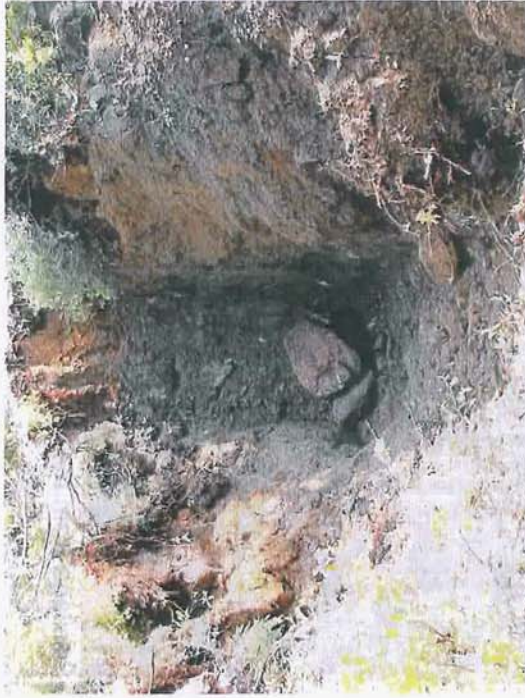
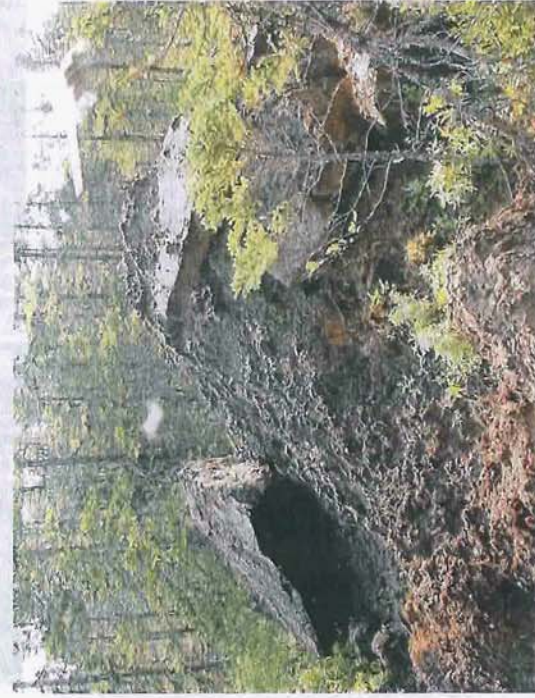
Test Pit Number	Depth (m) From - To	Description
TP-06-047	0.0 - 0.2	ROOTMAT - Black, organic silt with roots and organic matter, loose, moist, compressible.
5,356,558 N 543,568 E Zone 21 UTM NAD 83	0.2 - 0.5	WEATHERED GLACIAL TILL - Reddish brown, silty sand and gravel with cobbles and small boulders, compact, moist.
	0.5 - 2.2	GLACIAL TILL - Grey, sand and gravel, trace to some fines and cobbles, boulders located near the ground surface, dense to very dense, moist.
	2.2	Test pit terminated on bedrock. Note: 1) Test pit excavated using a CAT 320 excavator. 2) Groundwater not encountered.

Test pit excavation

Spoilage from the test pit excavation

Location: Test pit excavated in general area of proposed camp site.
 Date: September 9, 2006
 Notes: Sieve analysis conducted on Glacial Till soil from excavation spoilage.

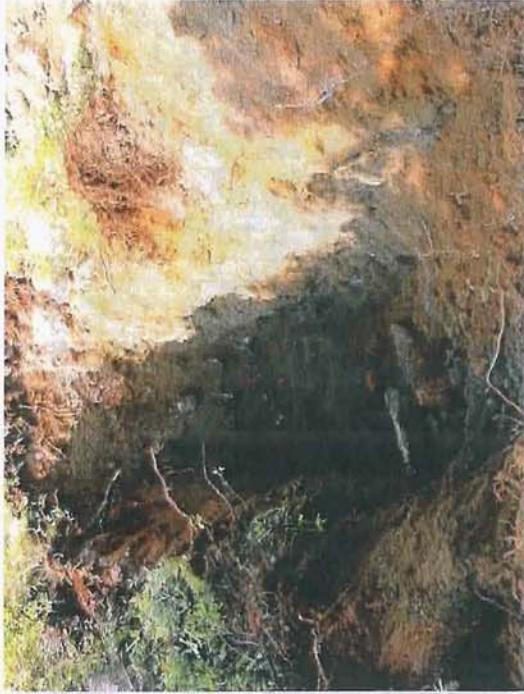
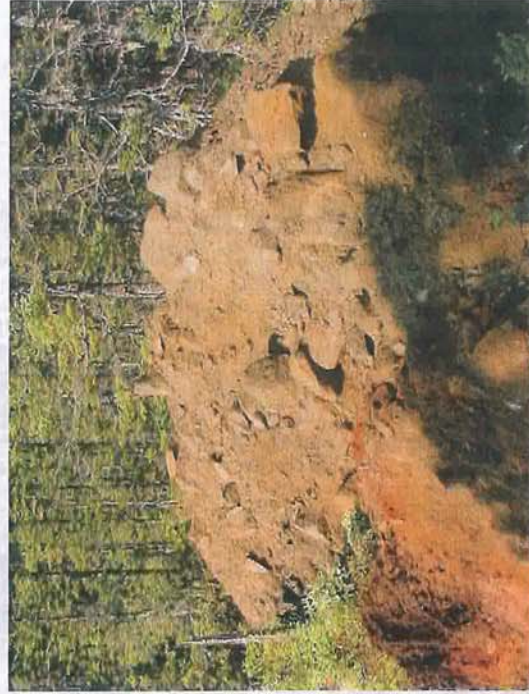
Test Pit Number	Depth (m) From - To	Description
TP-06-048	0.0 - 0.2	ROOTMAT - Black, organic silt with roots and organic matter, loose, moist, compressible.
5,356,586 N 543,549 E Zone 21 UTM NAD 83	0.2 - 0.5	WEATHERED GLACIAL TILL - Reddish brown, silty sand and gravel with cobbles and small boulders, compact, moist.
	0.5 - 2.5	GLACIAL TILL - Brownish grey, sand and gravel, trace to some fines, cobbles, and boulders, dense to very dense, moist.
	2.5	Test pit terminated on bedrock. Note: 1) Test pit excavated using a CAT 320 excavator. 2) Groundwater encountered in base of excavation.

Test pit excavation

Spoilage from the test pit excavation

Location: Test pit excavated in general area of proposed camp site.

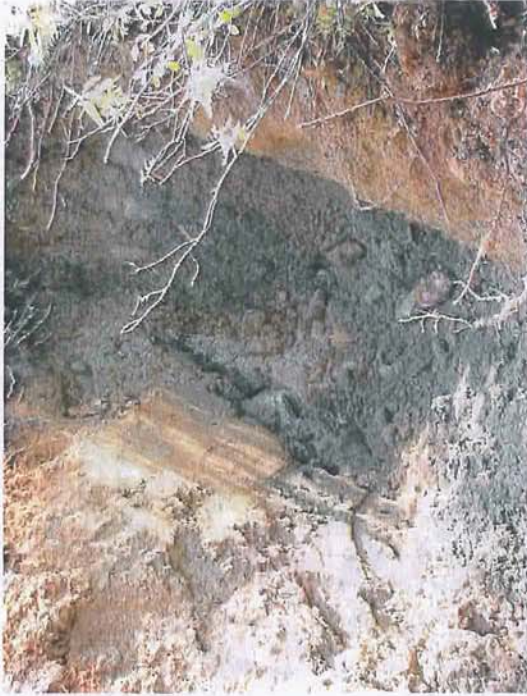
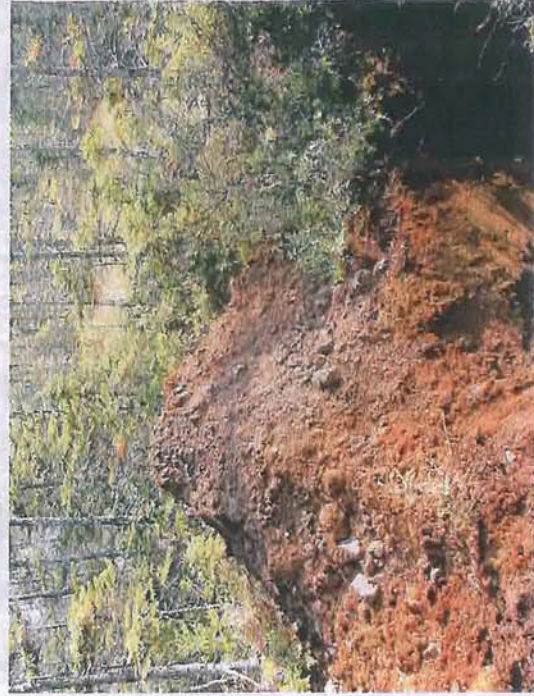
Test Pit Number	Depth (m) From – To	Description
TP-06-049 5,356,558 N 543,524 E Zone 21 UTM NAD 83	0.0 – 0.2 0.2 – 0.4 0.4 – 2.0 2.0	<p>ROOTMAT – Black, organic silt with roots and organic matter, loose, moist, compressible.</p> <p>WEATHERED GLACIAL TILL – Reddish brown, silty sand and gravel with occasional cobbles and small boulders, compact, moist.</p> <p>GLACIAL TILL – Grey, gravely sand, trace to some fines and cobbles, dense to very dense, moist.</p> <p>Test pit terminated on bedrock.</p> <p>Note: 1) Test pit excavated using a CAT 320 excavator. 2) Groundwater encountered in base of excavation. 3) Test pit excavated approximately 15 m from a marshy area.</p>

Location: Test pit excavated in general area of proposed camp site.
 Date: September 9, 2006
 Notes: Sieve analysis conducted on Glacial Till soil from excavation spoilage.

Test pit excavation

Spoilage from the test pit excavation

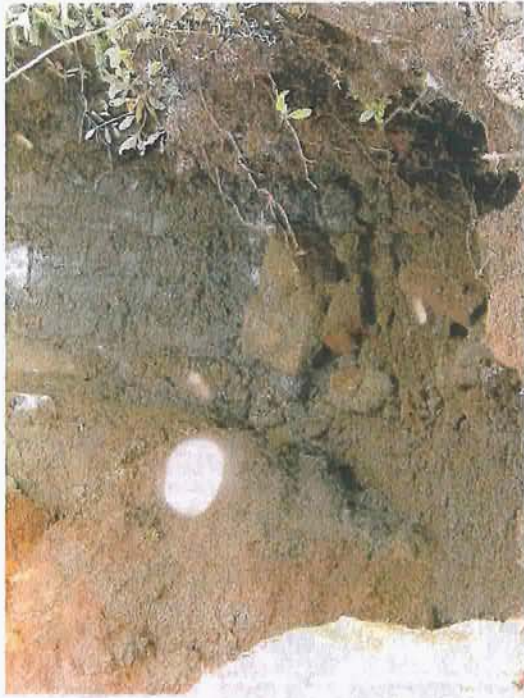
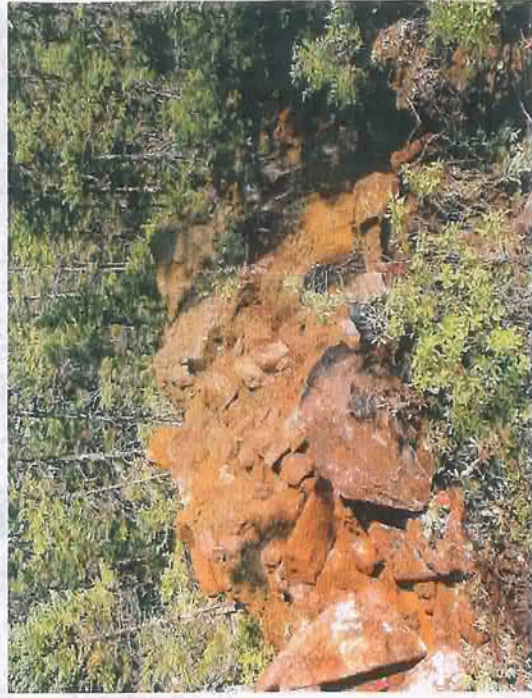
Test Pit Number	Depth (m) From - To	Description
TP-06-050 5,356,386 N 543,457 E Zone 21 UTM NAD 83	0.0 - 0.2 0.2 - 0.4 0.4 - 2.5 2.5	<p>ROOTMAT - Black, organic silt with roots and organic matter, loose, moist, compressible.</p> <p>WEATHERED GLACIAL TILL - Reddish brown, silty sand and gravel with cobbles and small boulders, compact, moist.</p> <p>GLACIAL TILL - Brownish grey, sand, gravel, cobbles, and boulders, trace to some fines, dense to very dense, moist.</p> <p>Test pit terminated on bedrock.</p> <p>Note: 1) Test pit excavated using a CAT 320 excavator. 2) Groundwater encountered in base of excavation.</p>

Test pit excavation

Spoilage from the test pit excavation

Location: Test pit excavated in general area of proposed camp site.
 Date: September 9, 2006
 Notes: Sieve analysis conducted on Glacial Till soil from excavation spoilage.

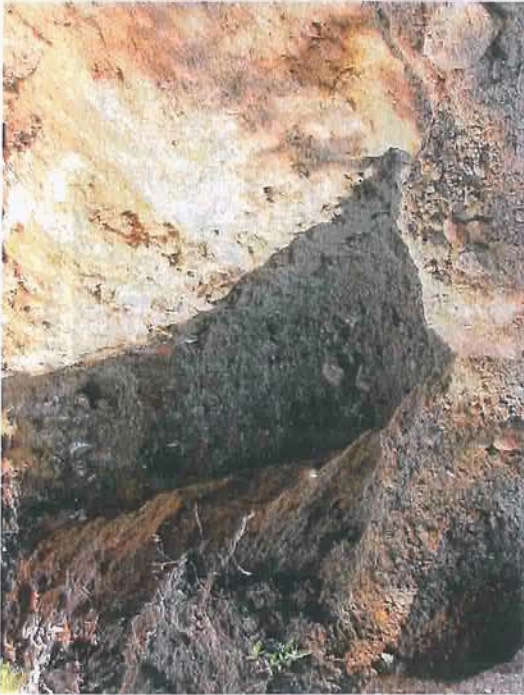
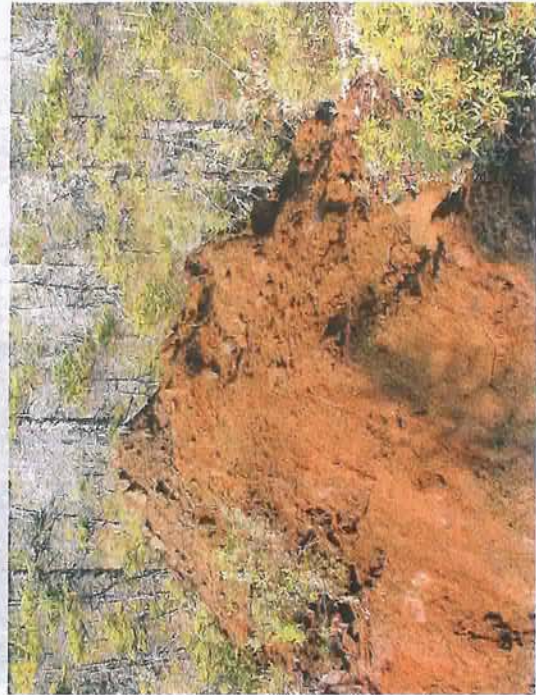
Test Pit Number	Depth (m) From - To	Description
TP-06-051 5,356,400 N 543,437 E Zone 21 UTM NAD 83	0.0 - 0.2 0.2 - 0.4 0.4 - 2.2 2.2	<p>ROOTMAT - Black, organic silt with roots and organic matter, loose, moist, compressible.</p> <p>WEATHERED GLACIAL TILL - Reddish brown, silty sand and gravel with occasional cobbles and small boulders, compact, moist.</p> <p>GLACIAL TILL - Brownish grey, gravely sand, some cobbles and fines, dense to very dense, moist.</p> <p>Test pit terminated on bedrock.</p> <p>Note: 1) Test pit excavated using a CAT 320 excavator. 2) Groundwater encountered at 1.5 m depth in the excavation.</p>

Location: Test pit excavated in general area of proposed camp site.
 Date: September 9, 2006
 Notes: Sieve analysis conducted on Glacial Till soil from excavation spoilage.

Test pit excavation

Spoilage from the test pit excavation

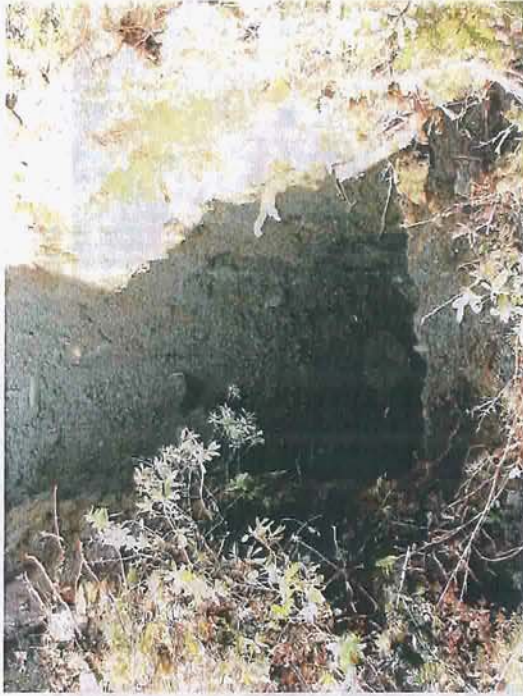
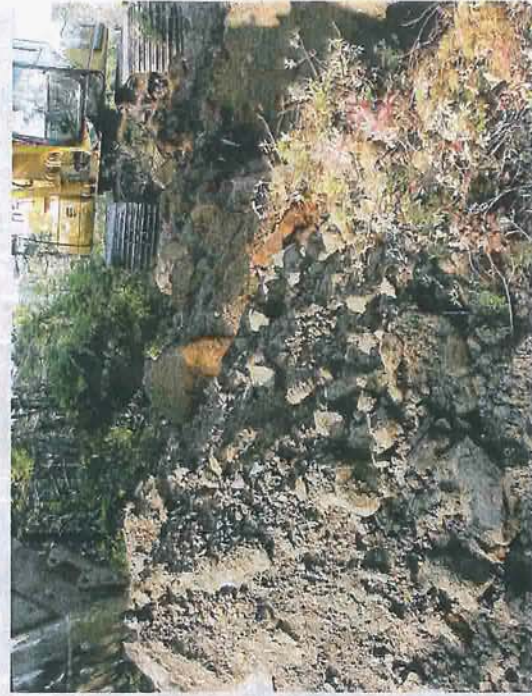
Test Pit Number	Depth (m) From - To	Description
TP-06-052 5,356,347 N 543,387 E Zone 21 UTM NAD 83	0.0 - 0.2 0.2 - 0.4 0.4 - 2.0 2.0	<p>ROOTMAT - Black, organic silt with roots and organic matter, loose, moist, compressible.</p> <p>WEATHERED GLACIAL TILL - Reddish brown, silty sand and gravel with occasional cobbles and small boulders, compact, moist.</p> <p>GLACIAL TILL - Grey, sand and gravel, some cobbles and fines, occasional boulders, dense to very dense, moist.</p> <p>Test pit terminated on bedrock.</p> <p>Note: 1) Test pit excavated using a CAT 320 excavator. 2) Groundwater not encountered.</p>

Test pit excavation

Spoilage from the test pit excavation

Location: Test pit excavated in general area of proposed camp site.
 Date: September 9, 2006

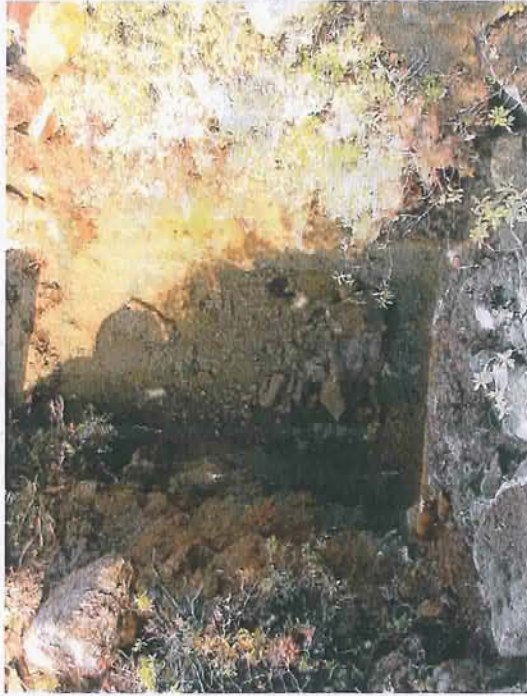
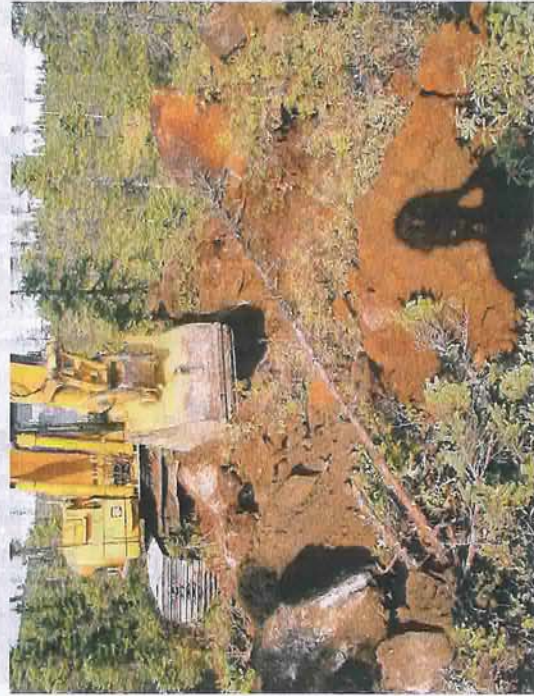
Test Pit Number	Depth (m) From - To	Description
TP-06-053	0.0 - 0.2	ROOTMAT - Black, organic silt with roots and organic matter, loose, moist, compressible.
5,356,299 N 543,347 E Zone 21 UTM NAD 83	0.2 - 0.4	WEATHERED GLACIAL TILL - Reddish brown, silty sand and gravel with occasional cobbles and small boulders, compact, moist.
	0.4 - 1.7	GLACIAL TILL - Brownish grey, sand and gravel, some cobbles, boulders, and fines, dense to very dense, moist.
	1.7	Test pit terminated on bedrock.
		Note: 1) Test pit excavated using a CAT 320 excavator. 2) Groundwater not encountered.

Test pit excavation

Spoilage from the test pit excavation

Location: Test pit excavated in general area of proposed camp site.
 Date: September 9, 2006

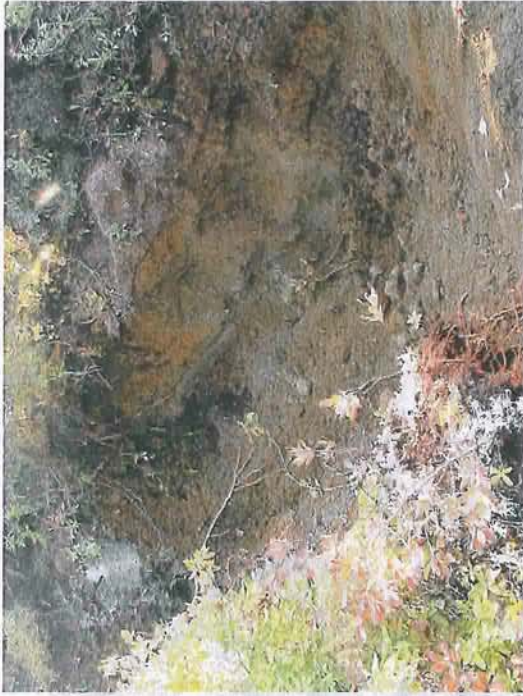
Test Pit Number	Depth (m) From - To	Description
TP-06-054 5,356,252 N 543,318 E Zone 21 UTM NAD 83	0.0 - 0.2	ROOTMAT - Black, organic silt with roots and organic matter, loose, moist, compressible.
	0.2 - 0.4	WEATHERED GLACIAL TILL - Reddish brown, silty sand and gravel with occasional cobbles and small boulders, compact, moist.
	0.4 - 1.2	GLACIAL TILL - Grey, sand and gravel, trace to some fines, occasional cobbles and boulders, dense to very dense, moist.
	1.2	Test pit terminated on bedrock. Note: 1) Test pit excavated using a CAT 320 excavator. 2) Groundwater not encountered.

Test pit excavation

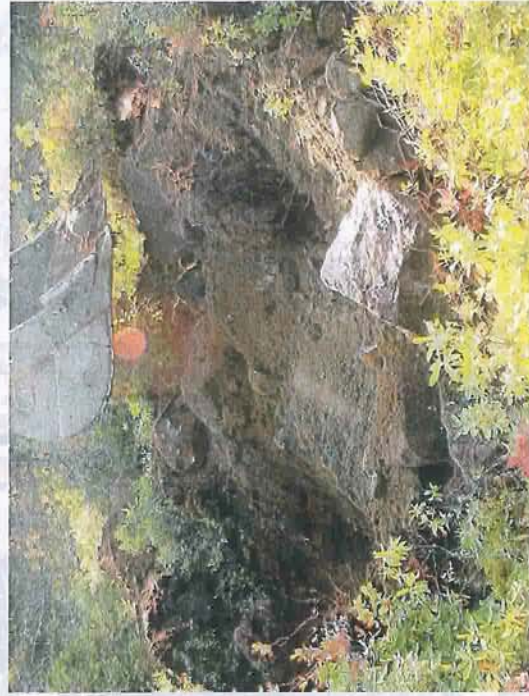
Location: Test pit excavated in general area of proposed camp site.

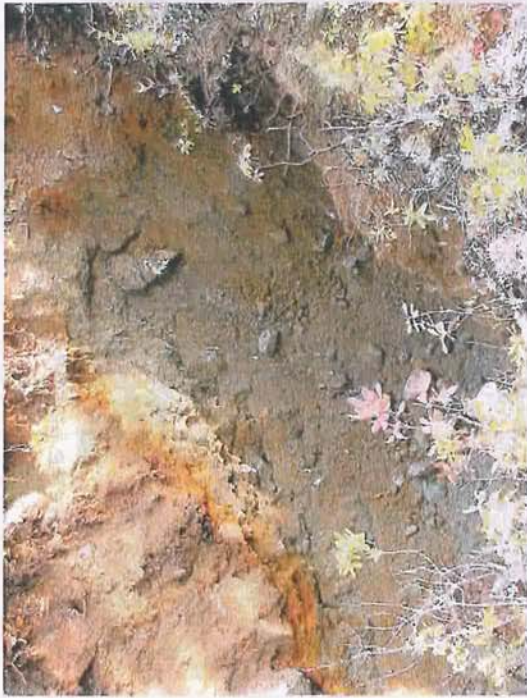
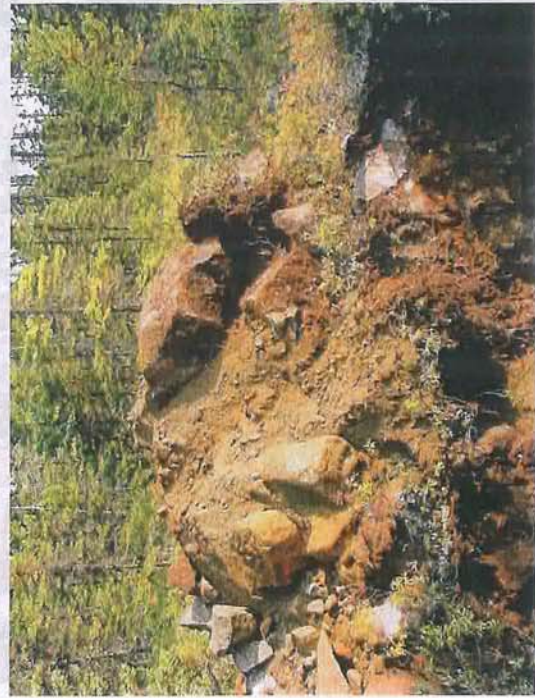
Test Pit Number	Depth (m) From - To	Description
TP-06-055	0.0 - 0.2	ROOTMAT - Black, organic silt with roots and organic matter, loose, moist, compressible.
5,356,213 N 543,237 E Zone 21 UTM NAD 83	0.2 - 0.4	WEATHERED GLACIAL TILL - Reddish brown, silty sand and gravel with occasional cobbles and small boulders, compact, moist.
	0.4 - 1.8	GLACIAL TILL - Grey, sand and gravel, some cobbles and boulders, trace to some fines, dense to very dense, moist.
	1.8	Test pit terminated on bedrock.
		Note: 1) Test pit excavated using a CAT 320 excavator. 2) Groundwater not encountered.

Location: Test pit excavated in general area of proposed camp site.
 Date: September 9, 2006
 Notes: Sieve analysis conducted on Glacial Till soil from excavation spoilage.

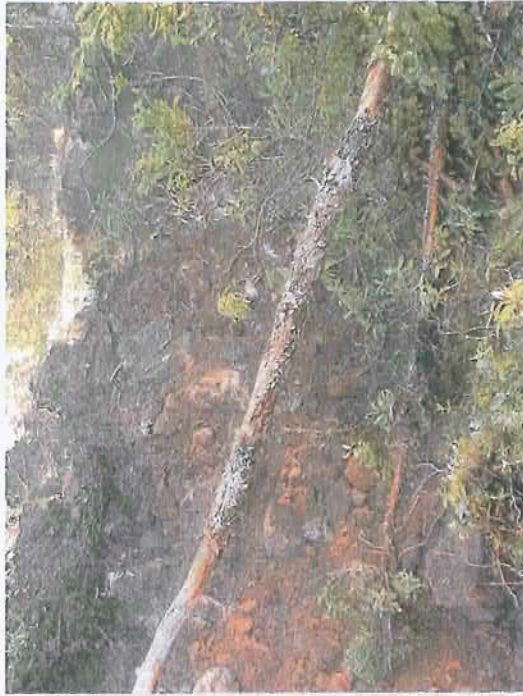
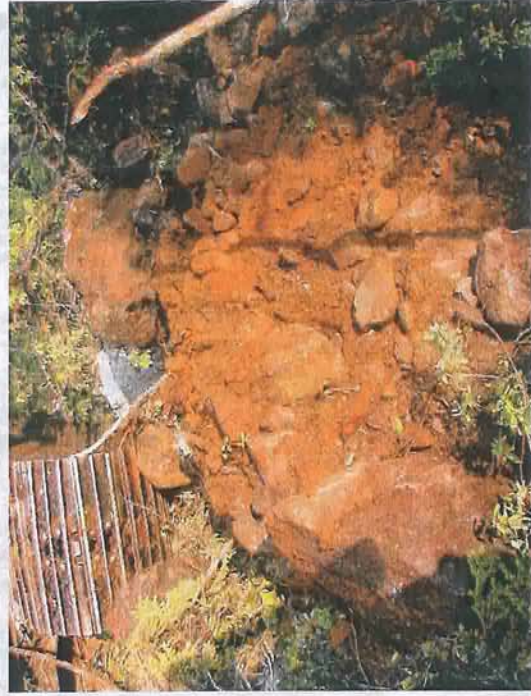
Test Pit Number	Depth (m) From - To	Description
TP-06-056	0.0 - 0.2	ROOTMAT - Black, organic silt with roots and organic matter, loose, moist, compressible.
5,356,181 N 542,964 E Zone 21 UTM NAD 83	0.2 - 0.6	GLACIAL TILL - Brownish grey, sand, gravel, cobbles, and boulders, trace to some fines, dense to very dense, moist.
	0.6	Test pit terminated on bedrock.
		Note: 1) Test pit excavated using a CAT 320 excavator. 2) Groundwater not encountered.

Location: Test pit excavated in general area of proposed camp site.

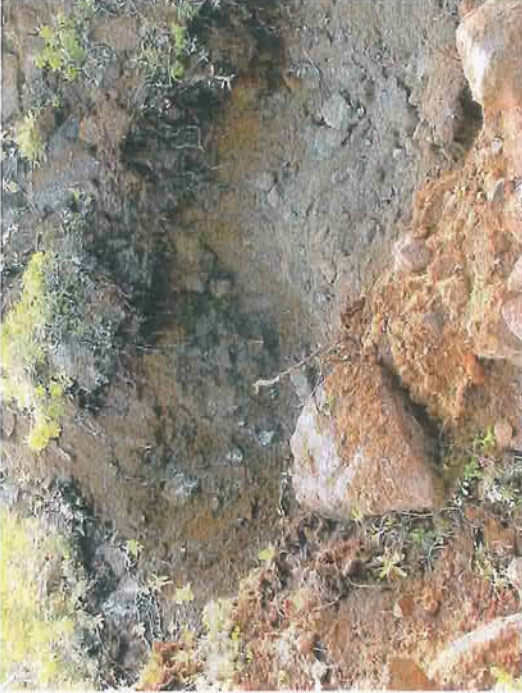
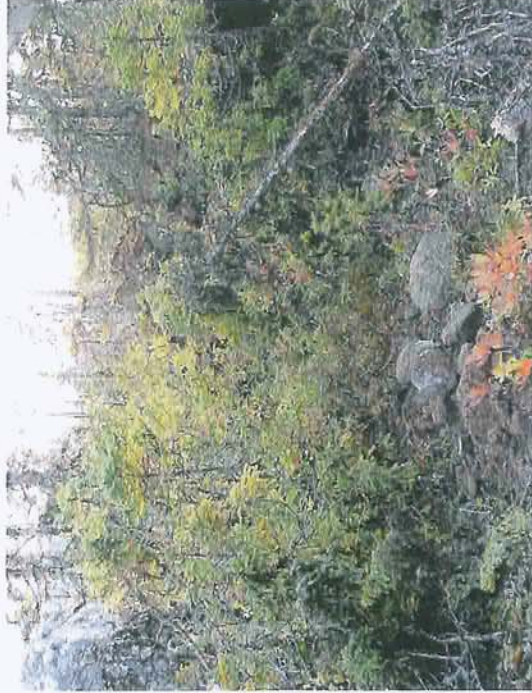
Test Pit Number	Depth (m) From - To	Description
TP-06-057 5,356,009 N 543,049 E Zone 21 UTM NAD 83	0.0 - 0.2 0.2 - 1.2 1.2	ROOTMAT - Black, organic silt with roots and organic matter, loose, moist, compressible. GLACIAL TILL - Grey, sand and gravel, some cobbles and boulders, trace to some fines, dense to very dense, moist. Test pit terminated on bedrock. Note: 1) Test pit excavated using a CAT 320 excavator. 2) Groundwater not encountered.

Location: Test pit excavated in general area of proposed camp site.

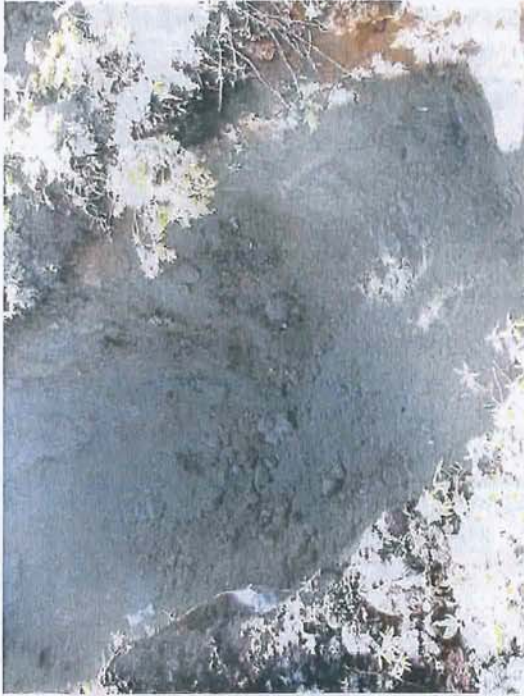
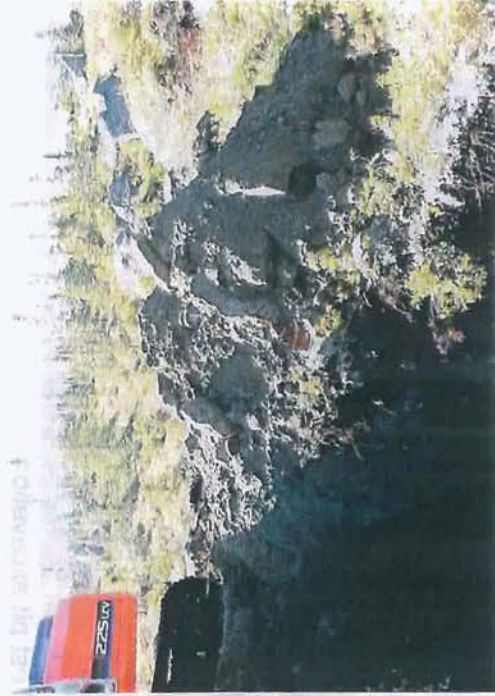
Test Pit Number	Depth (m) From - To	Description
TP-06-058 5,353,151 N 542,324 E Zone 21 UTM NAD 83	0.0 - 0.2	ROOTMAT - Black, organic silt with roots and organic matter, loose, moist, compressible.
	0.2 - 0.4	WEATHERED GLACIAL TILL - Reddish brown, silty sand and gravel with occasional cobbles and small boulders, compact, moist.
	0.4 - 1.3	GLACIAL TILL - Grey, sand, gravel, cobbles, and boulders, trace to some fines, dense to very dense, moist.
	1.3	Test pit terminated on bedrock.
		Note: 1) Test pit excavated using a Daewoo 225LCX excavator. 2) Groundwater not encountered.

Location: Test pit excavated in general area of proposed intersection of the main road and the proposed access road. Borrow "C"
Date: September 11, 2006
Notes: Sieve analysis conducted on Glacial Till soil from excavation spoilage.

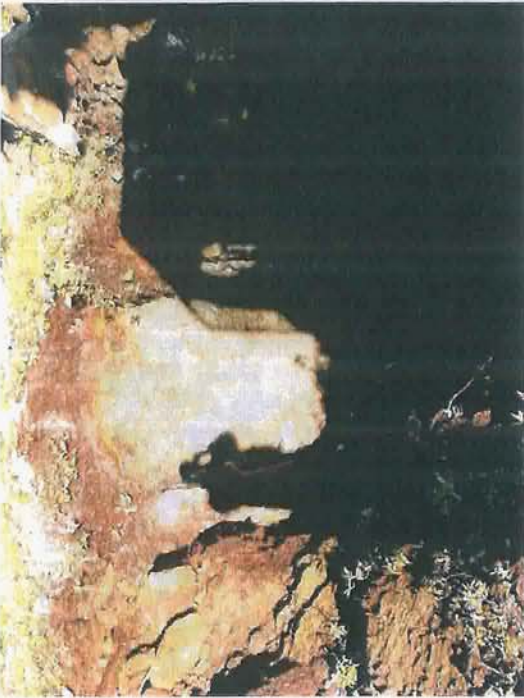
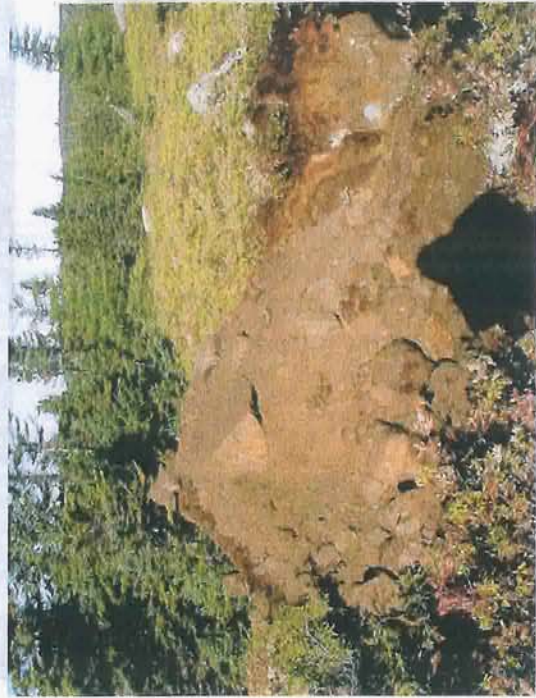
Test Pit Number	Depth (m) From - To	Description
TP-06-059 5,353,119 N 542,298 E Zone 21 UTM NAD 83	0.0 - 0.3 0.3 - 0.5 0.5 - 2.5 2.5	<p>ROOTMAT - Black, organic silt with roots and organic matter, loose, moist, compressible.</p> <p>WEATHERED GLACIAL TILL - Reddish brown, silty sand and gravel with occasional cobbles and small boulders, compact, moist.</p> <p>GLACIAL TILL - Brownish grey, sand, gravel, cobbles, and boulders, trace to some fines, dense to very dense, moist.</p> <p>Test pit terminated on bedrock or large boulder.</p> <p>Note: 1) Test pit excavated using a Daewoo 225LCX excavator. 2) Groundwater not encountered.</p>

Notes: Sieve analysis conducted on Glacial Till soil from excavation spoilage.

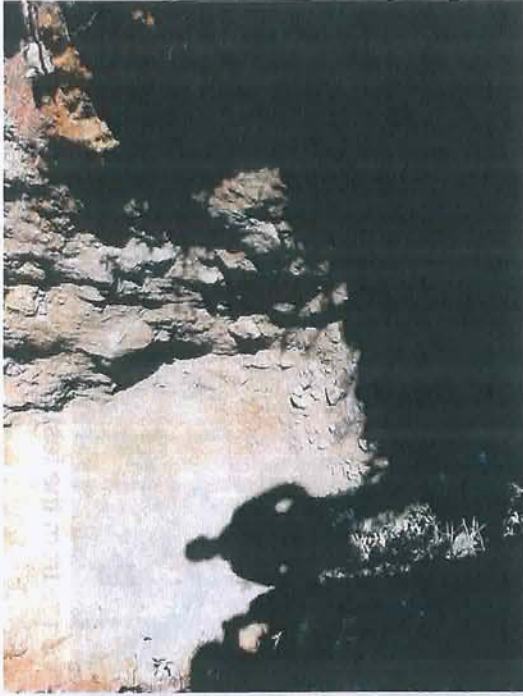
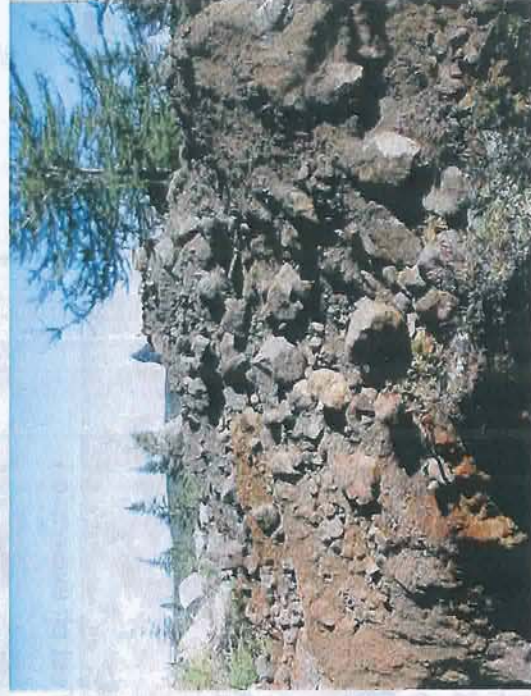
Test Pit Number	Depth (m) From - To	Description
TP-06-060 5,353,083 N 542,323 E Zone 21 UTM NAD 83	0.0 - 0.3 0.3 - 0.5 0.5 - 2.1	ROOTMAT - Black, organic silt with roots and organic matter, loose, moist, compressible. WEATHERED GLACIAL TILL - Reddish brown, silty sand and gravel with occasional cobbles and small boulders, compact, moist. GLACIAL TILL - Grey, sand, gravel, cobbles, and boulders, trace to some fines, dense to very dense, moist.
	2.1	Test pit terminated on bedrock or large boulder. Note: 1) Test pit excavated using a Daewoo 225LCX excavator. 2) Groundwater not encountered.

Location: Test pit excavated in general area of proposed intersection of the main road and the proposed access road. Borrow "C"
 Date: September 11, 2006
 Notes: Sieve analysis conducted on Glacial Till soil from excavation spoilage.

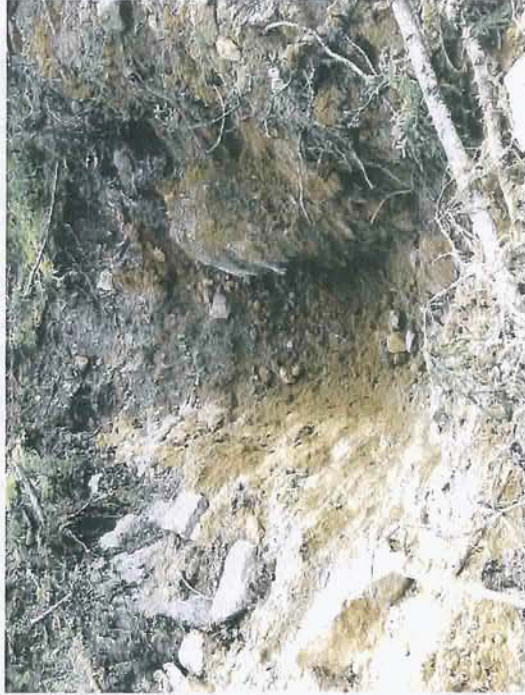
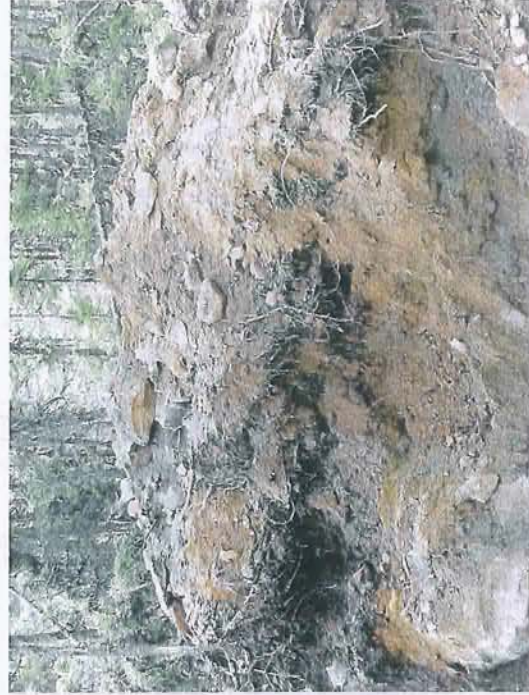
Test Pit Number	Depth (m) From - To	Description
TP-06-061 5,358,967 N 545,884 E Zone 21 UTM NAD83	0.0 - 0.2 0.2 - 0.4 0.4 - 2.3 2.3	<p>ROOTMAT - Black, organic silt with roots and organic matter, loose, moist, compressible. (Large boulder at surface)</p> <p>WEATHERED GLACIAL TILL - Reddish brown, silty sand and gravel with occasional cobbles and small boulders, compact, moist.</p> <p>GLACIAL TILL - Brownish grey, sand and gravel, some fines, cobbles and boulders, dense to very dense, moist.</p> <p>Test pit terminated on bedrock.</p> <p>Note: 1) Test pit excavated using a CAT 320 excavator. 2) Groundwater not encountered.</p>

Location: Test pit excavated along top of ridge on east side of river.
 Date: September 8, 2006
 Notes: Sieve analysis conducted on Glacial Till soil from excavation spoilage.

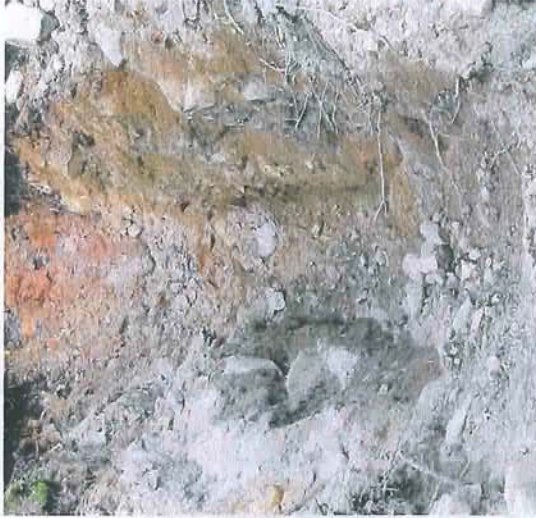
Test Pit Number	Depth (m) From - To	Description
TP-06-062 5,358,980 N 545,893 E Zone 21 UTM NAD83	0.0 - 0.2	ROOTMAT - Black, organic silt with roots and organic matter, loose, moist, compressible.
	0.2 - 0.6	WEATHERED GLACIAL TILL - Reddish brown, silty sand and gravel with occasional cobbles and small boulders, compact, moist.
	0.6 - 3.0	GLACIAL TILL - Grey to brown, silty sand and gravel, some cobbles and boulders, dense to very dense, moist.
	3.0	Test pit terminated on bedrock. Note: 1) Test pit excavated using a CAT 320 excavator. 2) Groundwater not encountered.

Location: Test pit excavated along top of ridge on east side of river.
Date: September 8, 2006
Notes: Sieve analysis conducted on Glacial Till soil from excavation spoilage.

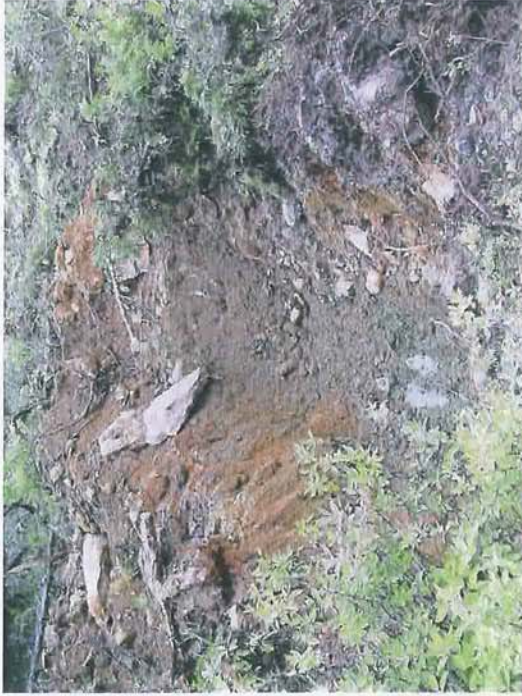
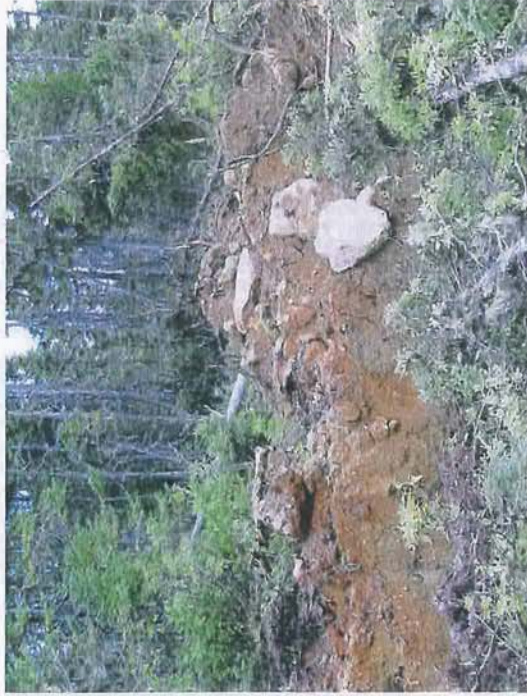
Test Pit Number	Depth (m) From - To	Description
TP-06-063	0.0 - 0.2	ROOTMAT - Black, organic silt with roots and organic matter, loose, moist, compressible.
5,358,919 N 545,891 E	0.2 - 0.6	WEATHERED GLACIAL TILL - Reddish brown, silty sand and gravel with occasional cobbles and small boulders, compact, moist.
Zone 21 UTM NAD83	0.6 - 1.3	GLACIAL TILL - Grey to brown, gravely sand, some fines, cobbles and boulders, dense to very dense, moist.
	1.3	Test pit terminated on bedrock. Note: 1) Test pit excavated using a CAT 320 excavator. 2) Groundwater seeping into bottom of test pit.

Location: Test pit excavated along top of ridge on east side of river.
 Date: September 8, 2006
 Notes: Sieve analysis conducted on Glacial Till soil from excavation spoilage.

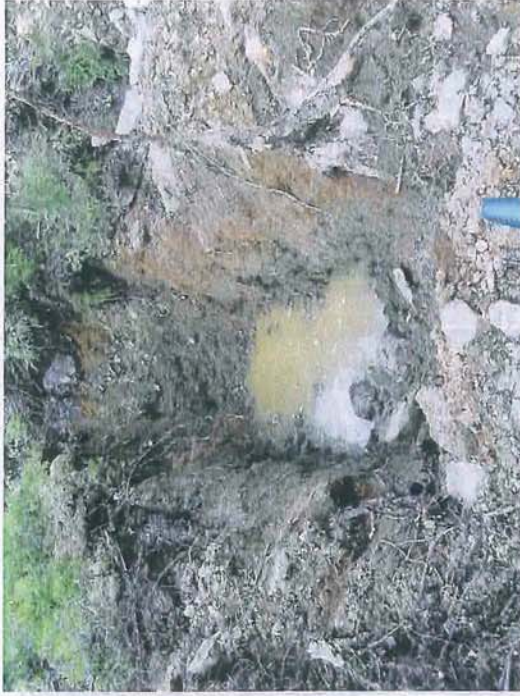
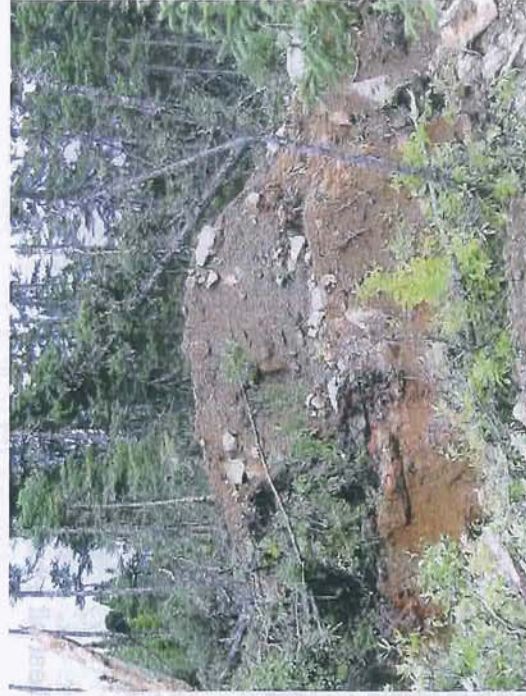
Test Pit Number	Depth (m) From - To	Description
TP-06-064 5,358,931 N 545,905 E Zone 21 UTM NAD83	0.0 - 0.3 0.3 - 0.6 0.6 - 2.2 2.2	<p>ROOTMAT - Black, organic silt with roots and organic matter, loose, moist, compressible.</p> <p>WEATHERED GLACIAL TILL - Reddish brown, silty sand and gravel with occasional cobbles and small boulders, compact, moist.</p> <p>GLACIAL TILL - Grey to brown, silty sand and gravel, some cobbles and boulders, dense to very dense, moist to saturated.</p> <p>Test pit terminated on bedrock.</p> <p>Note: 1) Test pit excavated using a CAT 320 excavator. 2) Groundwater at 1.8m below ground surface.</p>

Location: Test pit excavated along top of ridge on east side of river.
 Date: September 8, 2006
 Notes: Sieve analysis conducted on Glacial Till soil from excavation spoilage.

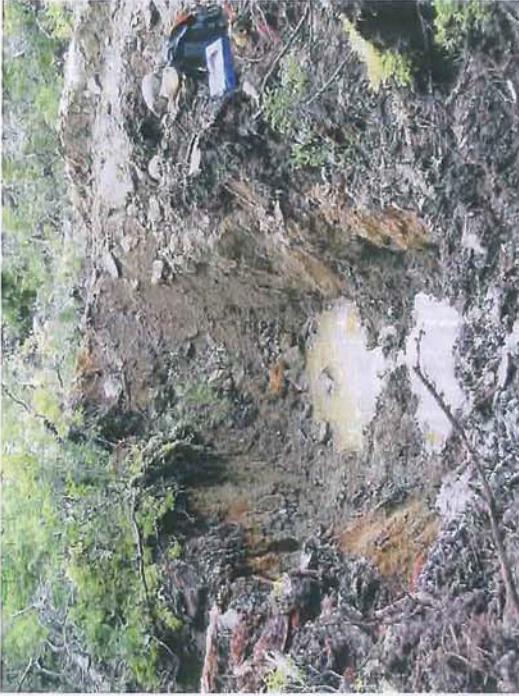
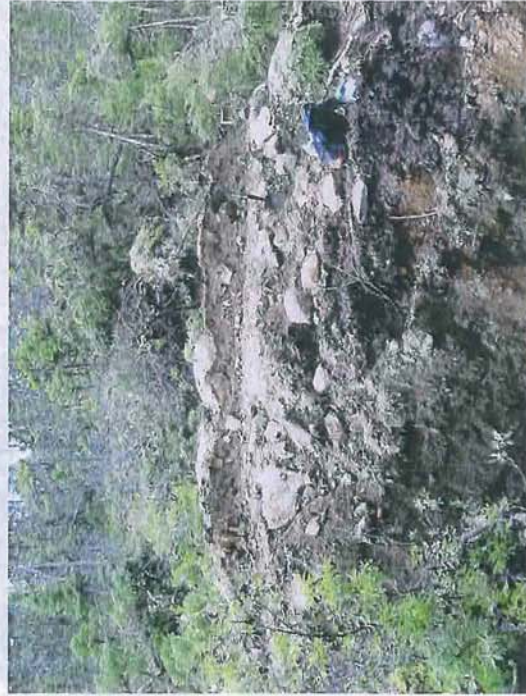
Test Pit Number	Depth (m) From - To	Description
TP-06-065 5,358,952 N 545,918 E Zone 21 UTM NAD83	0.0 - 0.3	ROOTMAT - Black, organic silt with roots and organic matter, loose, moist, compressible.
	0.3 - 0.6	WEATHERED GLACIAL TILL - Reddish brown, silty sand and gravel with occasional cobbles and small boulders, compact, moist.
	0.6 - 1.8	GLACIAL TILL - Grey to brown, gravely sand, some fines, cobbles and boulders, dense to very dense, moist to saturated. Test pit terminated on bedrock.
	1.8	Note: 1) Test pit excavated using a CAT 320 excavator. 2) Groundwater at 1.6m below ground surface.

Location: Test pit excavated along top of ridge on east side of river.
 Date: September 8, 2006
 Notes: Sieve analysis conducted on Glacial Till soil from excavation spoilage.

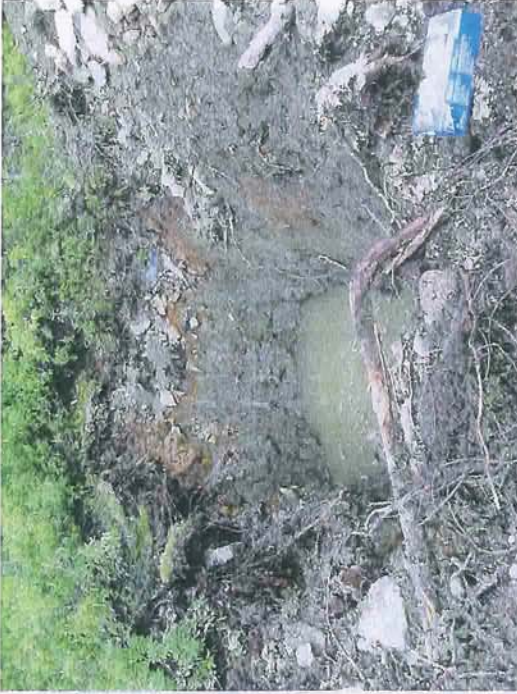
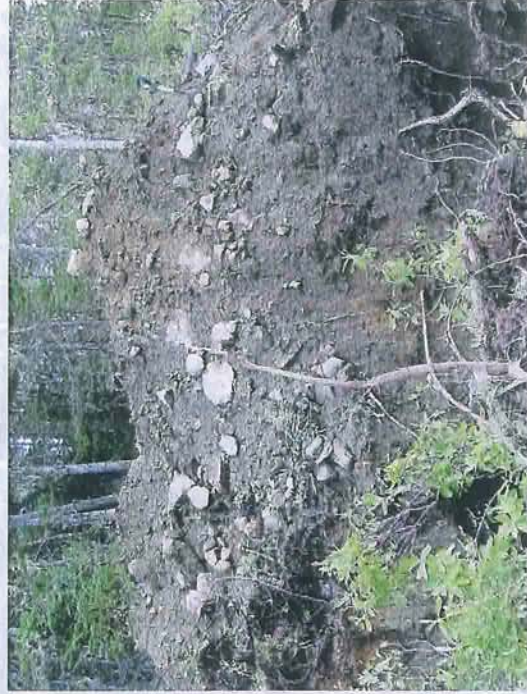
Test Pit Number	Depth (m) From - To	Description
TP-06-066	0.0 - 0.3	ROOTMAT - Black, organic silt with roots and organic matter, loose, moist, compressible.
5,358,972 N 545,924 E	0.3 - 0.5	WEATHERED GLACIAL TILL - Reddish brown, silty sand and gravel with occasional cobbles and small boulders, compact, moist.
Zone 21 UTM NAD83	0.5 - 2.5	GLACIAL TILL - Grey to brown, sand and gravel, some fines, cobbles and boulders, dense to very dense, moist to saturated.
	2.5	Test pit terminated on bedrock. Note: 1) Test pit excavated using a CAT 320 excavator. 2) Groundwater at 2.2m below ground surface.

Location: Test pit excavated along top of ridge on east side of river.
 Date: September 8, 2006
 Notes: Sieve analysis conducted on Glacial Till soil from excavation spoilage.

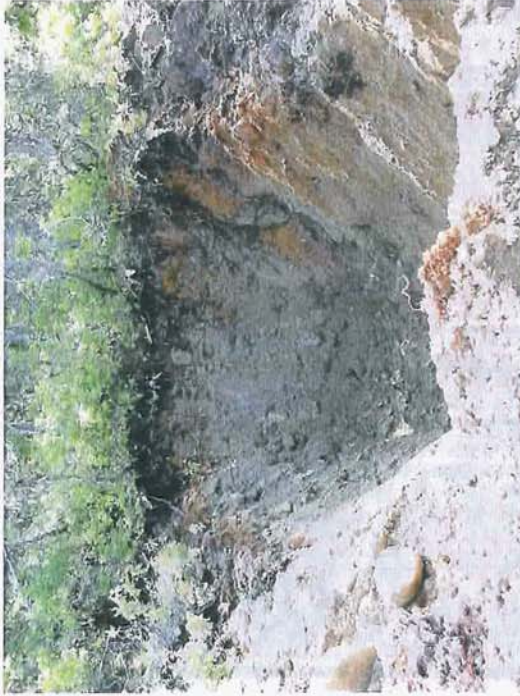
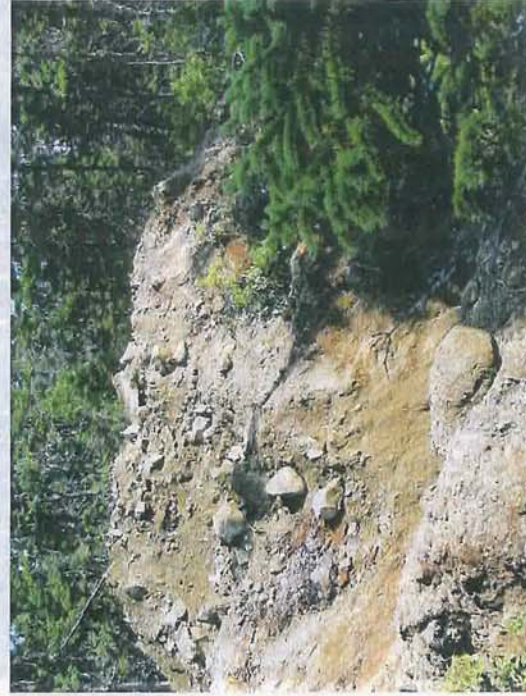
Test Pit Number	Depth (m) From - To	Description
TP-06-067	0.0 - 0.2	ROOTMAT - Black, organic silt with roots and organic matter, loose, moist, compressible.
5,358,988 N 545,941 E	0.2 - 0.4	WEATHERED GLACIAL TILL - Reddish brown, silty sand and gravel with occasional cobbles and small boulders, compact, moist.
Zone 21 UTM NAD83	0.4 - 1.8	GLACIAL TILL - Grey, sand and gravel, some fines, cobbles and boulders, dense to very dense, moist.
	1.8	Test pit terminated on bedrock.
		Note: 1) Test pit excavated using a CAT 320 excavator. 2) Groundwater not encountered.

Location: Test pit excavated along top of ridge on east side of river.
 Date: September 8, 2006
 Notes: Sieve analysis conducted on Glacial Till soil from excavation spoilage.

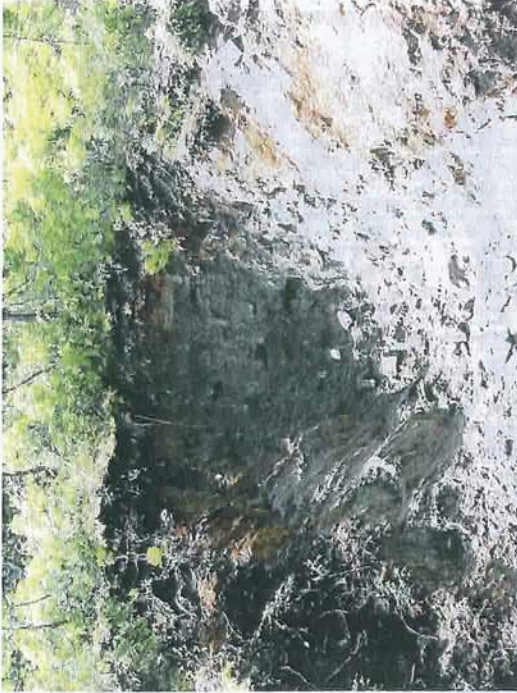
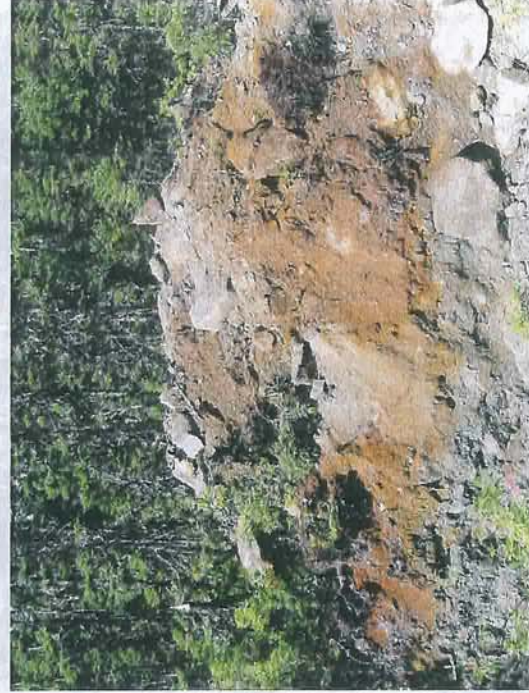
Test Pit Number	Depth (m) From - To	Description
TP-06-068	0.0 - 0.2	ROOTMAT - Black, organic silt with roots and organic matter, loose, moist, compressible.
5,359,008 N 545,945 E	0.2 - 0.5	WEATHERED GLACIAL TILL - Reddish brown, silty sand and gravel with occasional cobbles and small boulders, compact, moist.
Zone 21 UTM NAD83	0.5 - 2.0	GLACIAL TILL - Grey, sand and gravel, some fines, cobbles and boulders, dense to very dense, moist.
	2.0	Test pit terminated on bedrock.
		Note: 1) Test pit excavated using a CAT 320 excavator. 2) Groundwater not encountered.

Location: Test pit excavated along top of ridge on east side of river.
 Date: September 8, 2006
