Geotechnical Site Investigation Proposed Island Pond Hydro Electric Development (as prepared by AMEC)

**Geotechnical Site Investigation
Proposed Island Pond Hydro Electric
Development
South Central Newfoundland
Date: January 03, 2007
Final Report
Submitted by:
AMEC Earth & Environmental**

**GEOTECHNICAL INVESTIGATION
PROPOSED ISLAND POND
HYDROELECTRIC DEVELOPMENT
SOUTH CENTRAL NEWFOUNDLAND**

January 2007
TF6316540

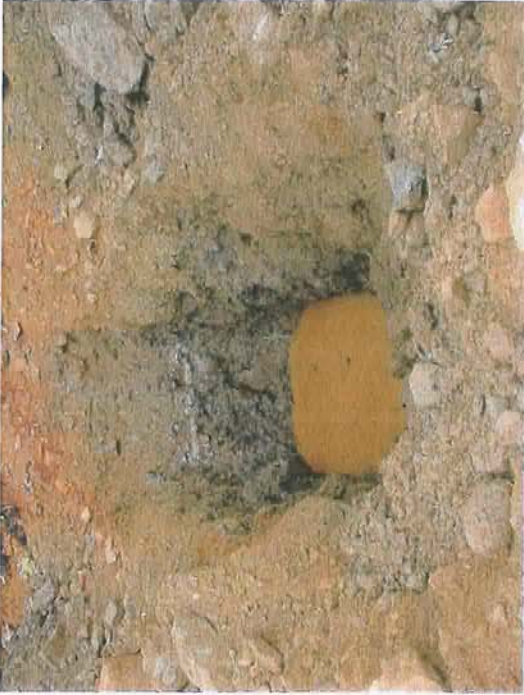
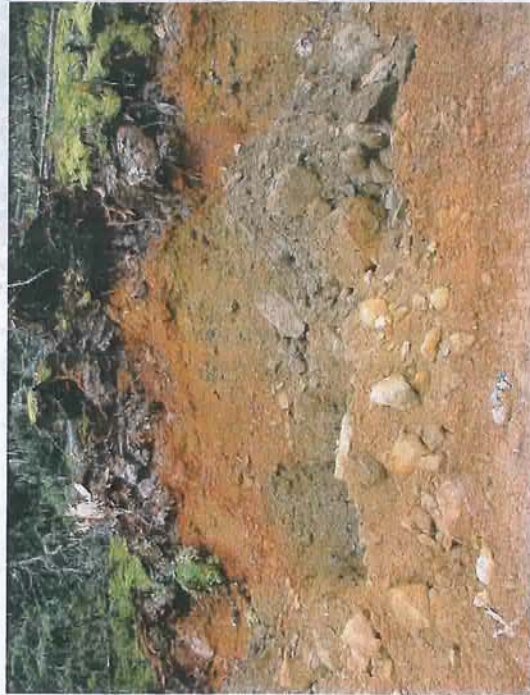
Test Pit Number	Depth (m) From - To	Description
TP-06-069	0.0 - 0.3	ROOTMAT - Black, organic silt with roots and organic matter, loose, moist, compressible.
5,358,939 N 545,822 E	0.3 - 0.6	WEATHERED GLACIAL TILL - Reddish brown, silty sand and gravel with occasional cobbles and small boulders, compact, moist.
Zone 21 UTM NAD83	0.6 - 3.5	GLACIAL TILL - Grey to brown, sand and gravel, some fines, cobbles and boulders, dense to very dense, moist.
	3.5 - 4.0	BEDROCK - Hard, moderately fractured, Mica Schist.
	4.0	Test pit terminated in bedrock.
		Note: 1) Test pit excavated using a CAT 320 excavator. 2) Groundwater / rainwater level at 3.0m below ground surface. 3) Excavated in the area constructed for the helicopter pad (north pad).

Location: Test pit excavated along east side of river at base of hillside.
 Date: September 9, 2006
 Notes: Sieve analysis conducted on Glacial Till soil from excavation spoilage.

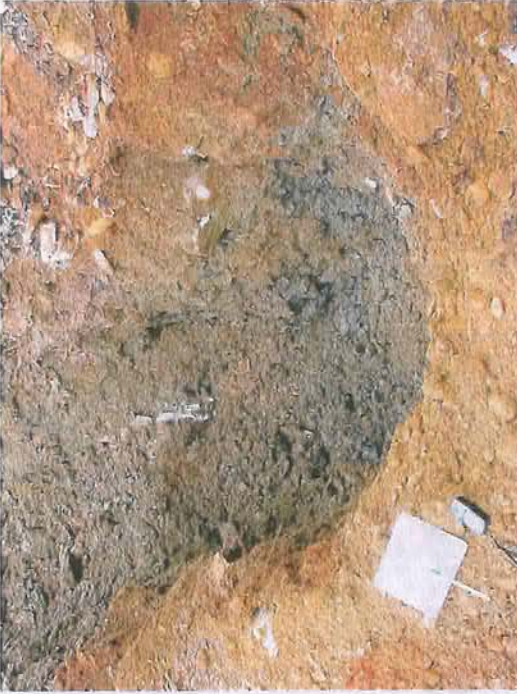
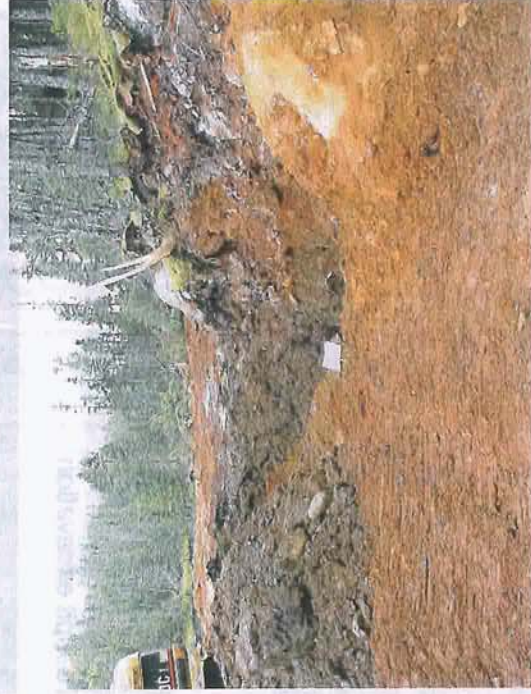
Test Pit Number	Depth (m) From - To	Description
TP-06-070	0.0 - 0.3	ROOTMAT - Black, organic silt with roots and organic matter, loose, moist, compressible.
5,358,917 N 545,823 E	0.3 - 0.6	WEATHERED GLACIAL TILL - Reddish brown, silty sand and gravel with occasional cobbles and small boulders, compact, moist.
Zone 21 UTM NAD83	0.6 - 3.0	GLACIAL TILL - Grey to brown, sand and gravel, some fines, occasional cobbles and boulders, dense to very dense, moist. Test pit terminated on bedrock.
	3.0	Note: 1) Test pit excavated using a CAT 320 excavator. 2) Groundwater encountered at 2.0 m depth. 3) Test pit excavated in the pad area constructed along the bank of the river.

Location: Test pit excavated along east side of river at base of hillside.
Date: September 9, 2006
Notes: Sieve analysis conducted on Glacial Till soil from excavation spoilage.

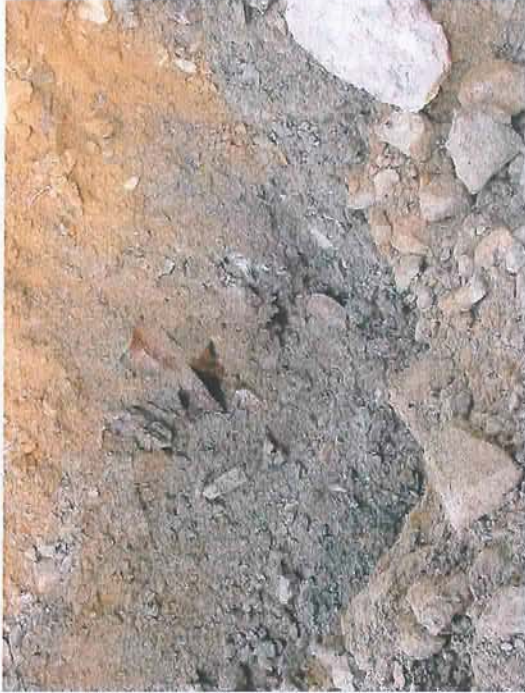
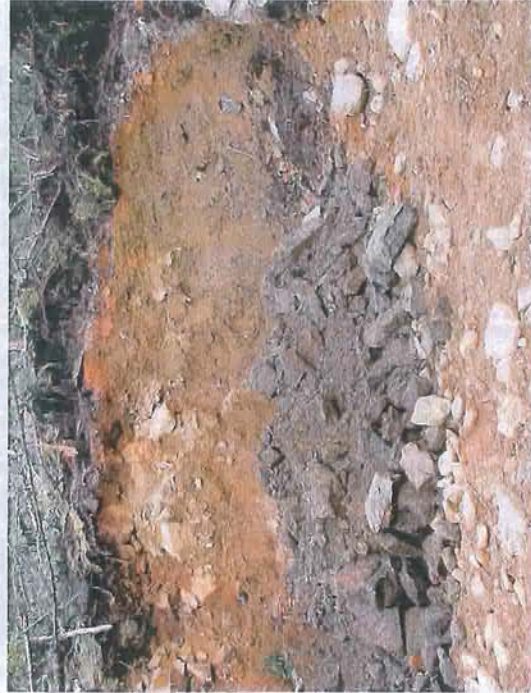
Test Pit Number	Depth (m) From - To	Description
TP-06-071	0.0 - 0.3	ROOTMAT - Black, organic silt with roots and organic matter, loose, moist, compressible.
5,358,890 N 545,827 E	0.3 - 0.6	WEATHERED GLACIAL TILL - Reddish brown, silty sand and gravel with occasional cobbles and small boulders, compact, moist.
Zone 21 UTM NAD83	0.3 - 5.0	GLACIAL TILL - Grey to brown, sand and gravel, some fines, cobbles and boulders, dense to very dense, moist.
	5.0 - 6.0	BEDROCK - Hard, moderately fractured, Mica Schist.
	6.0	Test pit terminated in bedrock.
		Note: 1) Test pit excavated using a CAT 320 excavator. 2) Groundwater not encountered. 3) Test pit was a continuation of Test Pit TP-10 excavated in the area of the helicopter pad (south pad).

Location: Test pit excavated along east side of river at base of hillside.
 Date: September 9, 2006
 Notes: Sieve analysis conducted on Glacial Till soil from excavation spoilage.

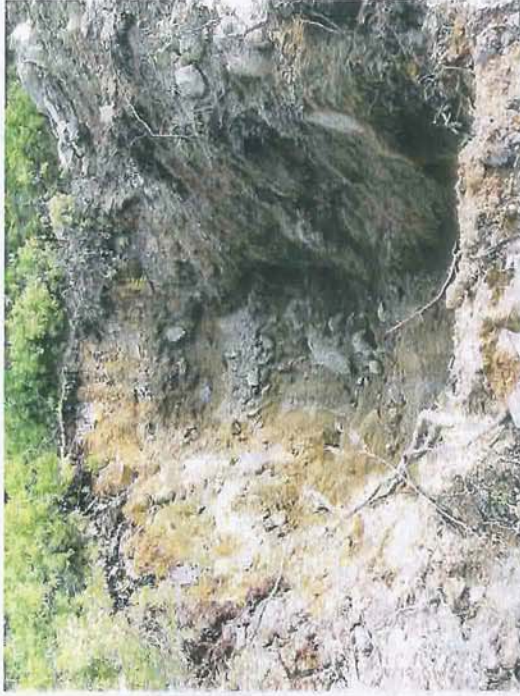
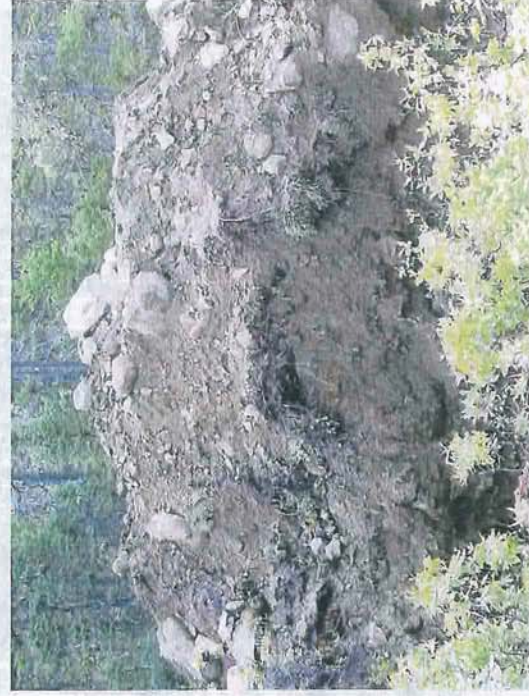
Test Pit Number	Depth (m) From - To	Description
TP-06-072	0.0 - 0.2	ROOTMAT - Black, organic silt with roots and organic matter, loose, moist, compressible.
5,358,951 N 545,878 E	0.2 - 0.4	WEATHERED GLACIAL TILL - Reddish brown, silty sand and gravel with occasional cobbles and small boulders, compact, moist.
Zone 21 UTM NAD83	0.4 - 2.0	GLACIAL TILL - Grey to brown, sand and gravel, some fines, cobbles and boulders, dense to very dense, moist.
	2.0	Test pit terminated on bedrock.
		Note: 1) Test pit excavated using a CAT 320 excavator. 2) Groundwater not encountered.

Location: Test pit excavated along top of ridge on east side of river.
Date: September 10, 2006
Notes: Location of hand excavated test pit in 1989 study.
 Sieve analysis conducted on Glacial Till soil from excavation spoilage.

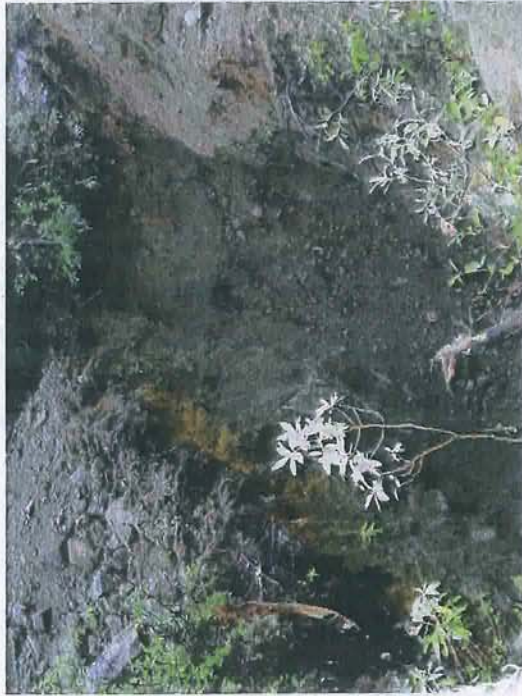
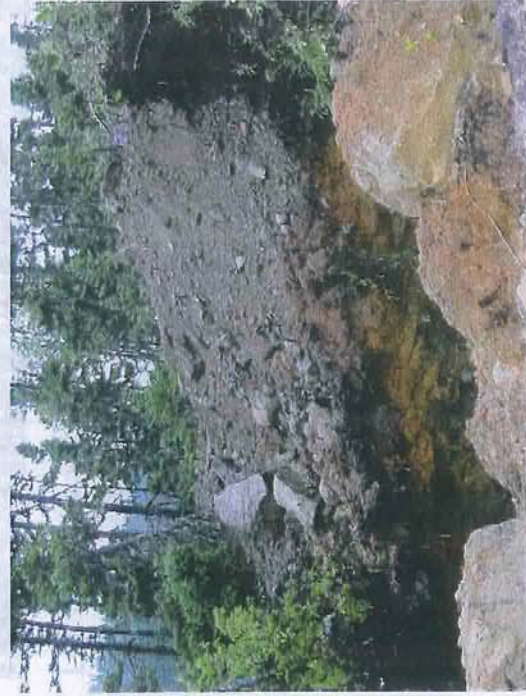
Test Pit Number	Depth (m) From - To	Description
TP-06-073	0.0 - 0.2	ROOTMAT - Black, organic silt with roots and organic matter, loose, moist, compressible.
5,358,871 N 545,854 E	0.2 - 0.4	WEATHERED GLACIAL TILL - Reddish brown, silty sand and gravel with occasional cobbles and small boulders, compact, moist.
Zone 21 UTM NAD83	0.4 - 2.0	GLACIAL TILL - Grey, sand and gravel, some fines, cobbles and boulders, dense to very dense, moist.
	2.0	Test pit terminated on bedrock.
		Note: 1) Test pit excavated using a Daewoo 225 excavator. 2) Groundwater not encountered.

Location: Test pit excavated along side of ridge on east side of river.
 Date: September 10, 2006
 Notes: Bedrock surface varies from 0.6m to 2.0m below ground surface.
 Sieve analysis conducted on Glacial Till soil from excavation spoilage.

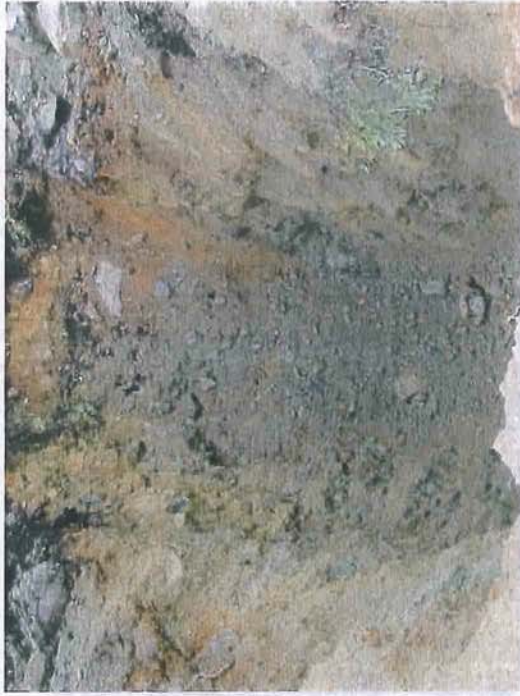
Test Pit Number	Depth (m) From - To	Description
TP-06-074 5,358,860 N 545,841 E Zone 21 UTM NAD83	0.0 - 0.2	ROOTMAT - Black, organic silt with roots and organic matter, loose, moist, compressible.
	0.2 - 0.4	WEATHERED GLACIAL TILL - Reddish brown, silty sand and gravel with occasional cobbles and small boulders, compact, moist.
	0.4 - 2.0	GLACIAL TILL - Grey, sand and gravel, some fines, cobbles and boulders, dense to very dense, moist.
	2.0 - 2.5	FRACTURED BEDROCK - Excavate into top layer of bedrock. Fractured and fragmented at surface.
	2.5	Test pit terminated in sound bedrock. Note: 1) Test pit excavated using a Daewoo 225 excavator. 2) Groundwater not encountered.

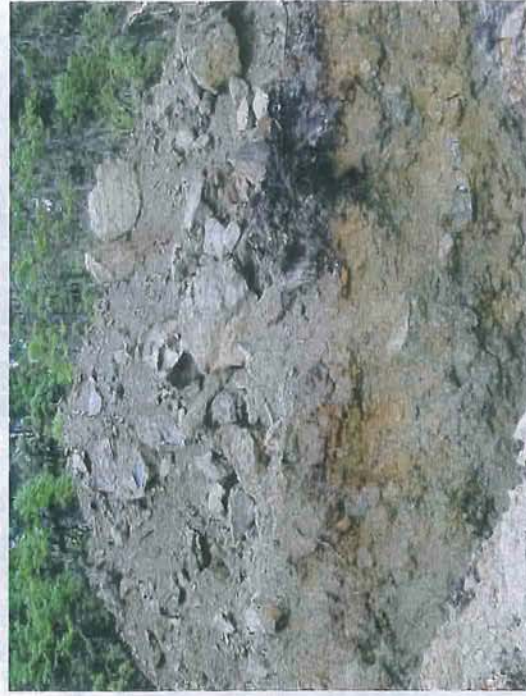
Spoilage from the test pit excavation

Location:
 Date: September 10, 2006
 Notes: Sieve analysis conducted on Glacial Till soil from excavation spoilage.

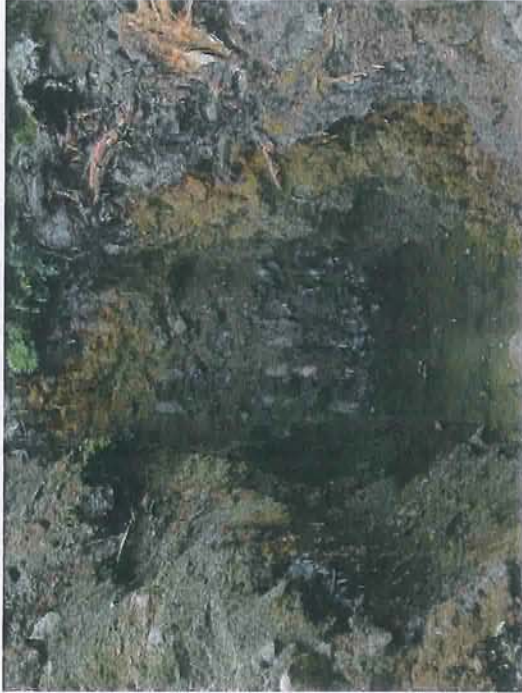
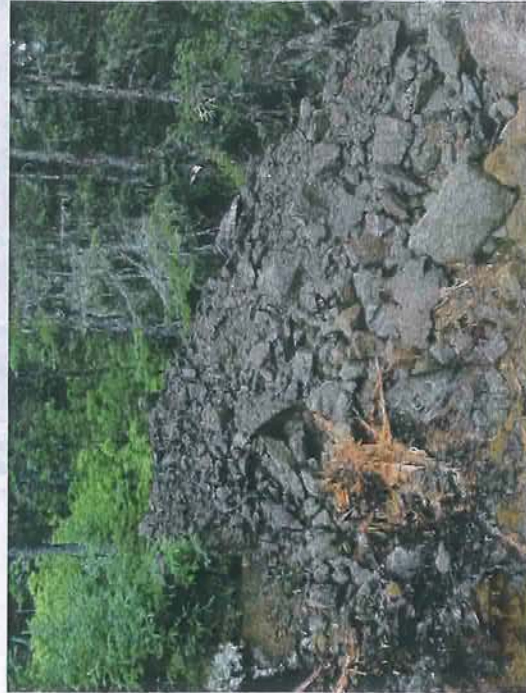
Test Pit Number	Depth (m) From - To	Description
TP-06-075	0.0 - 0.2	ROOTMAT - Black, organic silt with roots and organic matter, loose, moist, compressible.
5,358,860 N 545,839 E	0.2 - 0.5	WEATHERED GLACIAL TILL - Reddish brown, silty sand and gravel with occasional cobbles and small boulders, compact, moist.
Zone 21 UTM NAD83	0.5 - 2.2	GLACIAL TILL - Grey to brown, sand and gravel, some fines, occasional cobbles and boulders, dense to very dense, moist to saturated.
	2.2 - 2.6	FRACTURED BEDROCK - Excavate into top layer of bedrock. Fractured and fragmented at surface.
	2.6	Test pit terminated in sound bedrock. Note: 1) Test pit excavated using a Daewoo 225 excavator. 2) Groundwater / rainwater at bottom of excavation.

Location: Test pit excavated along side of ridge on east side of river.
 Date: September 10, 2006
 Notes: Sieve analysis conducted on Glacial Till soil from excavation spoilage.

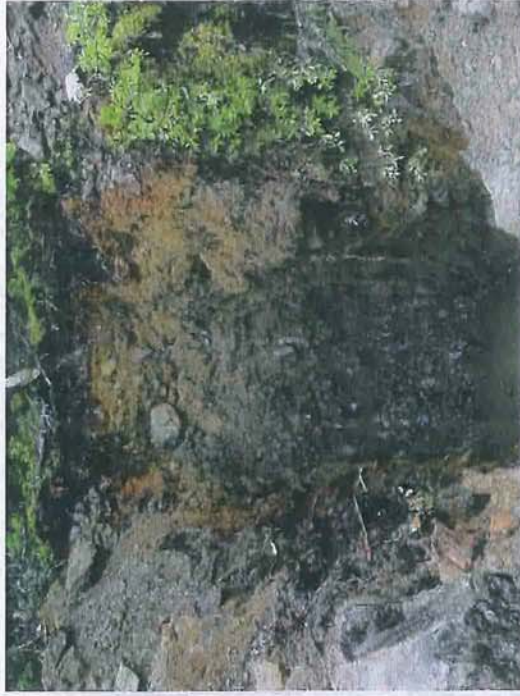
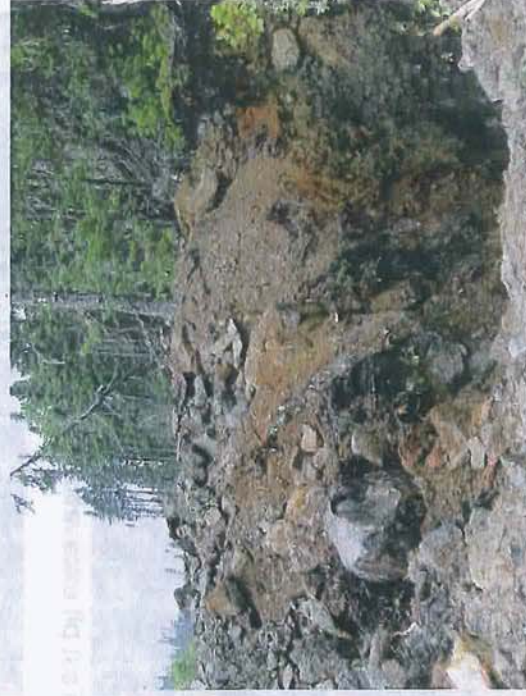
Test Pit Number	Depth (m) From - To	Description
TP-06-076	0.0 - 0.3	ROOTMAT - Black, organic silt with roots and organic matter, loose, moist, compressible.
5,358,868 N 545,834 E	0.3 - 0.6	WEATHERED GLACIAL TILL - Reddish brown, silty sand and gravel with occasional cobbles and small boulders, compact, moist.
Zone 21 UTM NAD83	0.6 - 1.8	GLACIAL TILL - Grey to brown, sand and gravel, some fines, cobbles and boulders, dense to very dense, moist to saturated.
	1.8 - 2.5	FRACTURED BEDROCK - Excavate into top layer of bedrock. Fractured and fragmented at surface.
	2.5	Test pit terminated in sound bedrock. Note: 1) Test pit excavated using a Daewoo 225 excavator. 2) Groundwater / rainwater at bottom of excavation.

Location: Test pit excavated along side of ridge on east side of river.
 Date: September 10, 2006
 Notes: Sieve analysis conducted on Glacial Till soil from excavation spoilage.

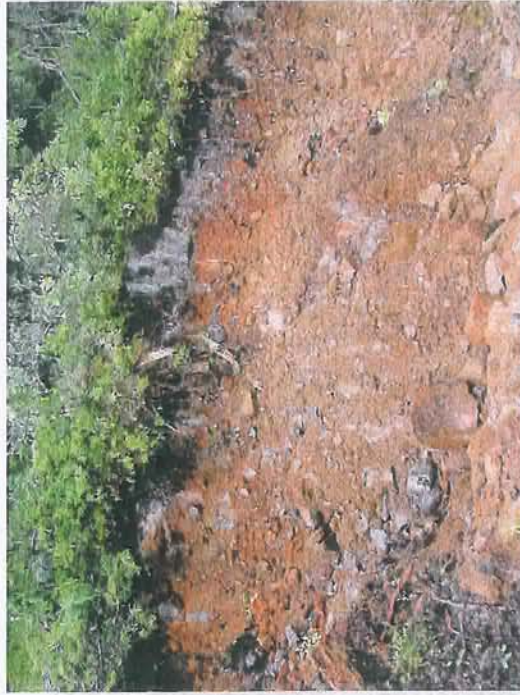
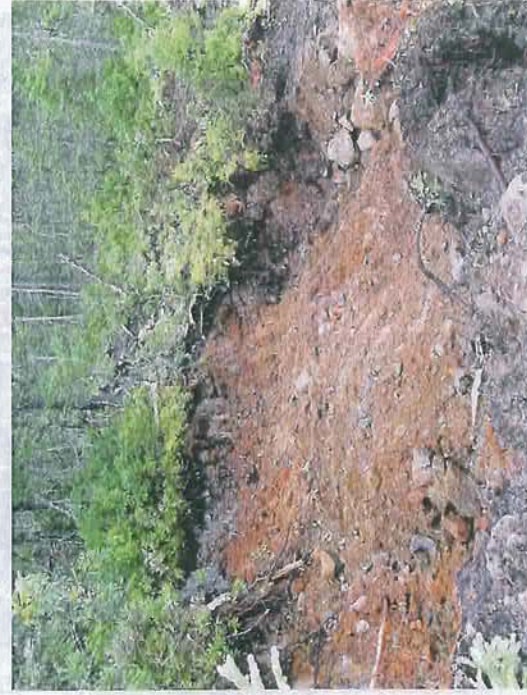
Test Pit Number	Depth (m) From - To	Description
TP-06-078 5,358,842 N 545,813 E Zone 21 UTM NAD83	0.0 - 0.2	ROOTMAT - Black, organic silt with roots and organic matter, loose, moist, compressible.
	0.2 - 0.5	WEATHERED GLACIAL TILL - Reddish brown, silty sand and gravel with occasional cobbles and small boulders, compact, moist. Thickness varies from 0.2m in the centre of test pit to 0.5m at the perimeter.
	0.5 - 0.8	FRACTURED BEDROCK - Excavate into top layer of bedrock at perimeter of test pit. Fractured and fragmented at surface.
	0.8	Test pit terminated in sound bedrock. Note: 1) Test pit excavated using a Daewoo 225 excavator. 2) Groundwater not encountered.

Location: Test pit excavated along east side of river at base of hillside.
Date: September 10, 2006

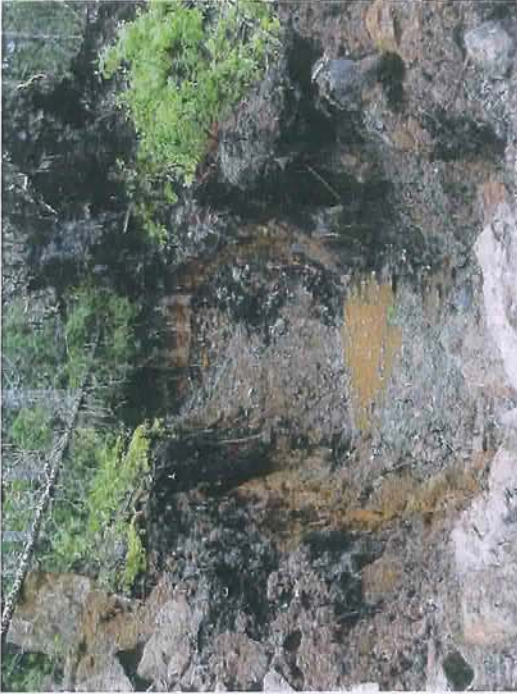
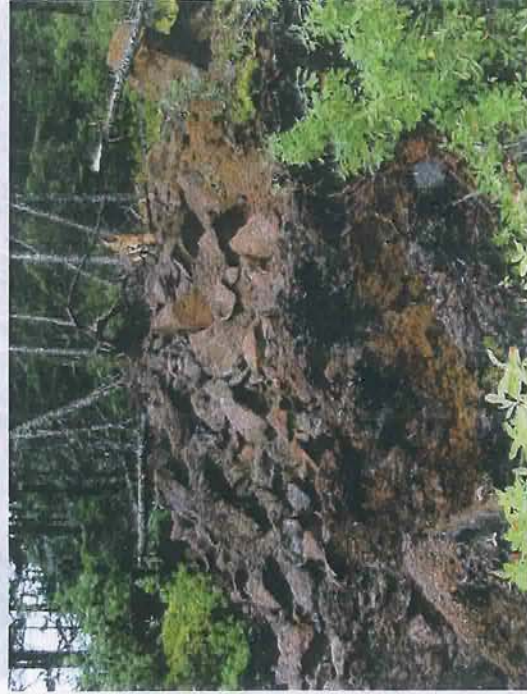
Test Pit Number	Depth (m) From - To	Description
TP-06-079	0.0 - 0.2	ROOTMAT - Black, organic silt with roots and organic matter, loose, moist, compressible.
5,358,824 N 545,811 E	0.2 - 0.4	WEATHERED GLACIAL TILL - Reddish brown, silty sand and gravel with occasional cobbles and small boulders, compact, moist.
Zone 21 UTM NAD83	0.4 - 1.0	GLACIAL TILL - Grey to brown, sand and gravel, some fines, cobbles and boulders, dense to very dense, moist to saturated.
	1.0 - 1.5	FRACTURED BEDROCK - Excavate into top layer of bedrock. Fractured and fragmented at surface.
	1.5	Test pit terminated in sound bedrock. Note: 1) Test pit excavated using a Daewoo 225 excavator. 2) Groundwater / rainwater at bottom of excavation.

Location: Test pit excavated along east side of river at base of hillside.
 Date: September 10, 2006

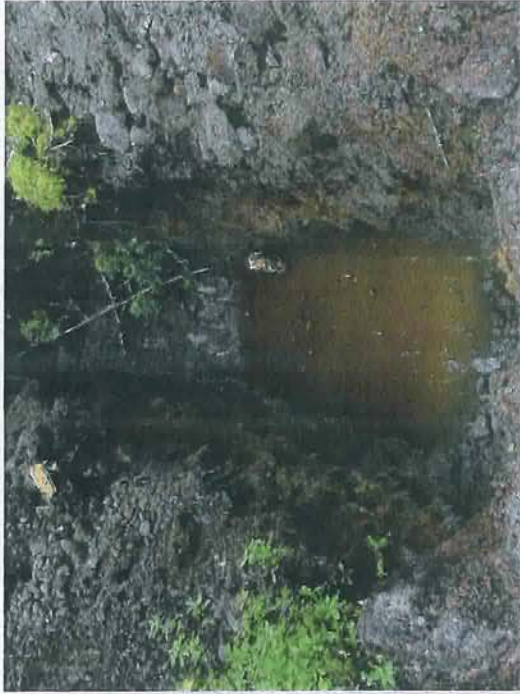
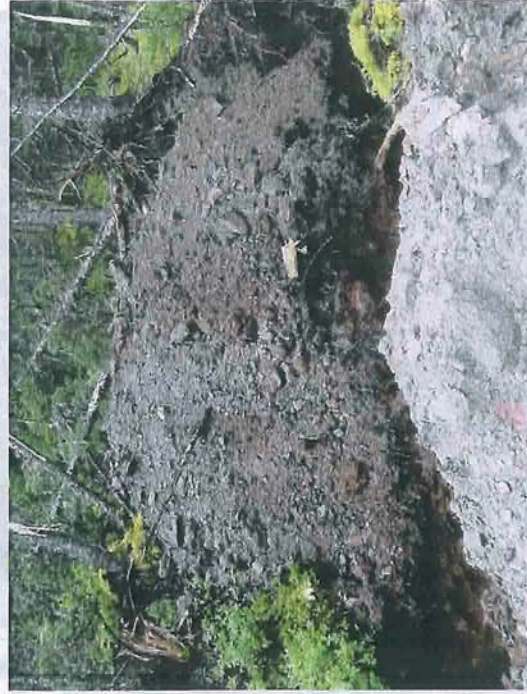
Test Pit Number	Depth (m) From - To	Description
TP-06-080	0.0 - 0.2	ROOTMAT - Black, organic silt with roots and organic matter, loose, moist, compressible.
5,358,825 N 545,819 E	0.2 - 0.5	WEATHERED GLACIAL TILL - Reddish brown, silty sand and gravel with occasional cobbles and small boulders, compact, moist.
Zone 21 UTM NAD83	0.5 - 3.0	GLACIAL TILL - Grey to brown, sand and gravel, some fines, occasional cobbles and boulders, dense to very dense, moist to saturated.
	3.0	Test pit terminated on bedrock.
		Note: 1) Test pit excavated using a Daewoo 225 excavator. 2) Groundwater / rainwater level at 2.0m below ground surface.

Location: Test pit excavated along east side of river at base of hillside.
 Date: September 10, 2006

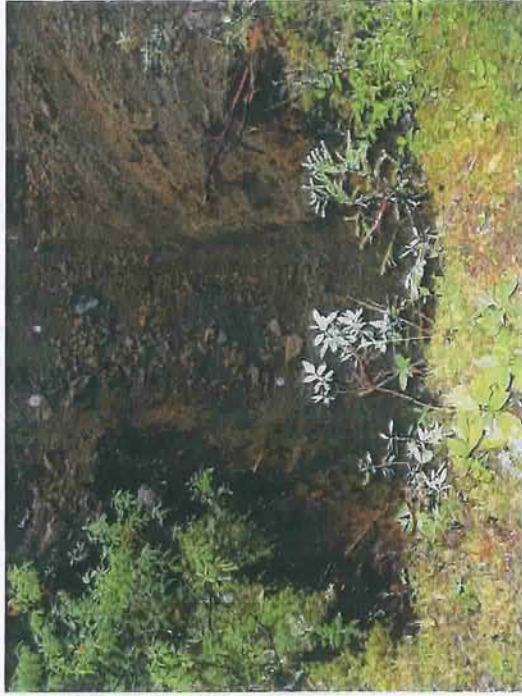
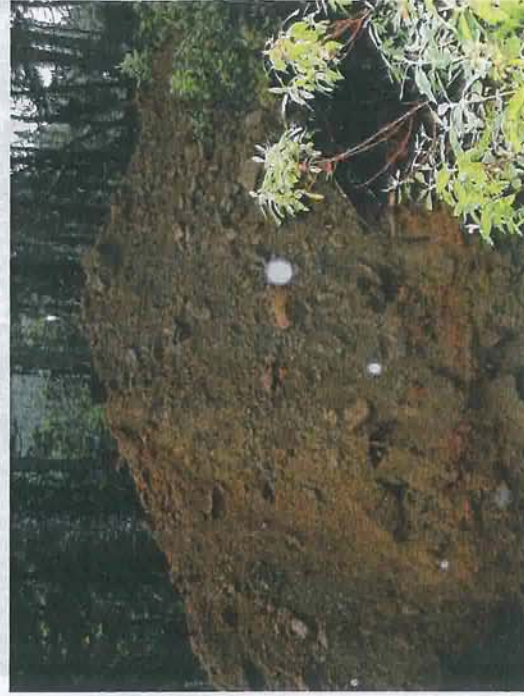
Test Pit Number	Depth (m) From - To	Description
TP-06-081	0.0 - 0.2	ROOTMAT - Black, organic silt with roots and organic matter, loose, moist, compressible.
5,358,834 N 545,834 E	0.2 - 0.4	WEATHERED GLACIAL TILL - Reddish brown, silty sand and gravel with occasional cobbles and small boulders, compact, moist.
Zone 21 UTM NAD83	0.4 - 2.2	GLACIAL TILL - Dark brown, sand and gravel, trace fines, occasional cobbles and boulders, dense to very dense, moist.
	2.2	Test pit terminated on bedrock.

Note: 1) Test pit excavated using a Daewoo 225 excavator.
 2) Groundwater not encountered.

Location: Test pit excavated along east side of river at base of hillside.
 Date: September 10, 2006
 Notes: Sieve analysis conducted on Glacial Till soil from excavation spoilage.

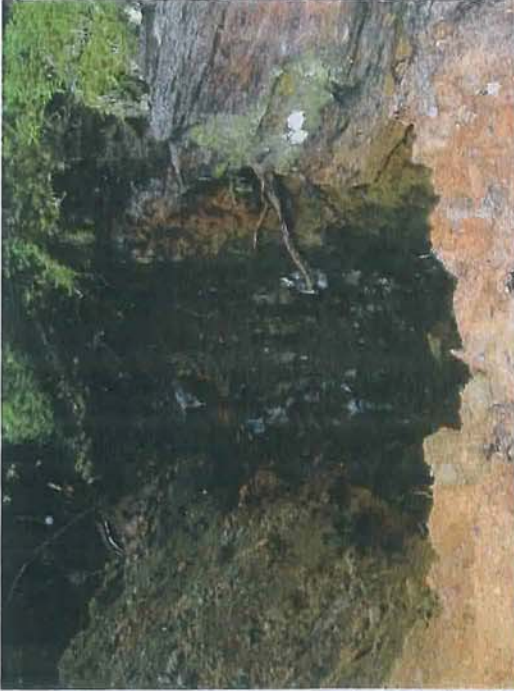
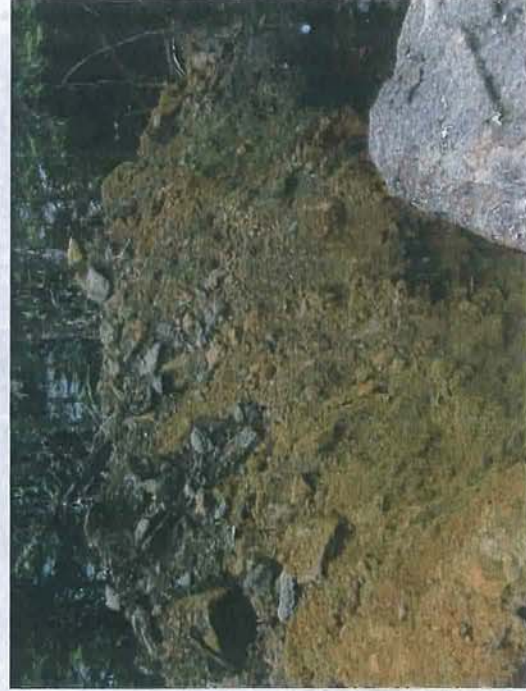
Test Pit Number	Depth (m) From - To	Description
TP-06-082	0.0 - 0.3	ROOTMAT - Black, organic silt with roots and organic matter, loose, moist, compressible.
5,358,963 N 545,827 E	0.3 - 0.6	WEATHERED GLACIAL TILL - Reddish brown, silty sand and gravel with occasional cobbles and small boulders, compact, moist.
Zone 21 UTM NAD83	0.6 - 2.5	GLACIAL TILL - Grey to brown, sand and gravel, some fines, occasional to some cobbles and boulders, dense to very dense, moist.
	2.5 - 2.7	FRACTURED BEDROCK - Excavate into top layer of bedrock. Fractured and fragmented at surface.
	2.7	Test pit terminated in sound bedrock. Note: 1) Test pit excavated using a Daewoo 225 excavator. 2) Groundwater not encountered.

Location: Test pit excavated along east side of river at base of hillside.
 Date: September 10, 2006
 Notes: Sieve analysis conducted on Glacial Till soil from excavation spoilage.

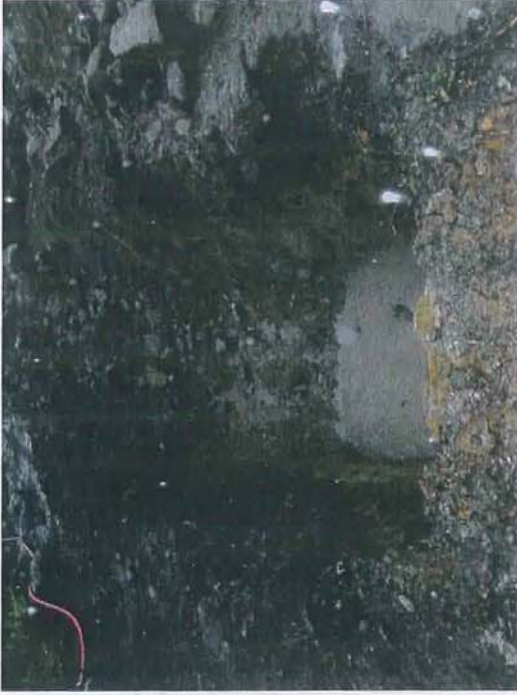
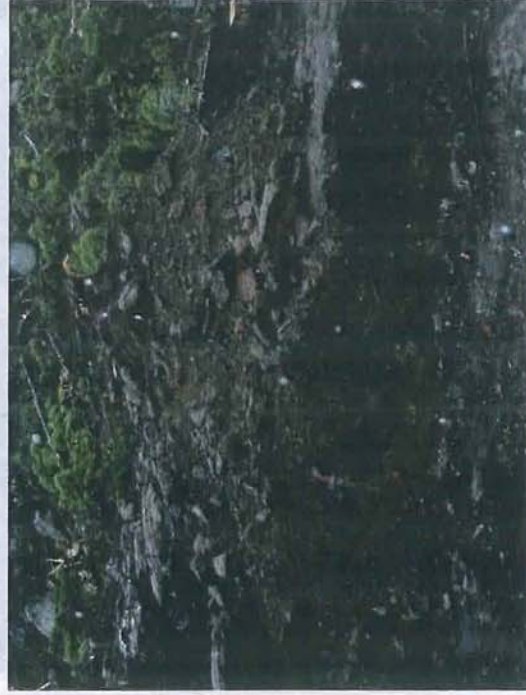
Test Pit Number	Depth (m) From - To	Description
TP-06-083 5,358,867 N 545,807 E	0.0 - 0.5	DISTURBED - Black, organic rootmat material mixed with weathered glacial till. Prepared by excavator for road surface to move drill. Excavated between BH1 and BH2.
Zone 21 UTM NAD83	0.5 - 0.8	WEATHERED GLACIAL TILL - Reddish brown, silty sand and gravel with occasional cobbles and small boulders, compact, moist.
	0.8 - 1.2	GLACIAL TILL - Grey to brown, sand and gravel, some fines and cobbles, dense to very dense, moist to saturated.
	1.2 - 1.5	FRACTURED BEDROCK - Excavate into top layer of bedrock. Fractured and fragmented at surface.
	1.5	Test pit terminated in sound bedrock. Note: 1) Test pit excavated using a Daewoo 225 excavator. 2) Groundwater / rainwater at bottom of excavation.

Location: Test pit excavated along east side of river at base of hillside, between BH1 and BH2.
Date: September 10, 2006
Notes: Sieve analysis conducted on Glacial Till soil from excavation spoilage.

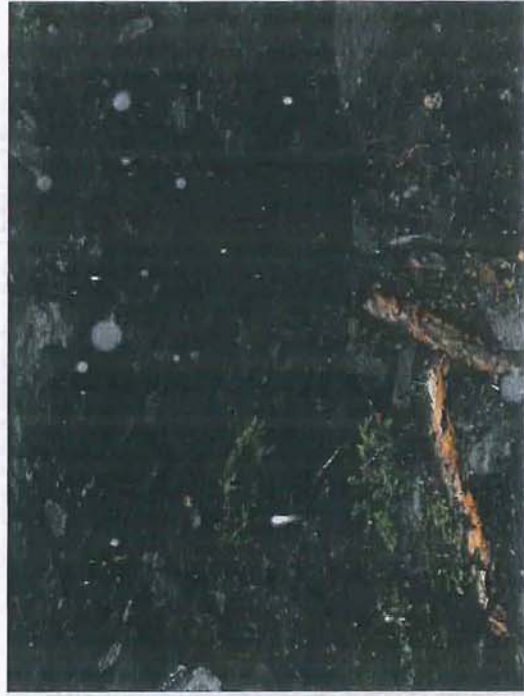
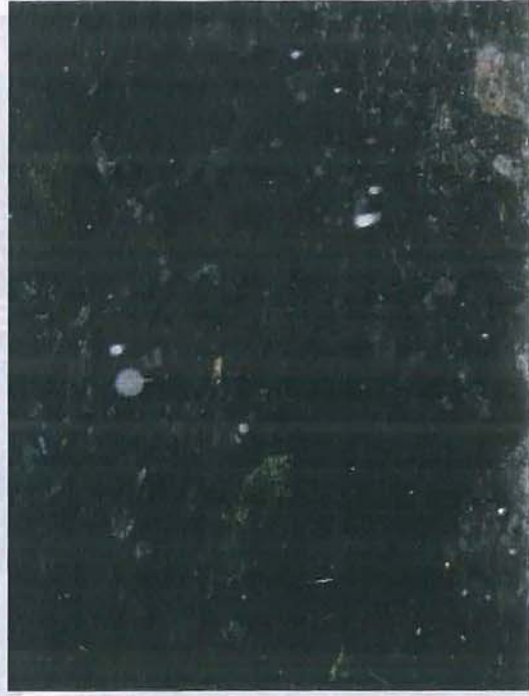
Test Pit Number	Depth (m) From - To	Description
TP-06-084 5,358,893 N 545,814 E	0.0 - 0.75	DISTURBED - Black, organic rootmat material mixed with weathered glacial till. Prepared by excavator for road surface to move drill. Excavated between BH2 and BH3.
Zone 21 UTM NAD83	0.75 - 1.0	GLACIAL TILL - Grey to brown, sand and gravel, some fines, cobbles and boulders, dense to very dense, moist to saturated.
	1.0 - 1.2	FRACTURED BEDROCK - Excavate into top layer of bedrock. Fractured and fragmented at surface.
	1.2	Test pit terminated in sound bedrock. Note: 1) Test pit excavated using a Daewoo 225 excavator. 2) Groundwater not encountered.

Location: Test pit excavated along east side of river at base of hillside, between BH2 and BH3.
 Date: September 10, 2006

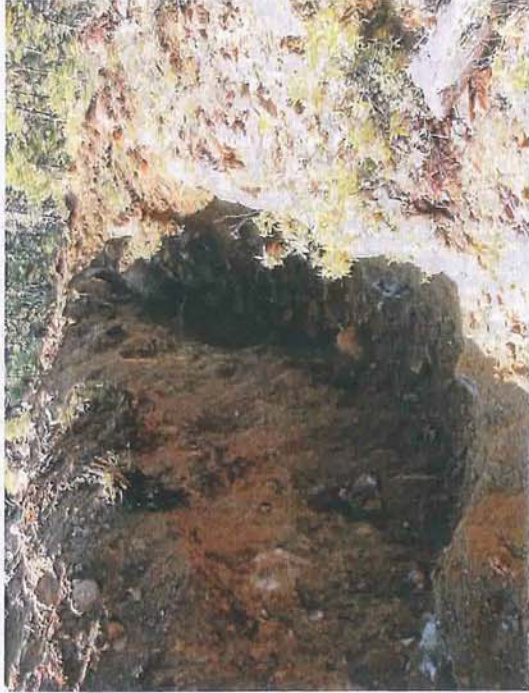
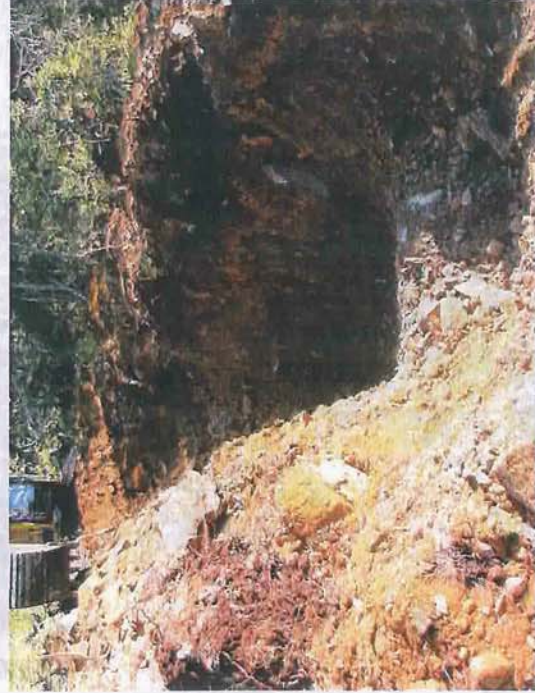
Test Pit Number	Depth (m) From - To	Description
TRENCH A 5,358,898 N 545,866 E to 5,358,924 N 545,868 E	0.0 - 0.2 0.2 - 0.5	ROOTMAT - Black, organic silt with roots and organic matter, loose, moist, compressible. WEATHERED GLACIAL TILL - Reddish brown, silty sand and gravel with occasional cobbles and small boulders, compact, moist.
Zone 21 UTM NAD83	0.5 - 0.8 to 3.0	GLACIAL TILL - Grey to brown, sand with some gravel and fines, occasional cobbles and boulders, dense to very dense, moist.
	0.8 to 3.0	BEDROCK - Hard, moderately fractured, Mica Schist.

Note: 1) Test pit excavated using a CAT 320 excavator.
 2) Bedrock surface erratic and varied from 0.8 m to 3.0 m depth.

Location: Trench excavated along east side of river at crest of the bank.
 Date: September 8, 2006
 Notes: Sieve analysis conducted on Glacial Till soil from excavation spoilage.

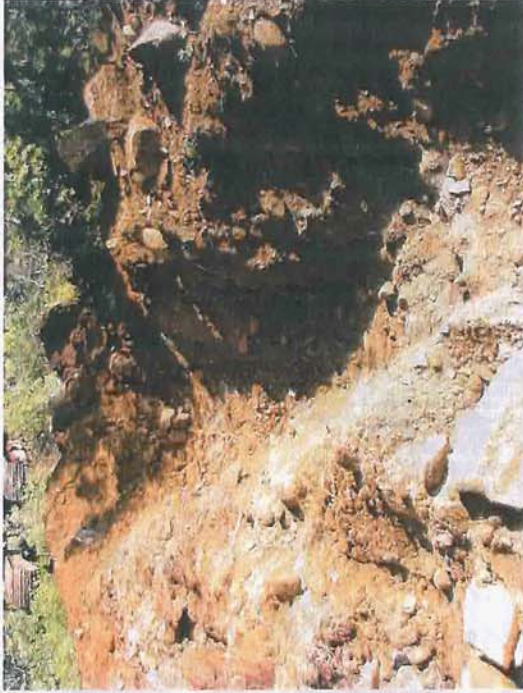
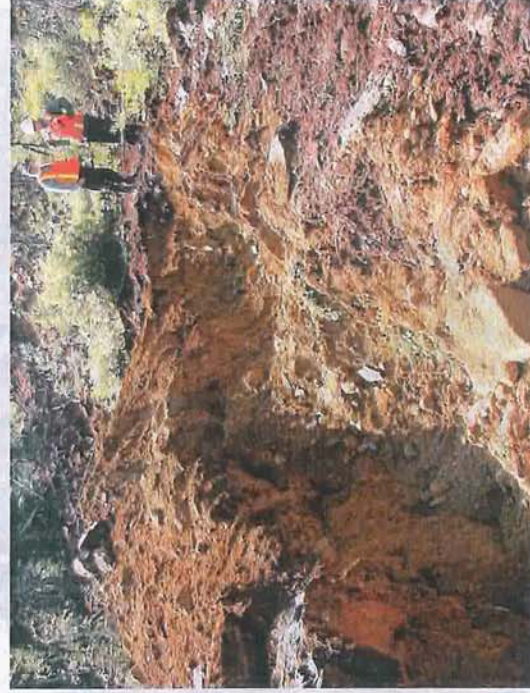
Test Pit Number	Depth (m) From - To	Description
TRENCH B	0.0 - 0.2	ROOTMAT - Black, organic silt with roots and organic matter, loose, moist, compressible.
5,358,939 N 545,867 E to 5,358,964 N 545,874 E	0.2 - 0.5	WEATHERED GLACIAL TILL - Reddish brown, silty sand and gravel with occasional cobbles and small boulders, compact, moist.
Zone 21 UTM NAD83	0.5 - 1.2 to 1.8	GLACIAL TILL - Grey to brown, sand with some gravel and fines, occasional cobbles and boulders, dense to very dense, moist.
	1.2 to 1.8	BEDROCK - Hard, moderately fractured, Mica Schist.

Note: 1) Test pit excavated using a CAT 320 excavator.
 2) Bedrock surface erratic and varied from 1.2 m to 1.8 m depth.

Location: Trench excavated along east side of river along the crest of the bank.
 Date: September 8, 2006
 Notes: Sieve analysis conducted on Glacial Till soil from excavation spoilage.

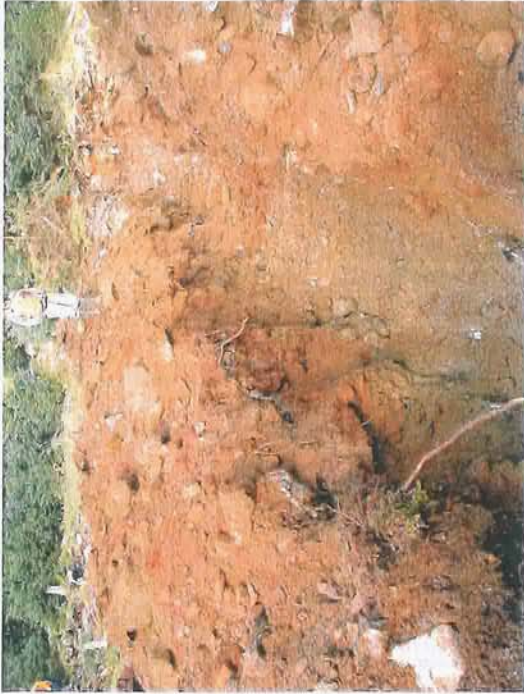
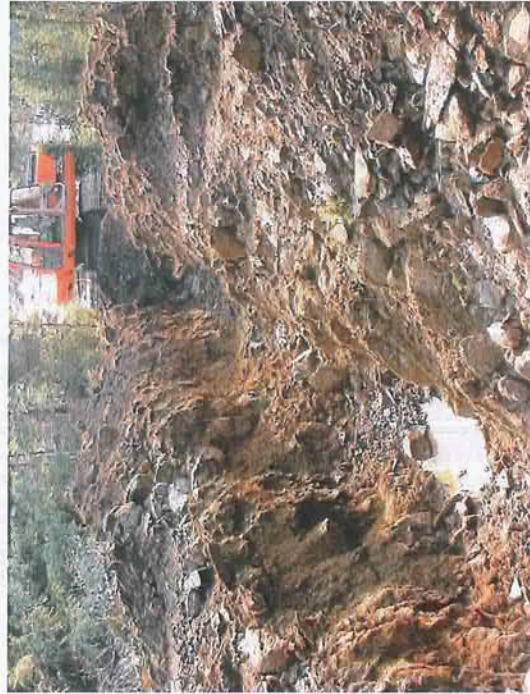
Test Pit Number	Depth (m) From – To	Description
TRENCH C 5,358,905 N 545,758 E to 5,358,908 N 545,745 E Zone 21 UTM NAD83	0.0 – 0.2 0.2 – 0.5 0.5 – 1.0 to 1.4 1.0 to 1.4	<p>ROOTMAT – Black, organic silt with roots and organic matter, loose, moist, compressible.</p> <p>WEATHERED GLACIAL TILL – Reddish brown, silty sand and gravel with occasional cobbles and small boulders, compact, moist.</p> <p>GLACIAL TILL – Grey to brown, sand with some gravel and fines, occasional cobbles and boulders, dense to very dense, moist to saturated.</p> <p>BEDROCK – Hard, moderately fractured, Mica Schist.</p> <p>Test pit terminated on bedrock.</p> <p>Note: 1) Test pit excavated using a CAT 320 excavator. 2) Bedrock surface erratic and varied from 1.0 m to 1.4 m depth. 3) Bedrock was able to be excavated approximately 0.3 m in places. 4) Bedrock was dipping ~ 70 degrees W with a N-S strike.</p>

Location: Trench excavated along wide side in area of the proposed dam.
 Date: September 9, 2006
 Notes: Sieve analysis conducted on Glacial Till soil from excavation spoilage.

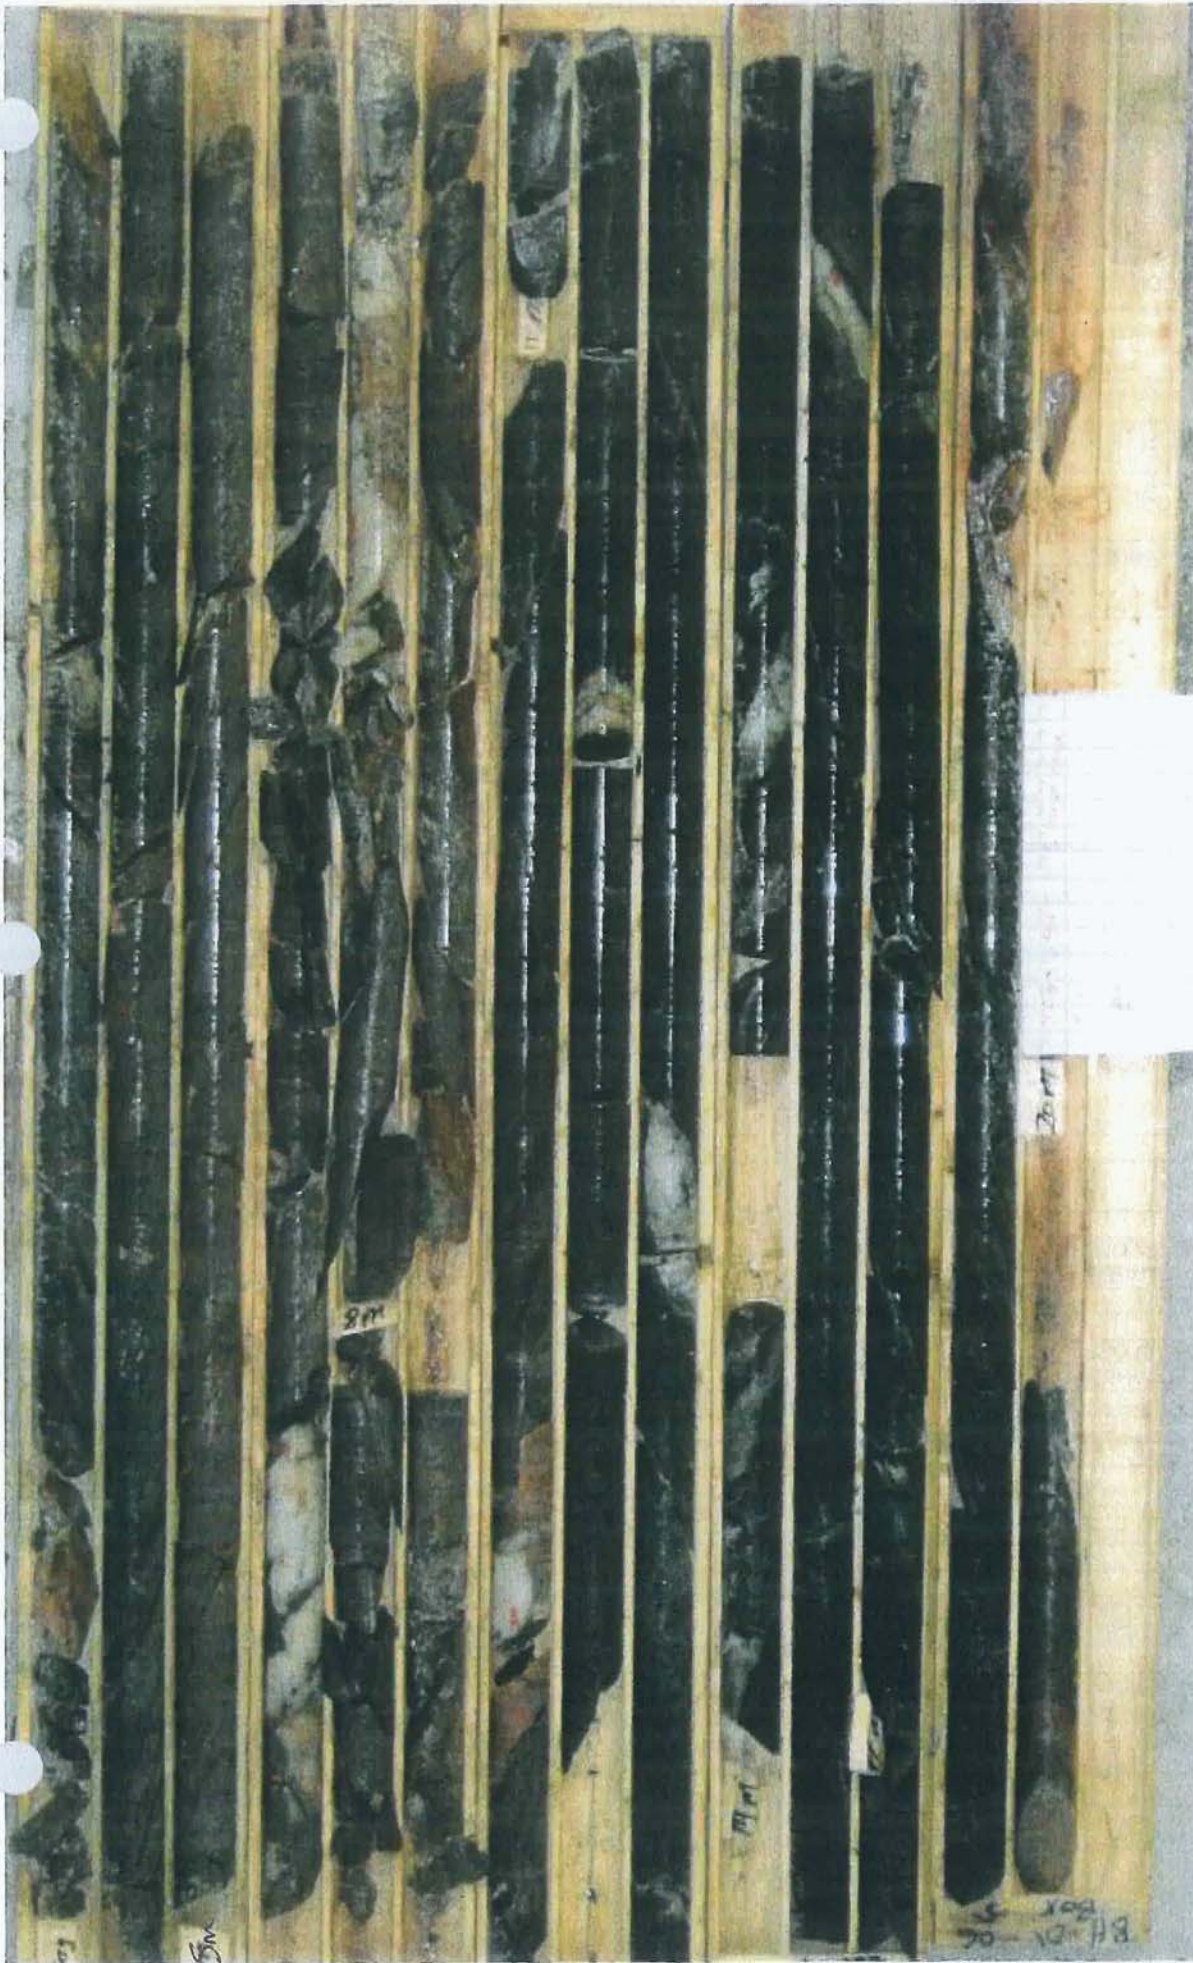
TAKEN BY:	AH	PROJECT	ISLAND POND HYDROELECTRIC DEVELOPMENT
CHECKED:	KDP	DRAWING	ROCK CORE PHOTO - BH-06-001
FILE NO.	Tf6316540	SCALE	NTS
		DATE	JAN 2, 2007
		PHOTO NO.	BH-06-001
		REV.

ELEVATION (m)	DEPTH (m)	SYMBOL	STRATIGRAPHIC DESCRIPTION	SAMPLES				REMARKS
				No.	TYPE	RECOVERY (%)	N VALUE or RQD (%)	
	1		BOULDERS AND COBBLES - Grey, boulders and cobbles with some sand and gravel, moist, compact to dense.	1	CORE	100	0	Zone 21 UTM NAD 83 Coordinates taken using hand held GPS East Coordinate: 0545816 North Coordinate: 5358912 Packer test conducted from 3.0 m to 6.0 m depth. Due to poor bedrock condition packer test failed. No additional tests attempted due to poor rock quality.
	2		BEDROCK - Dark grey, schist, closely spaced joint fractures with rust staining on fractures. Schistosity at 20 degrees to core axis. Visible pyrite along foliations. Quartz veins present throughout borehole.	2	CORE	100	53	
	5		Crushed zone at 7.0 m to 7.2 m depth.					
	6		Crushed zone at 8.3 m to 8.4 m depth. Sheer zone at 8.7 m depth. Can see stratum on fractured planes. Crushed zone at 9.7 m to 9.8 m depth.	3	CORE	100	22

9		Quartz vein at 40 degrees to core axis at 8.4 m depth. Potassium feldspar present in quartz vein and muscovite visible along fractured plane and in core.	4	CORE	100	54	
	11		Pink, schist, closely spaced joint fractures with rust staining on fractures. Schistosity at 20 degrees to core axis. Visible pyrite along foliations.	5	CORE	100	78	
	14		Dark grey, schist, closely spaced joint fractures with rust staining on fractures. Schistosity at 20 degrees to core axis. Visible pyrite along foliations.	6	CORE	100	63
