Geotechnical Site Investigation Proposed Island Pond Hydro Electric Development (as prepared by AMEC)

**Geotechnical Site Investigation
Proposed Island Pond Hydro Electric
Development
South Central Newfoundland
Date: January 03, 2007
Final Report
Submitted by:
AMEC Earth & Environmental**

**GEOTECHNICAL INVESTIGATION
PROPOSED ISLAND POND
HYDROELECTRIC DEVELOPMENT
SOUTH CENTRAL NEWFOUNDLAND**

January 2007
TF6316540

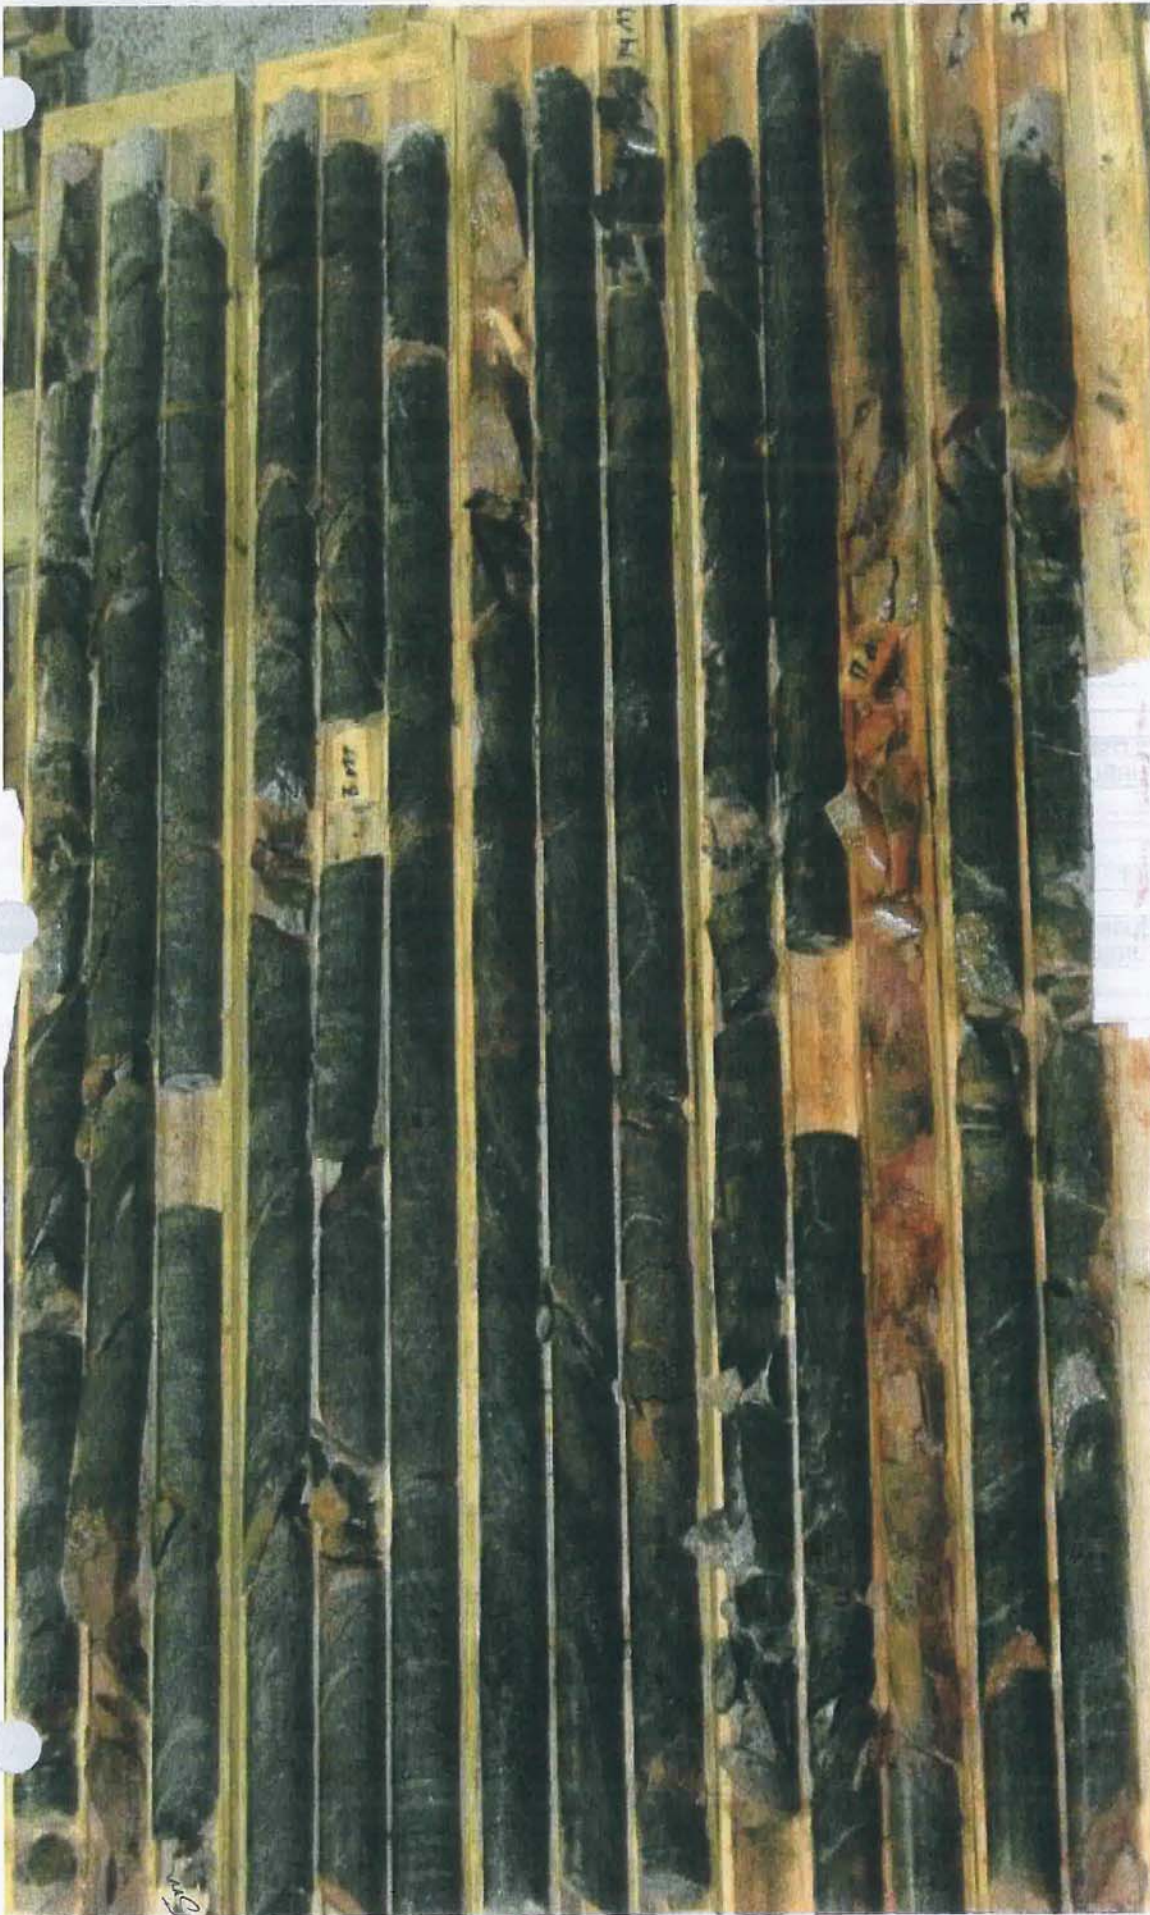
ELEVATION (m)	DEPTH (m)	SYMBOL	STRATIGRAPHIC DESCRIPTION	SAMPLES					REMARKS
				No.	TYPE	RECOVERY (%)	N VALUE or ROD (%)		
	1		BOULDERS AND COBBLES - Grey, boulders and cobbles with some sand and gravel, moist, compact to dense.	1	CORE	100	0	-	Zone 21 UTM NAD 83 Coordinates taken using hand held GPS East Coordinate: 0545811 North Coordinate: 5358878 Fault zone approximately 10 cm wide. Gauge present.
	2		BEDROCK - Dark grey schist with red hematite staining, muscovite and pyrite visible, foliations at 20 to 30 degrees to core axis.	2	CORE	100	0	-	
	3		Crushed zone at 3.4 m to 3.5 m depth.	3	CORE	100	20	-	
	4		Crushed zone at 3.7 m to 3.8 m depth.	4	CORE	100	40	-	
	5		Fault present at 4.6 m depth.						
	6			5	CORE	100	57	-	
	7		Crushed zone at 7.8 m to 7.9 m depth.	6	CORE	100	63	-	
	8								
	9			7	CORE	100	41	-	
	10								
	11		Fault present at 10.85 m depth.						Fault zone approximately 5 cm wide. Gauge present. Packer test conducted from 11.0 m to 14.0 m depth. Due to poor bedrock condition packer test failed. No additional tests attempted due to poor rock quality.

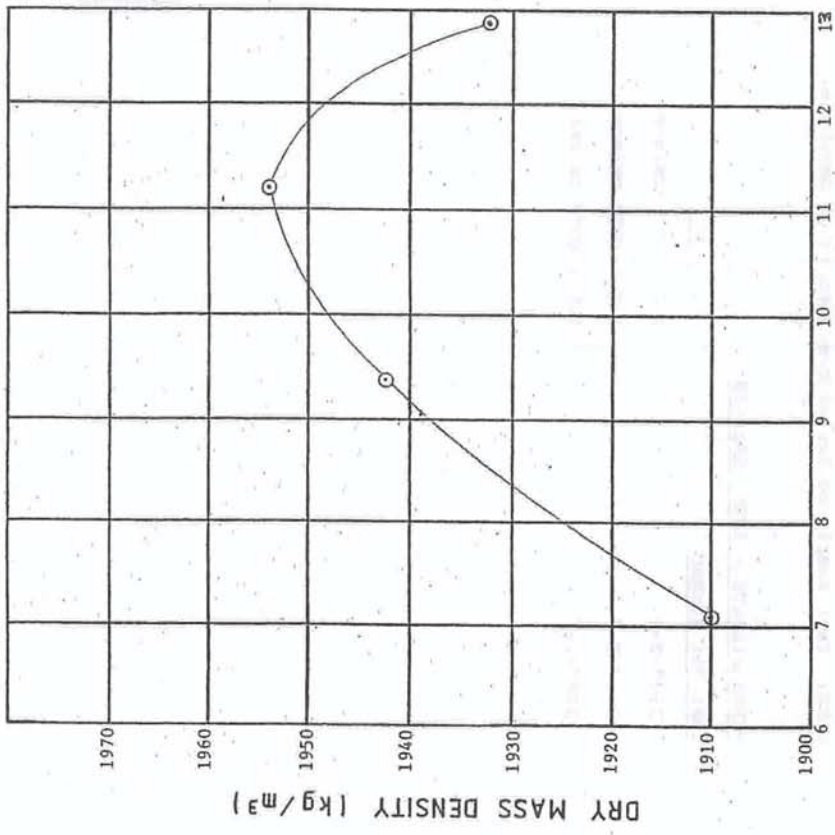
PROJECT No : 87-862 FIGURE No :
PROJECT : ISLAND POND
LOCATION : TP-1987-T-16

PROCTOR DENSITY TEST DATE : November 4, 1987
TEST METHOD : Standard ASTM D698 MAXIMUM DRY MASS DENSITY 1954 kg/m³
SOIL DESCRIPTION : Sand with trace of silt and gravel. OPTIMUM WATER CONTENT 11.2 %
REMARKS :

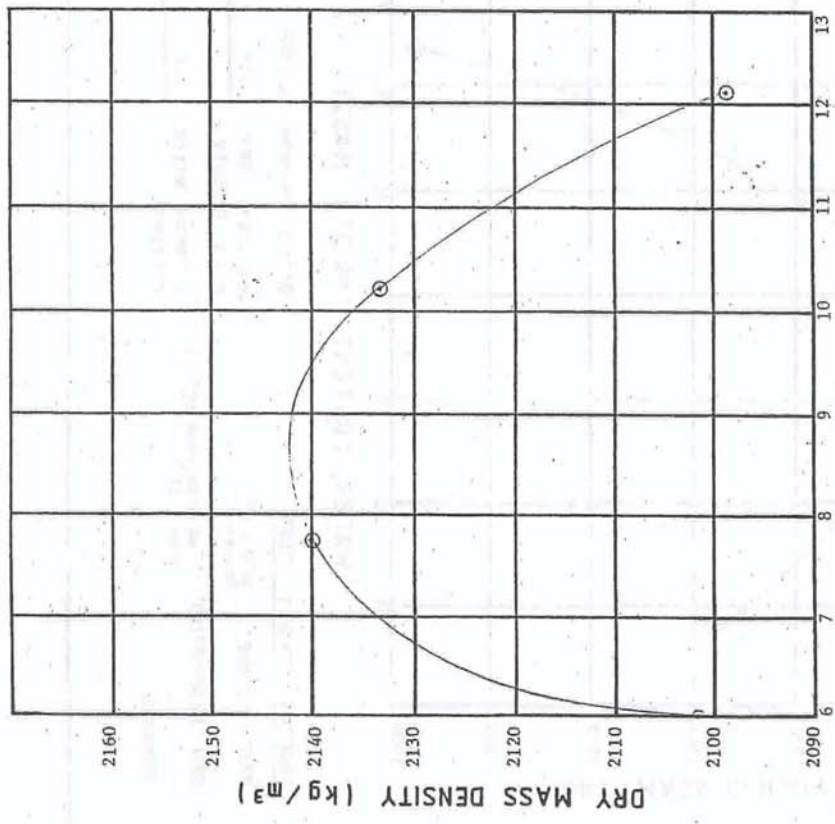
PROJECT No : 87-862 FIGURE No :
PROJECT : ISLAND POND
LOCATION : TP-1987-T-15

PROCTOR DENSITY TEST DATE : November 4, 1987
TEST METHOD : Standard ASTM D698 MAXIMUM DRY MASS DENSITY 2142 kg/m³
SOIL DESCRIPTION : Sand and gravel with trace of silt OPTIMUM WATER CONTENT 8.7 %
REMARKS :

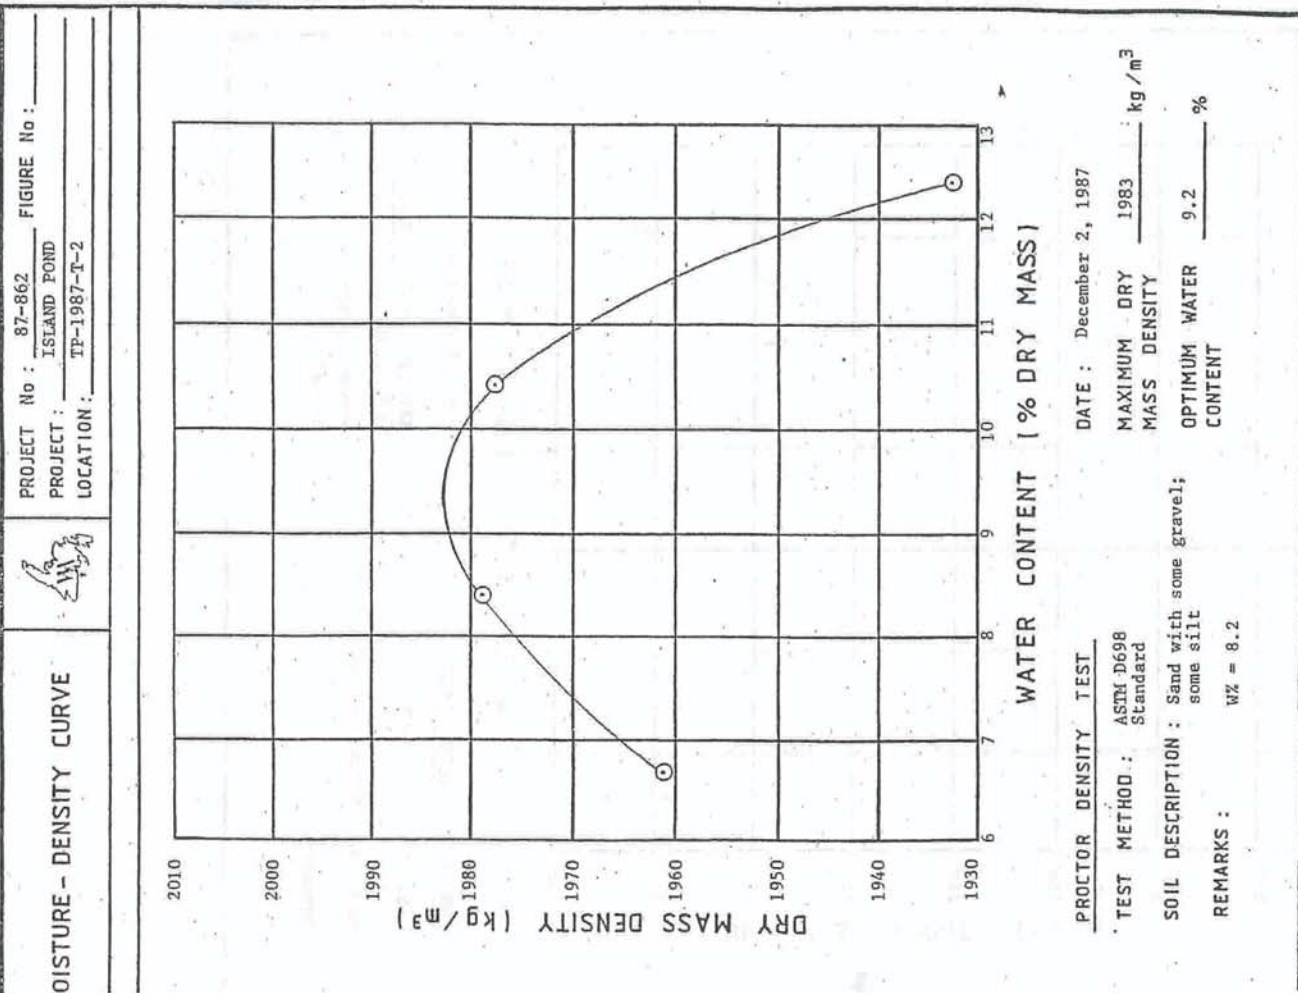
PROJECT No : 87-862 FIGURE No :
PROJECT : ISLAND POND
LOCATION : TP-1987-T-2

PROCTOR DENSITY TEST DATE : December 2, 1987
TEST METHOD : ASTM D698 Standard MAXIMUM DRY MASS DENSITY : 1983 kg/m³
SOIL DESCRIPTION : Sand with some gravel; some silt OPTIMUM WATER CONTENT : 9.2 %
REMARKS : W% = 8.2
