1 Q. Provide a document that clearly outlines the retirement costs to take Holyrood out
2 of service 2017 (or beyond)? What is the cost to convert unit(s) to synchronous
3 condenser operation? Are these costs factored into the CPW analysis?
4

1 Q. With respect to Exhibit 19 (Muskrat Falls), has there been any detailed analysis
2 carried out relating to the clay spur and the effectiveness of the sump pump system
3 under impounded conditions (tests, simulations, experience of other dam
4 operators)? Please provide supporting documentation.

The purpose of this WTO was to determine the suitability of the pumpwell system installed in the north spur at the Muskrat Falls site with a view to a life extension of ten years. The review included an on-site inspection of the system to determine the present physical condition and operational characteristics.

CLIENT  		PRIME CONSULTANT  	
PROJECT TITLE LOWER CHURCHILL HYDROELECTRIC PROJECT ENGINEERING STUDIES		WTO NUMBER & TITLE MF-1260 CONDITION ASSESSMENT OF EXISTING EQUIPMENT	DRAWING TITLE SPUR LOCATION RELATIVE TO HAPPY VALLEY-GOOSE BAY
DATE: NOVEMBER 2007		PROJECT No. H325967	DRAWING No. FIGURE 1

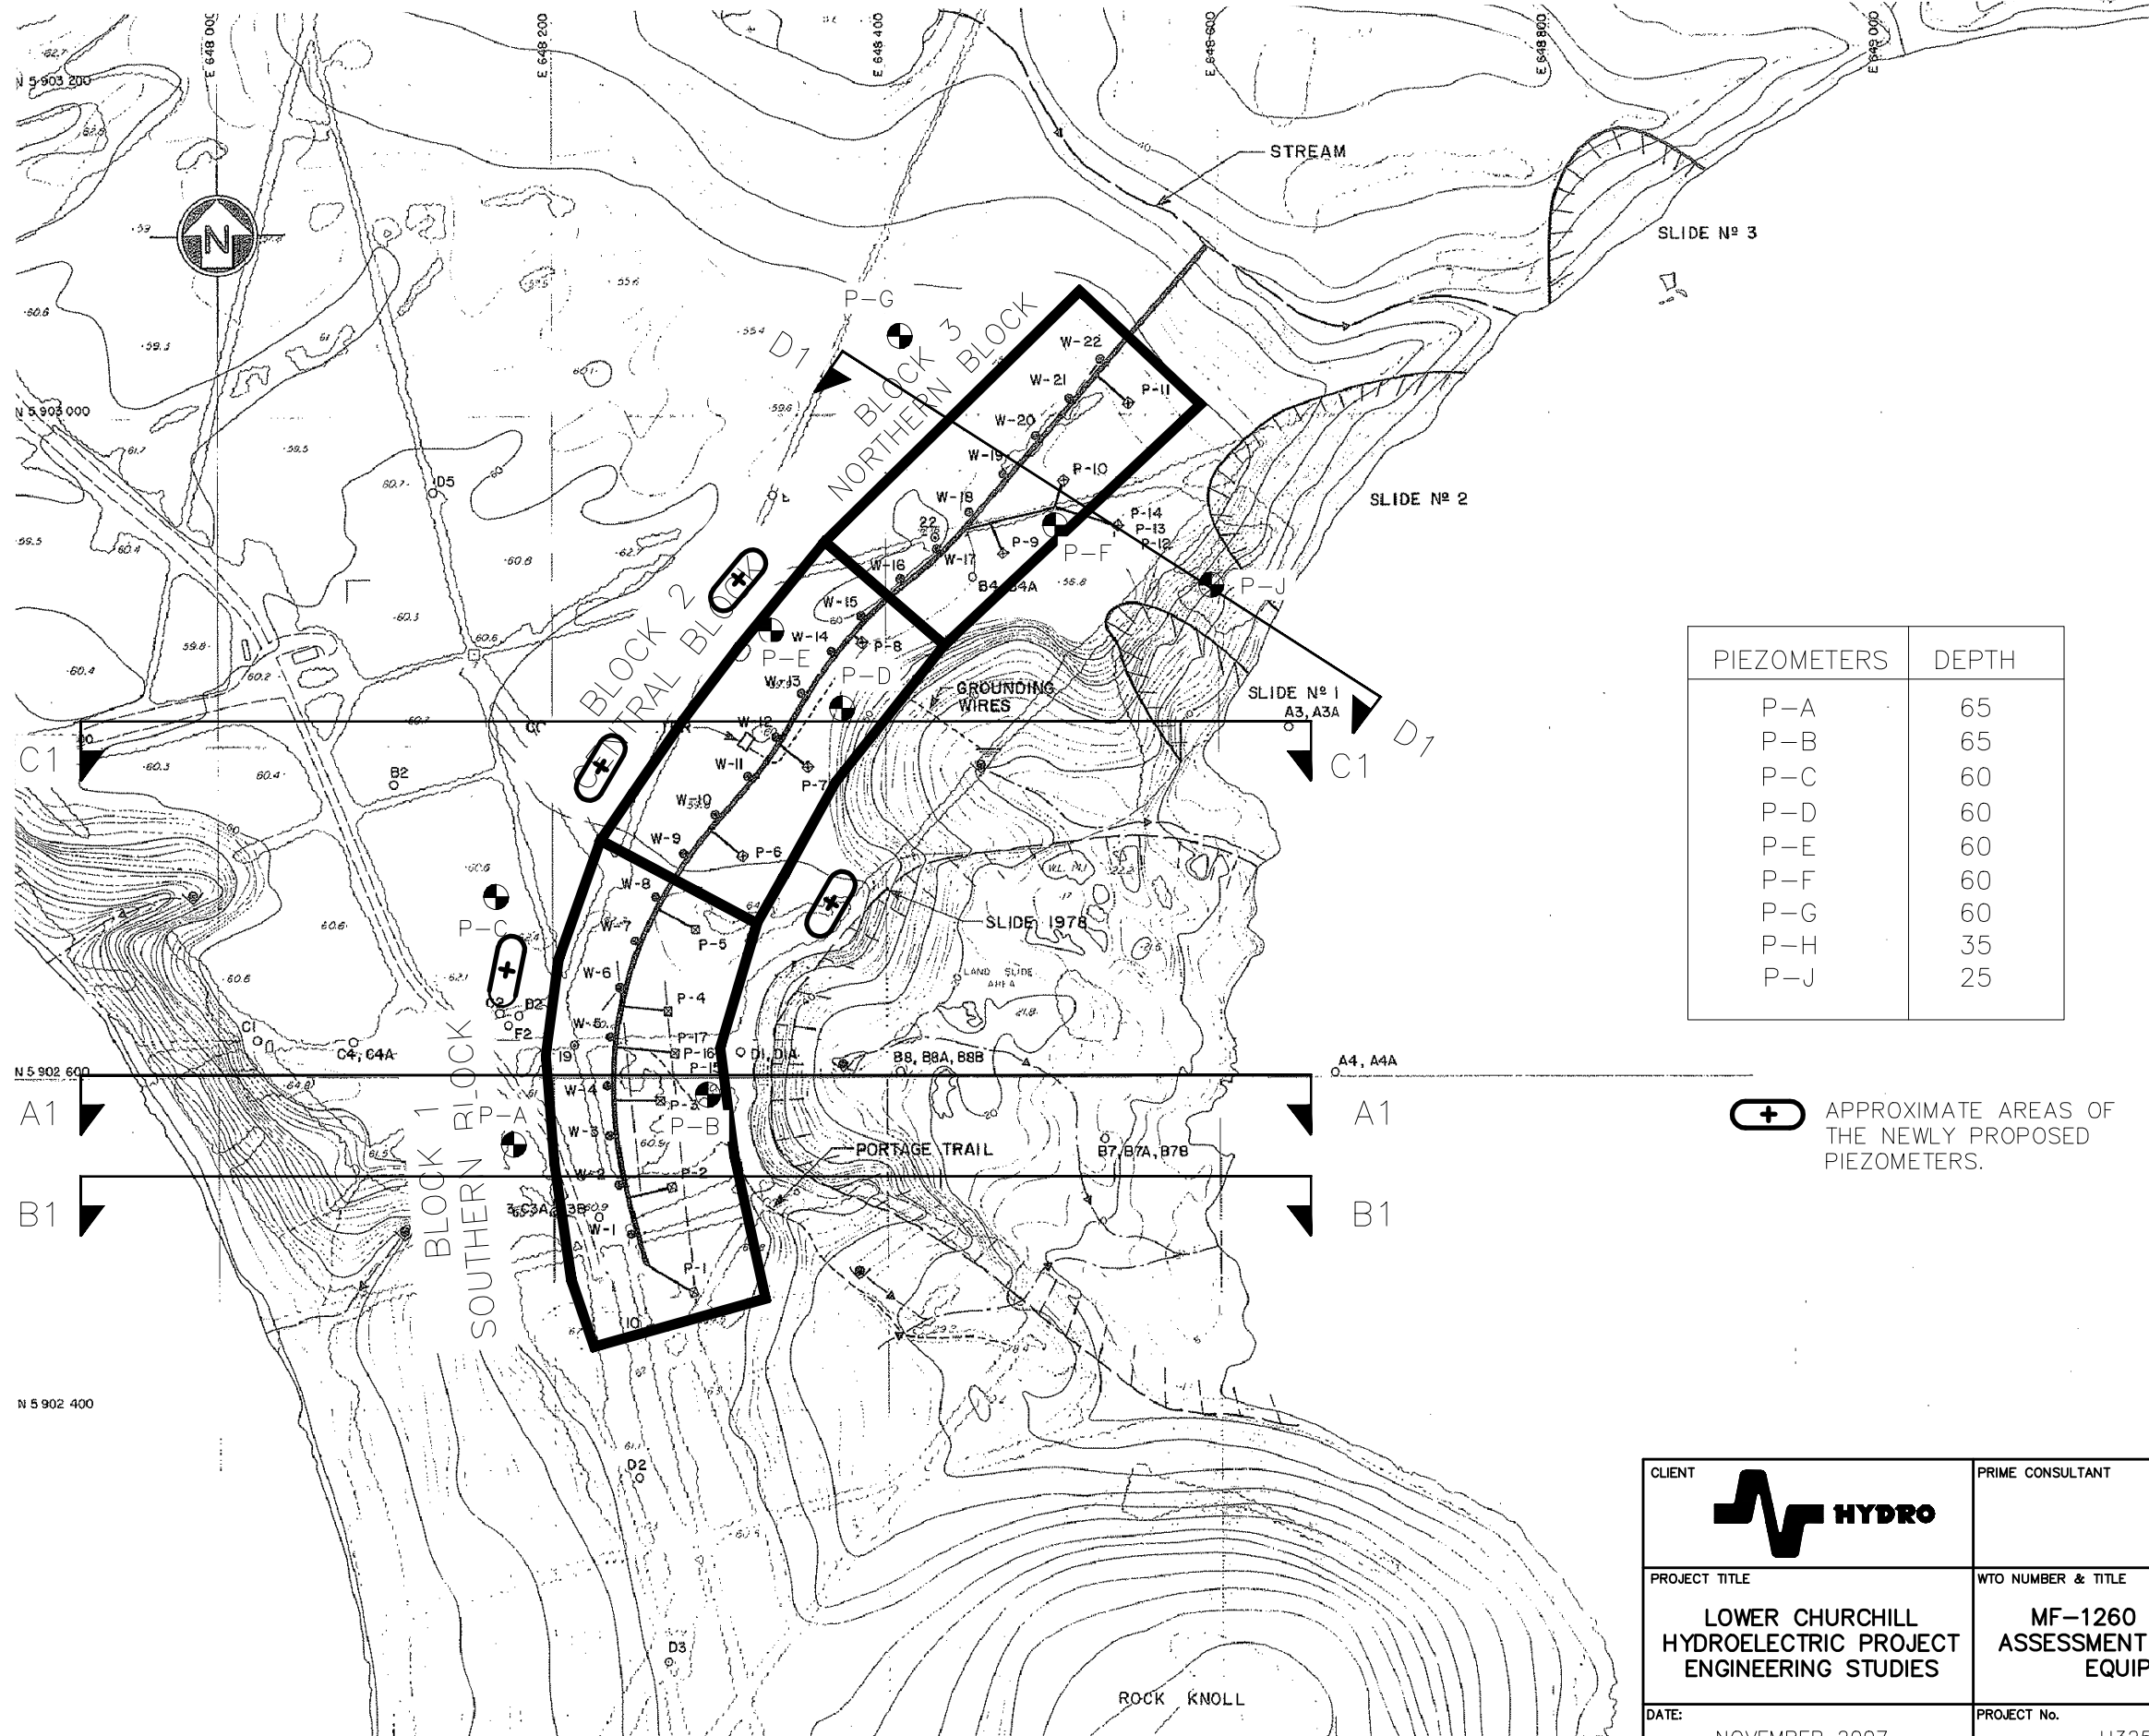
CLIENT HYDRO	PRIME CONSULTANT HATCH	
PROJECT TITLE LOWER CHURCHILL HYDROELECTRIC PROJECT ENGINEERING STUDIES	WTO NUMBER & TITLE MF-1260 CONDITION ASSESSMENT OF EXISTING EQUIPMENT	DRAWING TITLE ORIGINAL BLOCK TEST PLAN
DATE: NOVEMBER 2007	PROJECT No. H325967	DRAWING No. FIGURE 4

Initially, it was intended to divide the wells into three main blocks as shown in Figure 4. These test blocks were to consist of the following wells and piezometers:

- In order to develop a more complete understanding of the phreatic surface and to assist in the creation of hydrogeological cross sections, such as those presented in Section 4.4, and in other sections to be developed in the future, it is suggested to install 4 new double standpipe piezometers. It is estimated that this will cost in the order of \$120,000 plus engineering and management fees (Details are provided in Appendix E). The locations of the new piezometers are suggested as follows as shown in Figure 4:

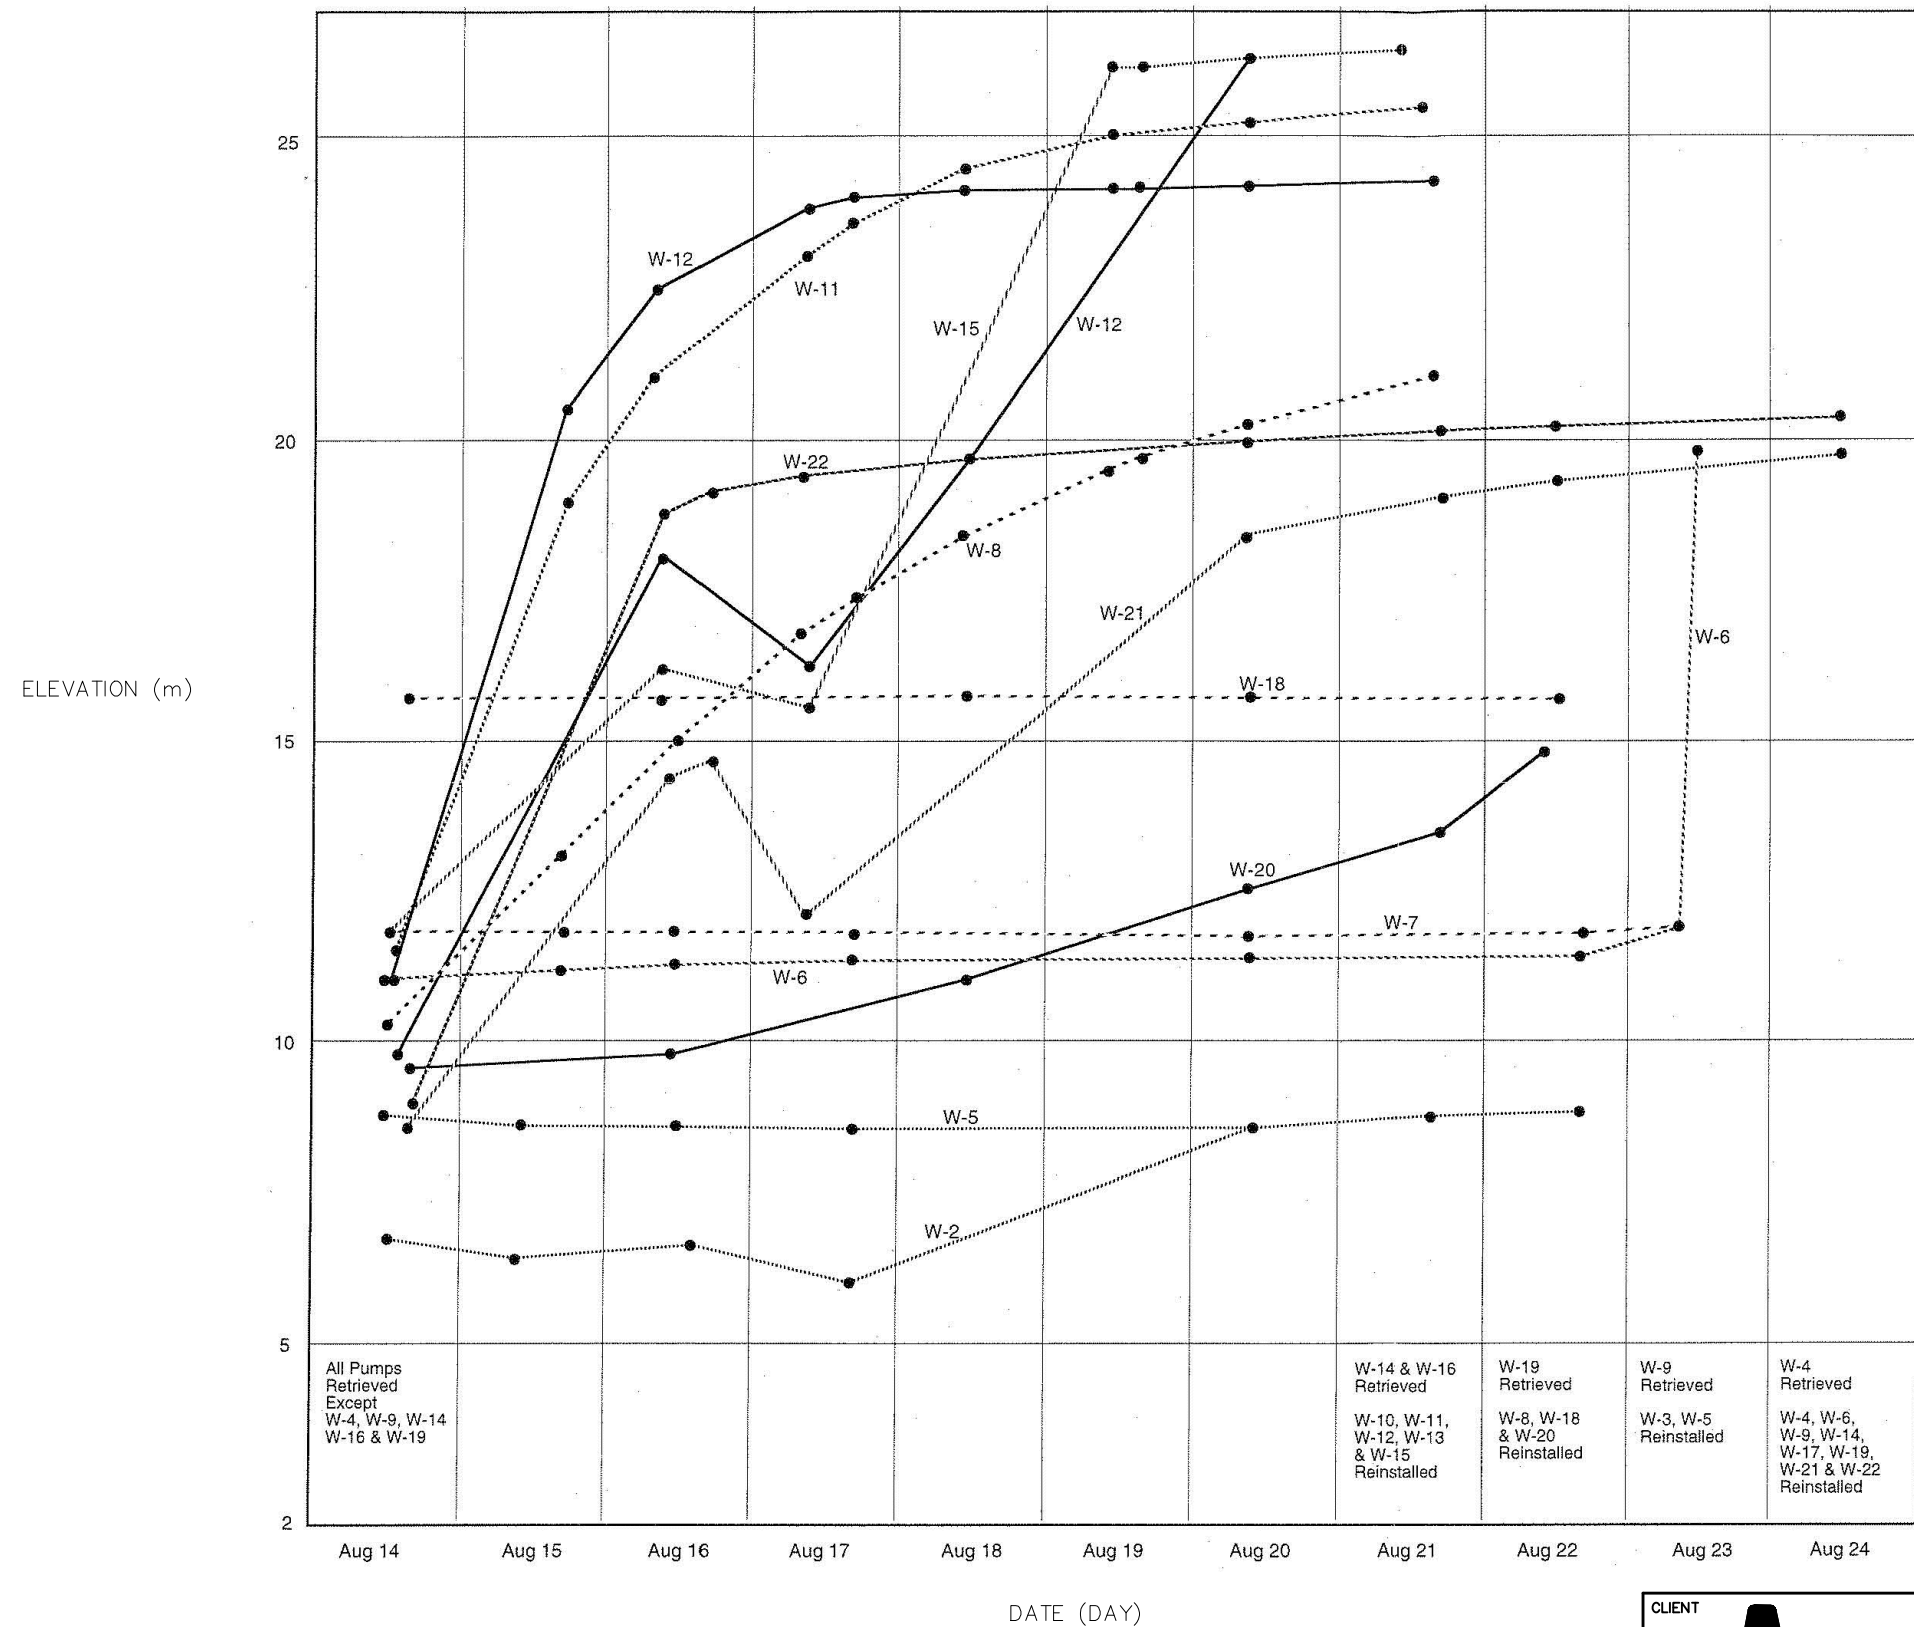
CLIENT 	PRIME CONSULTANT 	
PROJECT TITLE LOWER CHURCHILL HYDROELECTRIC PROJECT ENGINEERING STUDIES	WTO NUMBER & TITLE MF-1260 CONDITION ASSESSMENT OF EXISTING EQUIPMENT	DRAWING TITLE RECOVERY IN SELECTED WELLS, PERFORMED BY ACRES - 1996.
DATE: NOVEMBER 2007	PROJECT No. H325967	DRAWING No. FIGURE 6

In August, 1996, a series of recovery tests was made by Acres on the pumps for 11 days to study the groundwater regime in the stratified drift unit (between el -10 and 50) and its response to pumping. In that recovery test, all pumps, other than W-4, W-9, W-14, W-16, and W-19, were retrieved and cleaned over a period of 7 days and the water recoveries were recorded accordingly. Since W-4, W-9, W-14, W-16, and W-19 are the most active, they were retrieved and cleaned in one day. Figure 6 describes the variation of the water elevations and the sequence of pumps after reinstallation/retrieval. In addition, Table 2 provides a summary of the characteristics and water level measurements in the wells. This table contains the water elevations in the wells in 1994 and 1995 in addition to the results of the recovery test during the 11 days. It should be mentioned that the pumps in W-4 and W-9 which are the most active wells were not left out of the well overnight.

During the 1996 recovery test, the wells could be divided into three major zones: Southern (W-1 to W-7), Central (W-8 to W-17), and Northern (W-18 to W-22). The major observations of the recovery test can be stated as:

- The sand component of about 50 percent is significant in the downstream south side of the spur near the rock knoll, and decreases in the northerly direction. In other words, the downstream south side contains more pervious sediments and offers better opportunities for dewatering than the northern part.

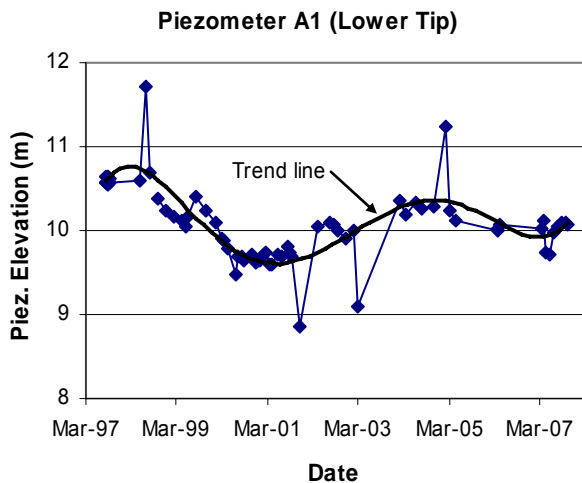
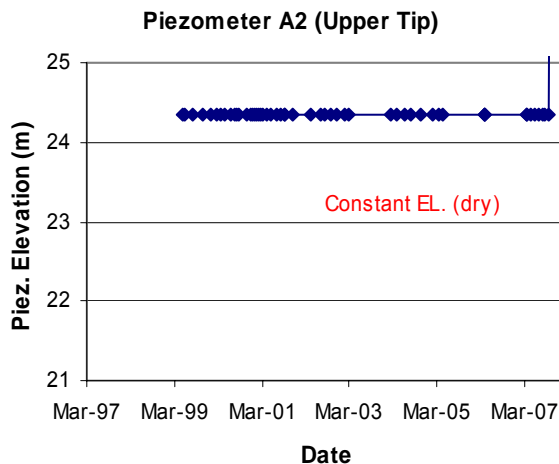
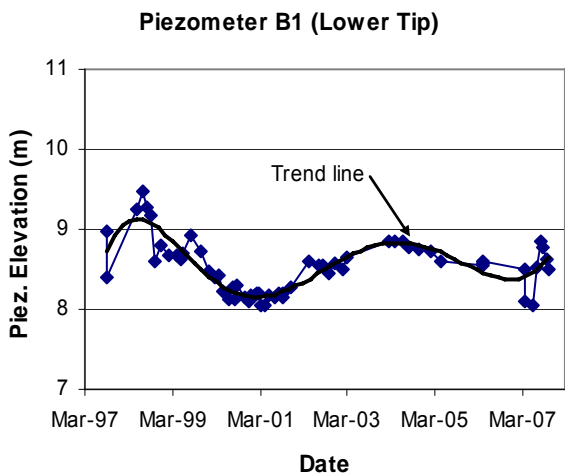
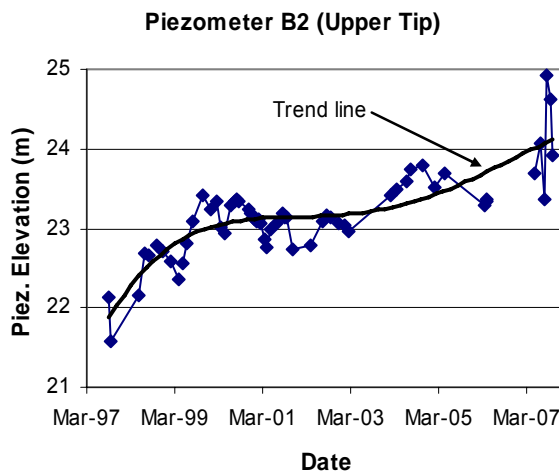
Figure 7 - Piezometer water level variations from 1997 to 2007: (a) P-A1 lower tip, (b) P-A2 upper tip, (c) P-B1 lower tip, (d) P-B2 upper tip

Figures 7 to 10 plot the variation of piezometer water elevation for the last 10 years. Out of 12 observed tips, the readings of four tips are not consistent with the other installations or historic data. These are: P-A2, P-B2, P-C, and P-D2. In the piezometers which have two tips, the suffixes 1 and 2 refer to lower and higher tips, respectively.

Comparing the variation of the upstream water levels (showing highest in 1999 and lowest in 2003) with the variation of piezometers P-A, P-B, and P-D, Figures 7 and 8 (which have their lowest elevation in 2001 and the highest value in 2004/5), it can be concluded that there is no clear correlation between upstream river water level variation and the piezometric elevations.

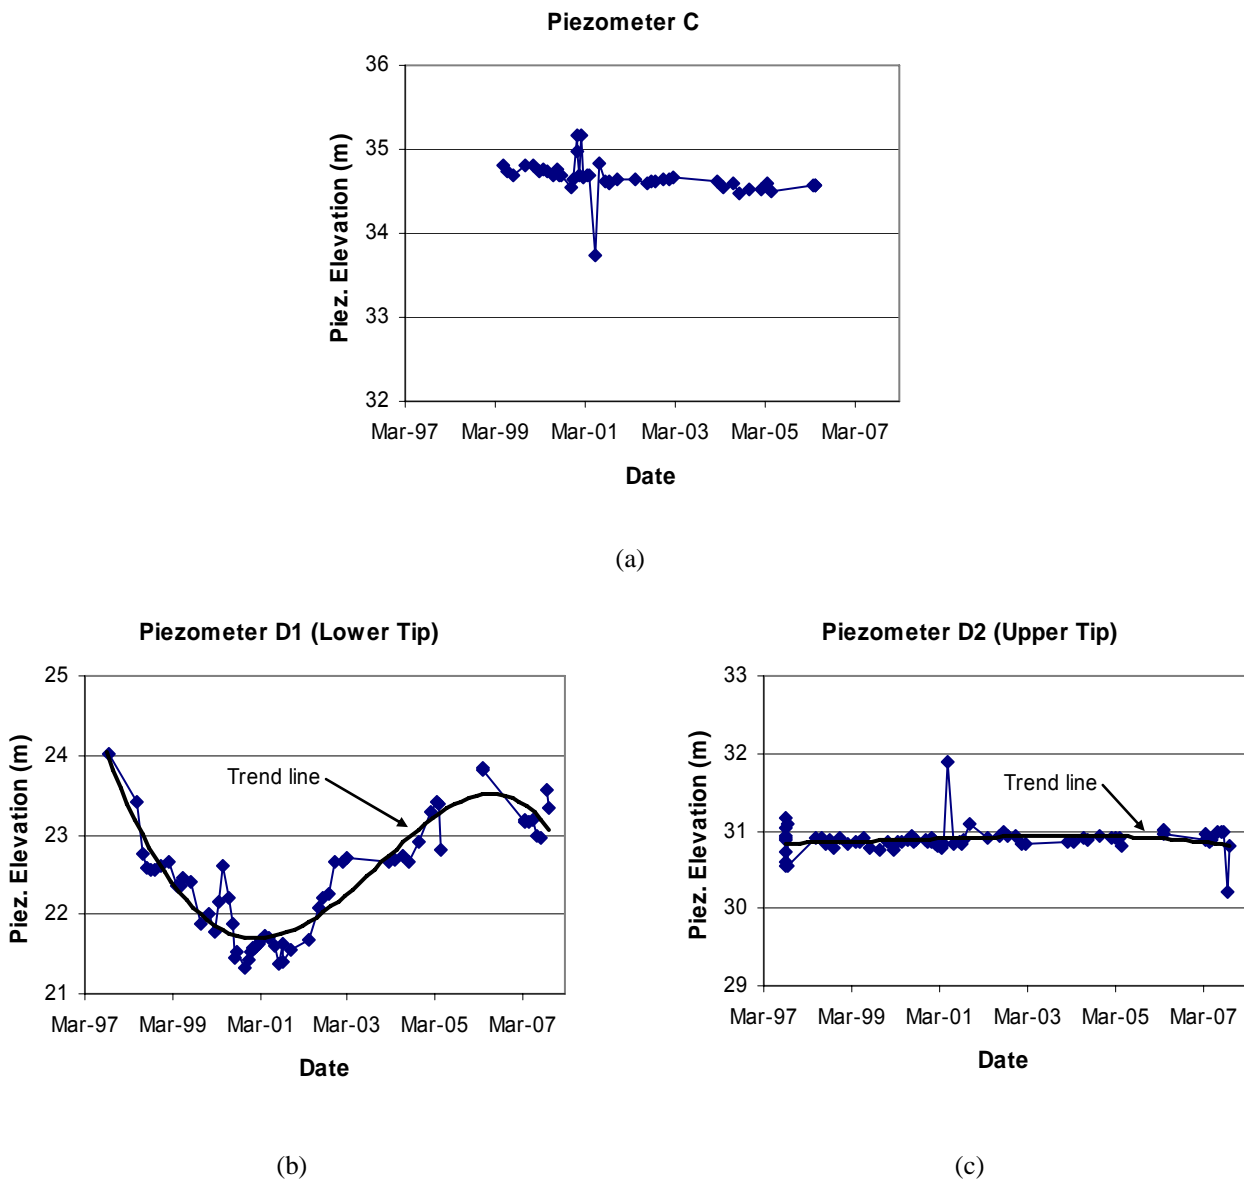
Figure 8 - Piezometer water level variations from 1997 to 2007: (a) P-C, (b) P-D1 upper tip, (c) P-D2 lower tip

- Piezometer C (P-C) has been out of order since March 2007 (riser pipe blockage) and has previously shown little response since installation.
- Three weirs which were recommended in 1997 were not seen – Hydro staff reported that they are accessible only with difficulty.

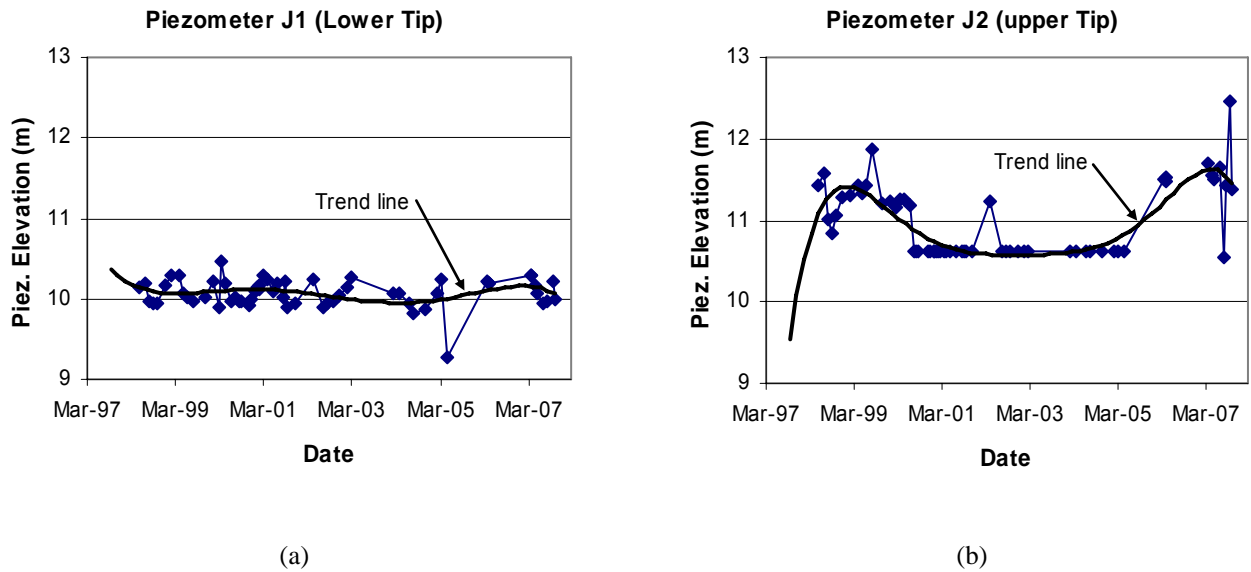
Figure 10 - Piezometer water level variation from 1997 to 2007: (a) P-J1 lower tip, (b) P-J2 upper tip

- P-J1 shows an approximately constant level of el 10 m. In March 2007, this tip showed the highest elevation of el 10.3.
- P-J2, which is the higher tip, was dry from 2000 to March 2005. From April 2006, the piezometer showed an increase in water elevation of about 0.9 m. In March 2007, this value was equal to el 11.70 m and in September 2007, it was el 11.54 m. In August 2007, the water level was reported as el 14.95 m, which may not be correct and was eliminated from the figure.

- Similar to the two tips of P-F, the two piezometer tips (P-J1 and P-J2) show approximately the same value or a slightly downward gradient.

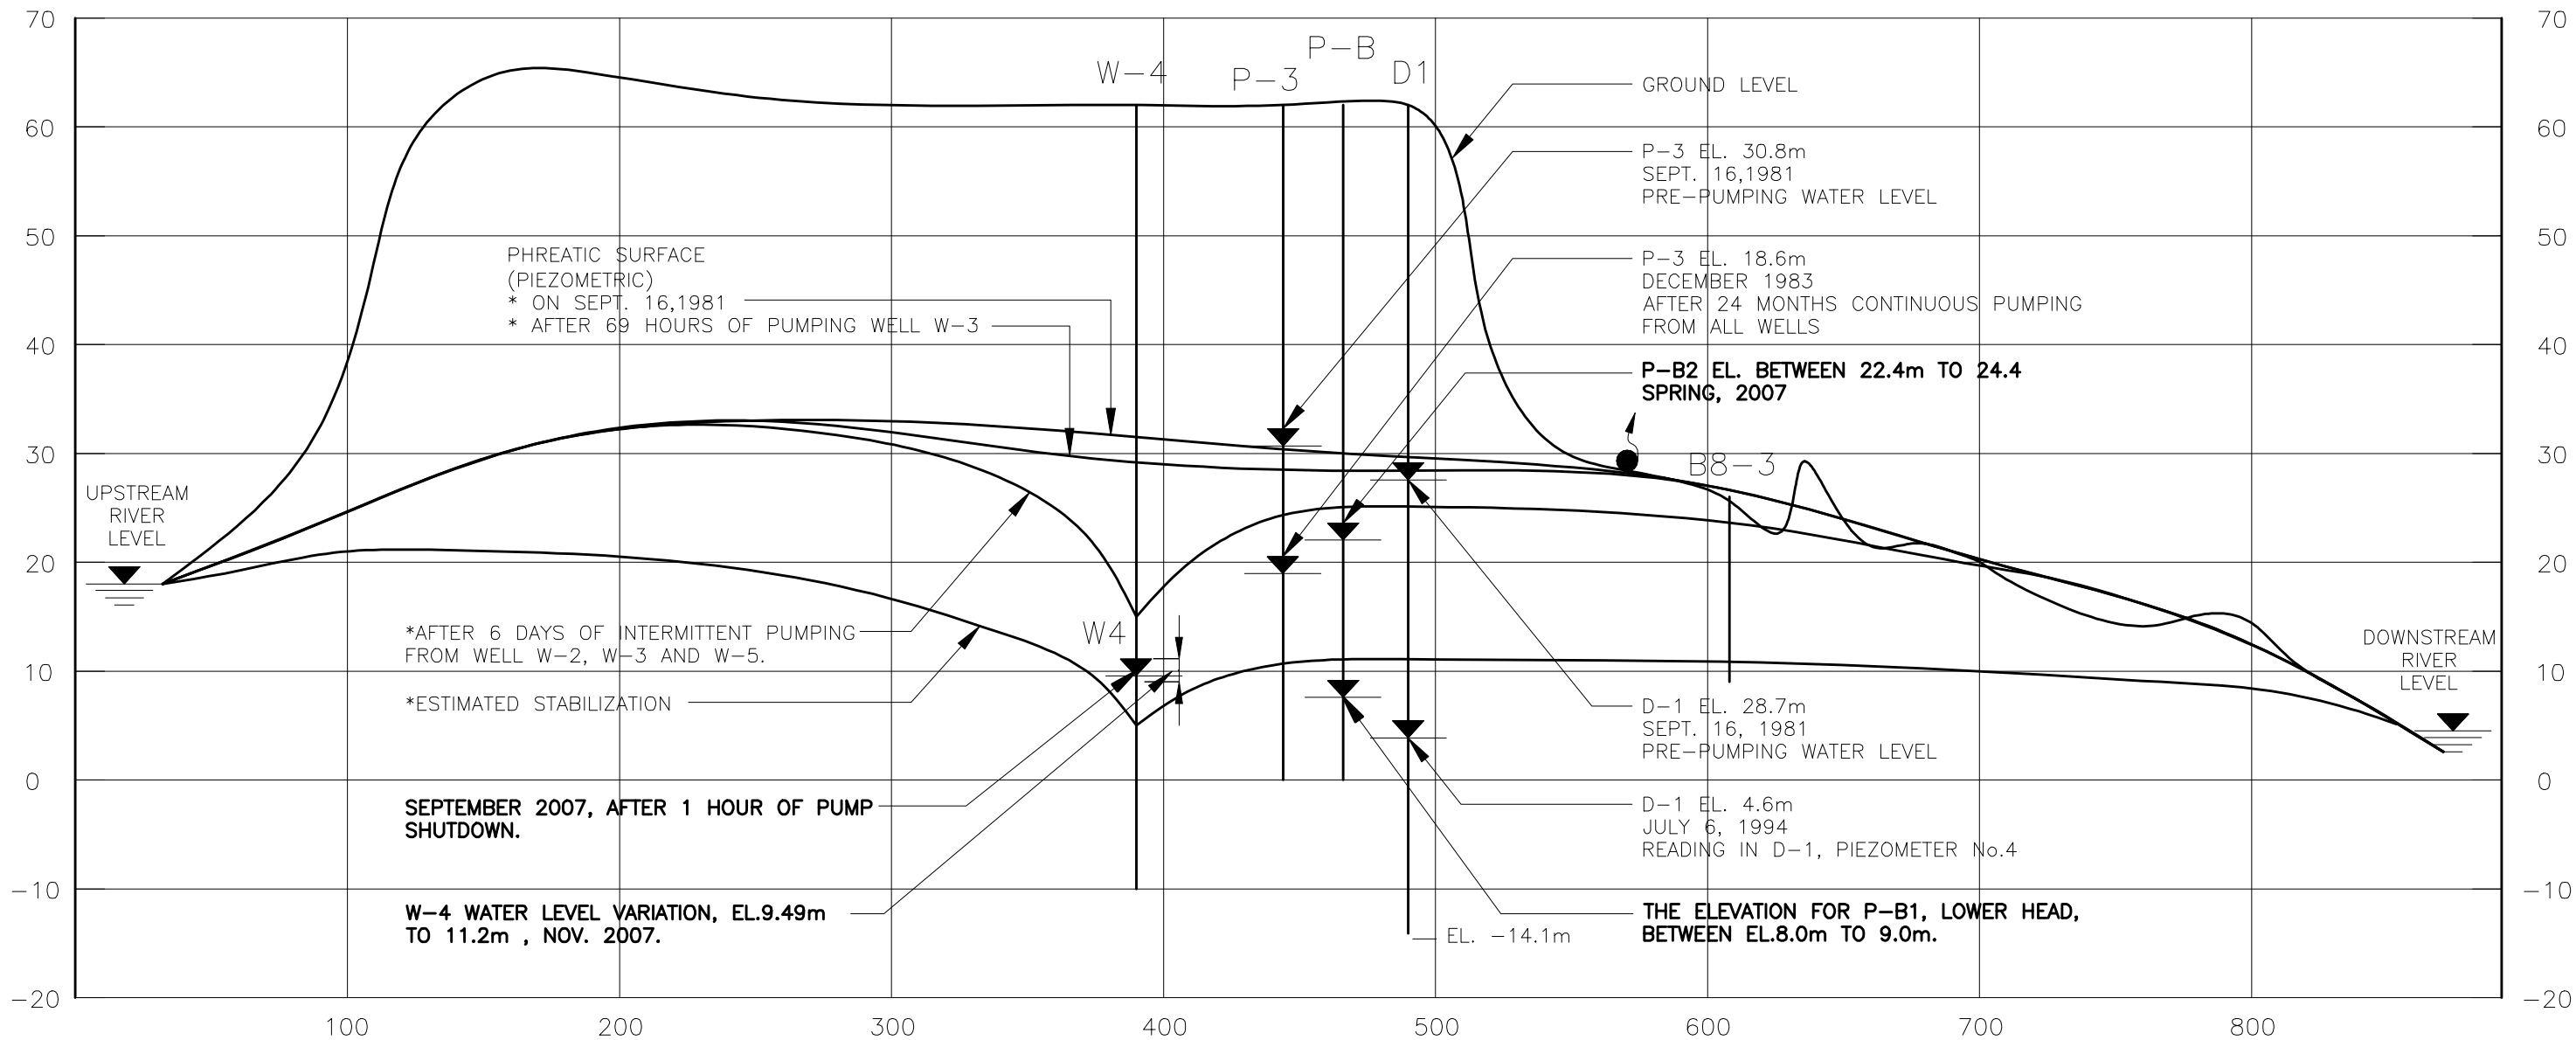
CLIENT 	PRIME CONSULTANT 	
PROJECT TITLE LOWER CHURCHILL HYDROELECTRIC PROJECT ENGINEERING STUDIES	WTO NUMBER & TITLE MF-1260 CONDITION ASSESSMENT OF EXISTING EQUIPMENT	DRAWING TITLE MUSKRAT FALLS HYDROGEOLOGIC SECTIONS SECTION A1-A1
DATE: NOVEMBER 2007	PROJECT No. H325967	DRAWING No. FIGURE 11

This section, Figure 11, is important because it is close to the narrowest section of the spur, there is a lot of information from other sources, and W-4, which is the most active pump, is located on the section. In the report by Acres International (1994), W-4 is noted to be responsible for 85% of the total dewatering of the system.

NOTE:
DRAWING THE CURRENT PHREATIC SURFACE NOT PRACTICAL WITH ONLY TWO DATA POINTS.

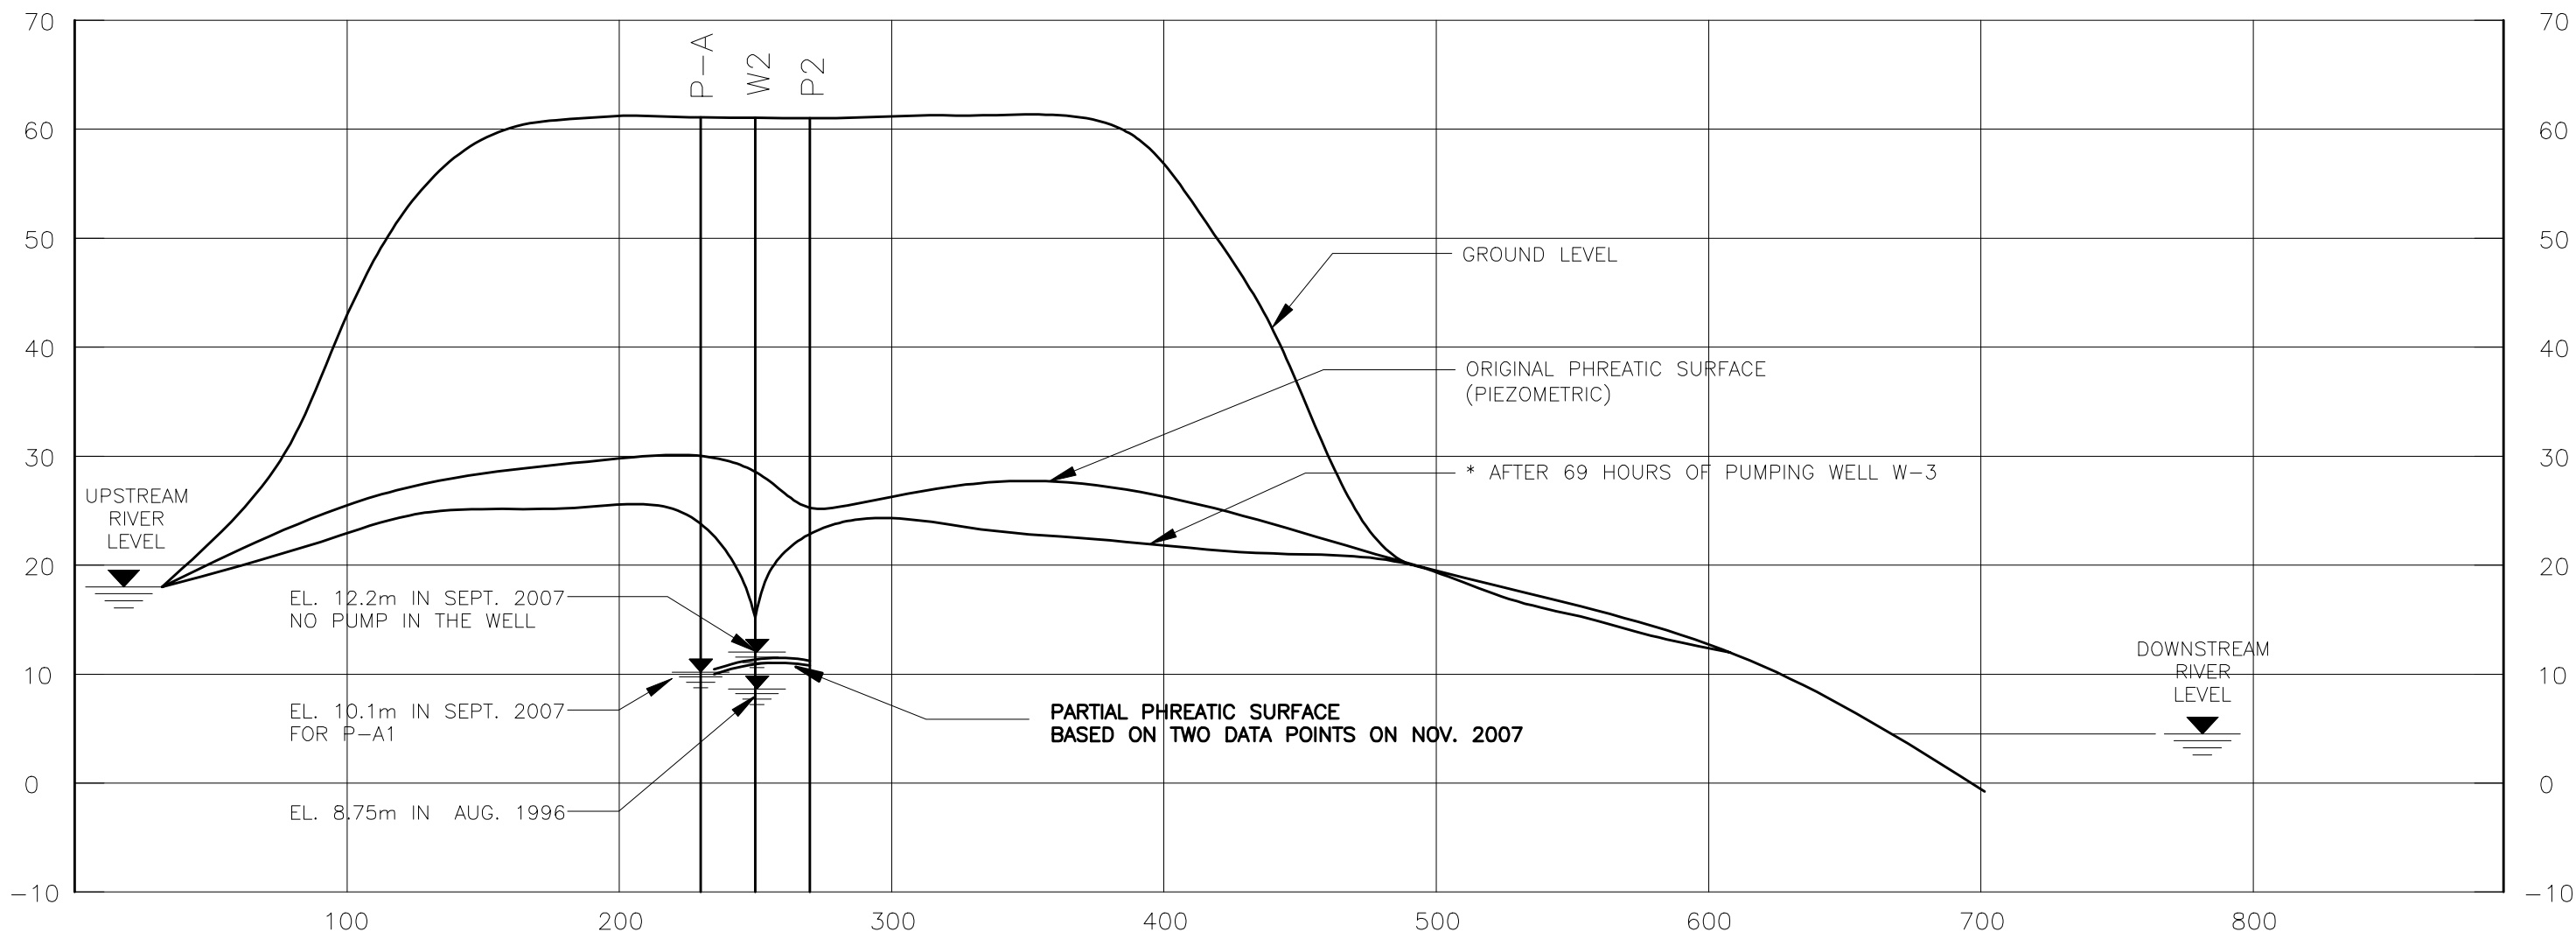
PROJECT TITLE LOWER CHURCHILL HYDROELECTRIC PROJECT ENGINEERING STUDIES	WTO NUMBER & TITLE MF-1260 CONDITION ASSESSMENT OF EXISTING EQUIPMENT	DRAWING TITLE MUSKRAT FALLS HYDROGEOLOGIC SECTIONS SECTION B1-B1
DATE: NOVEMBER 2007	PROJECT No. H325967	DRAWING No. FIGURE 12

This section, Figure 12, is also close to the narrow part of the spur. The original phreatic surface is plotted based on the information provided from SNC-Lavalin report: "Muskrat Falls Dewatering System – Engineering Assessment", Plate-4. The piezometric line resulted from 69 hours of pumping. Drawdown data points by Pumps 2,3,4, and 5 were also derived from the report.

The water table in the piezometer P2, read in Dec 1983 (original piezometric surface), indicates that the water table had dropped to el 10 m from el 26 m. In Aug 1996, the water level in W-2 was recorded by Acres to be el 8.75 m which is the lowest derived head in this section. This is shown in Figure 12. The two readings in Sept in P-A1 and Nov 2007 in W-2 indicate that the water tables are about el 10.1 and el 12.2 m, respectively. During the recovery test, the water elevation increased in W-2 by only 0.04 m, which is less than the level rise in the adjacent piezometers. This suggests that W-2 may be damaged as suggested by the removal of the pump several years ago. A well video inspection may reveal any problems.

NOTE:
DRAWING THE CURRENT PHREATIC SURFACE
IS NOT PRACTICAL WITH ONLY TWO DATA
POINTS.

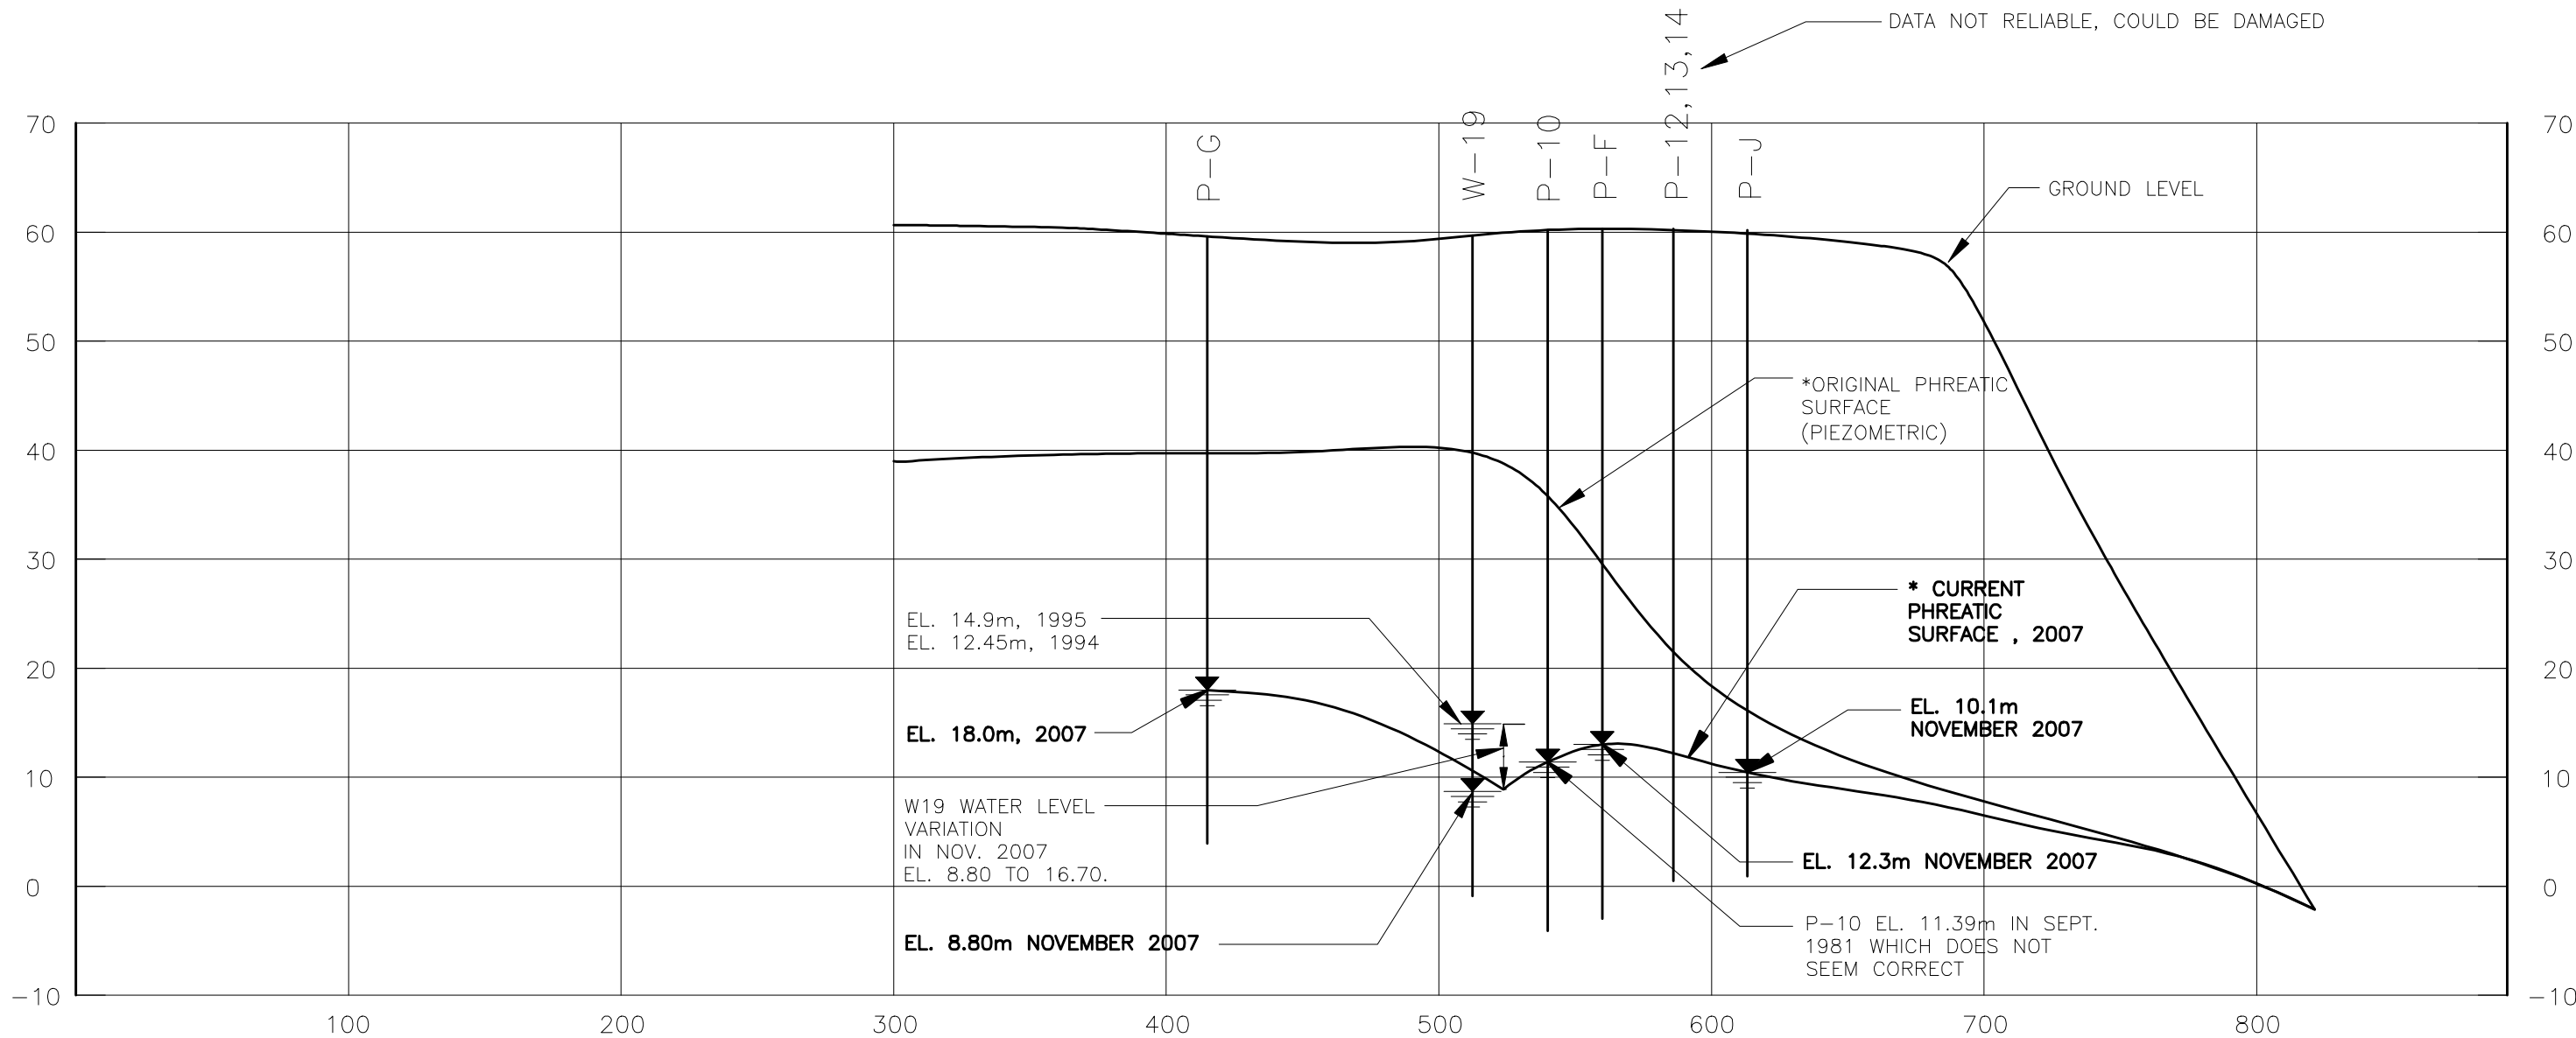
CLIENT 	PRIME CONSULTANT 	
PROJECT TITLE LOWER CHURCHILL HYDROELECTRIC PROJECT ENGINEERING STUDIES	WTO NUMBER & TITLE MF-1260 CONDITION ASSESSMENT OF EXISTING EQUIPMENT	DRAWING TITLE MUSKRAT FALLS HYDROGEOLOGIC SECTIONS SECTION D1-D1
DATE: NOVEMBER 2007	PROJECT No. H325967	DRAWING No. FIGURE 14

There are three piezometers and one well located in this cross section, as shown in Figure 14, which allow a precise illustration of the current stabilized phreatic surface. However, as discussed in Section 4.2, the piezometric surface has risen significantly since 2005.

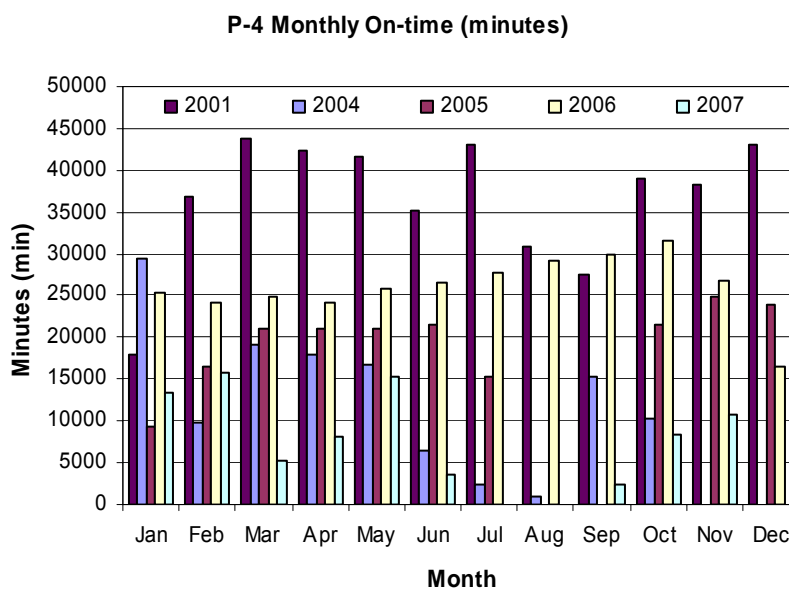
Figure 18 - Monthly on-time for pump no. 4 (P-4)

Figure 18 demonstrates the total monthly on-time for pump no.4 for the last four years (2004 to 2007) as well as a randomly chosen year, 2001, for comparison purposes. This figure shows that the data are usually well recorded for the first six months of each year. The pump experienced its most active year of the four in 2006; however, the values are significantly lower than in 2001. The pump P-4 in well W-4 was changed in September 2007, and the recorded values show that there is a significant decrease in the on-time Oct and Nov 2007 when compared with Oct and Nov 2004 to 2006. The relatively high on-time throughout 2006 suggests that the pump was not performing satisfactorily during this year, as the well water inflow to the well could not be evacuated fast enough. As a result, pump on-time data might be a useful tool for the purpose of system maintenance. The decreased on-time values in the recent years in comparison to 2001 suggest that P-4 has become less active which should be considered carefully.

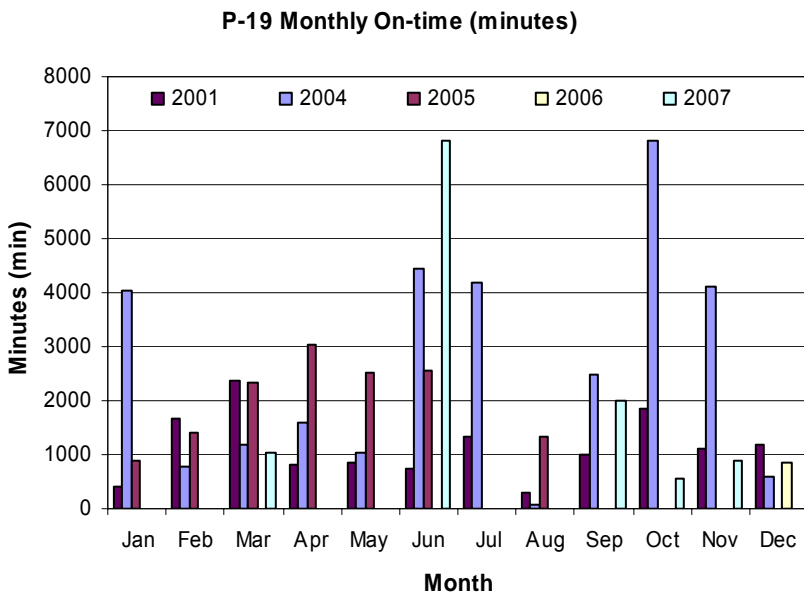
Figure 20 - Monthly on-time for pump no. 19 (P-19)

Figure 20 shows the on-time for pump no. 19. This figure suggests that the pump is generally inactive for years after 2005. This pump is located in the northern block where the water table level has significantly increased in the years after 2005.

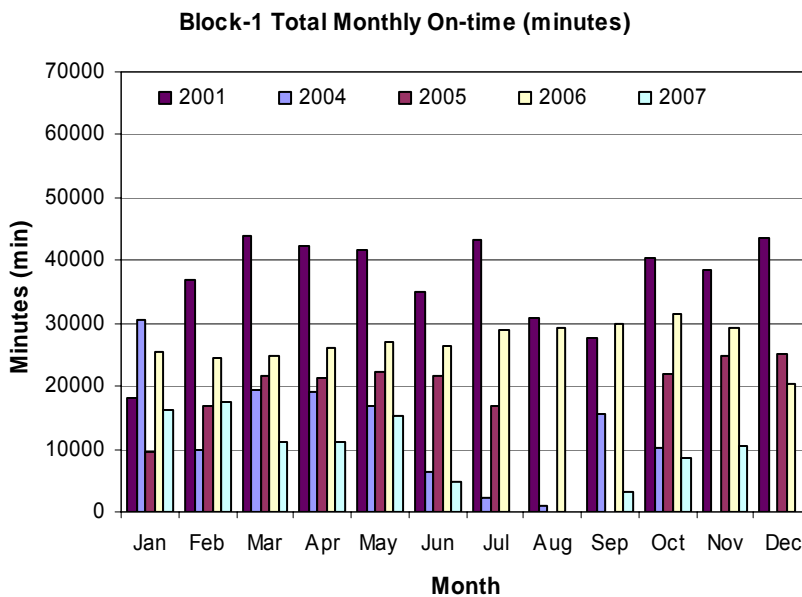
Figure 21 - Total monthly on-time for Block-1 (Southern Block)

Figure 21 depicts the total monthly on-time for the block 1 (Southern Block). The block experienced its most active time during year 2006, as a result of high pump no.4 activity; however, the on-time values are much less than the year of 2001.

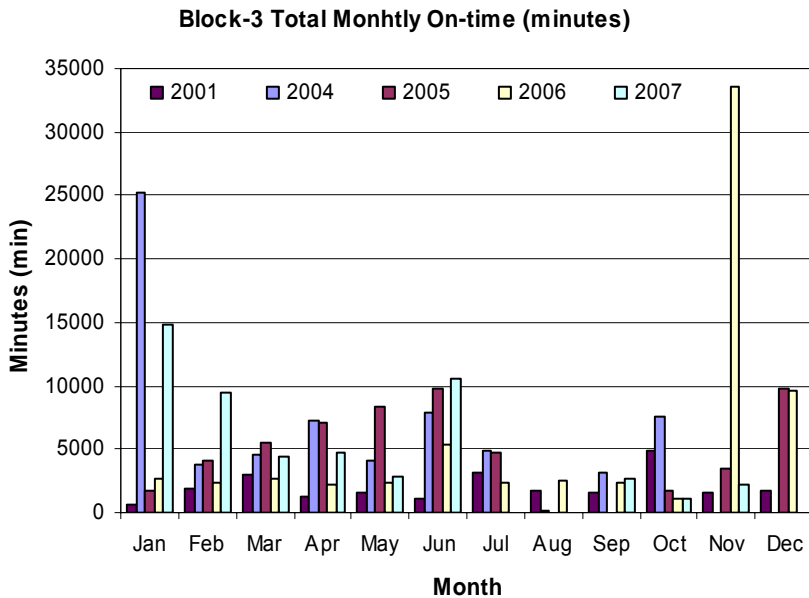
Figure 23 - Total monthly on-time for Block-3 (Northern Block)

Figure 23 confirms that Block-3 (Northern Block) is generally much less active than the other two blocks. The two monthly on-time values, Jan 2004 and Nov 2006, are significantly higher than the other years. This might be the result of inconsistent recordings of some on-time activities.
