1 Q. Provide a document that clearly outlines the retirement costs to take Holyrood out
2 of service 2017 (or beyond)? What is the cost to convert unit(s) to synchronous
3 condenser operation? Are these costs factored into the CPW analysis?
4

1 Q. With respect to Exhibit 19 (Muskrat Falls), has there been any detailed analysis
2 carried out relating to the clay spur and the effectiveness of the sump pump system
3 under impounded conditions (tests, simulations, experience of other dam
4 operators)? Please provide supporting documentation.

The purpose of this WTO was to determine the suitability of the pumpwell system installed in the north spur at the Muskrat Falls site with a view to a life extension of ten years. The review included an on-site inspection of the system to determine the present physical condition and operational characteristics.

CLIENT  		PRIME CONSULTANT  	
PROJECT TITLE LOWER CHURCHILL HYDROELECTRIC PROJECT ENGINEERING STUDIES		WTO NUMBER & TITLE MF-1260 CONDITION ASSESSMENT OF EXISTING EQUIPMENT	DRAWING TITLE SPUR LOCATION RELATIVE TO HAPPY VALLEY-GOOSE BAY
DATE: NOVEMBER 2007		PROJECT No. H325967	DRAWING No. FIGURE 1

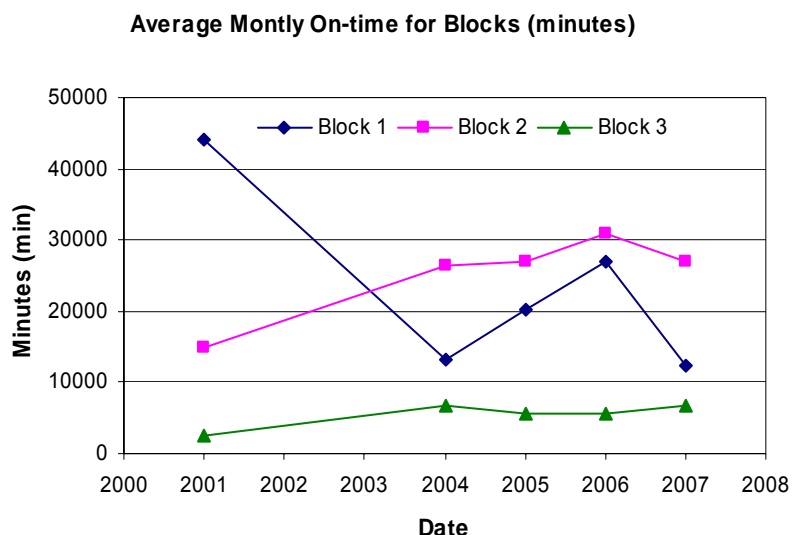
Figure 24 - Average monthly on-time for different blocks

Figure 24 shows the average monthly on-time for different blocks for the last four years. This figure shows that Block-2 (Central Block) is the most active block in the recent years followed by Block-1. While the on-time of Block-3 has been almost constant over the years, the other two blocks experienced the most active years in 2006 (other than 2001).

- Considering all the uncertainties in the dewatering system data recording and transmission as mentioned in Section 4.6, historical pump operation data indicates that the pumps in the northern block are generally inactive (Figure 24). The average monthly on-time of the northern block is significantly lower than the other two blocks. This observation is to be compared within an observed rise in groundwater levels in piezometers within this block. Despite the increase in the on-time hours in recent years in comparison to 2001, it is clear that pumping in the north block is inefficient.

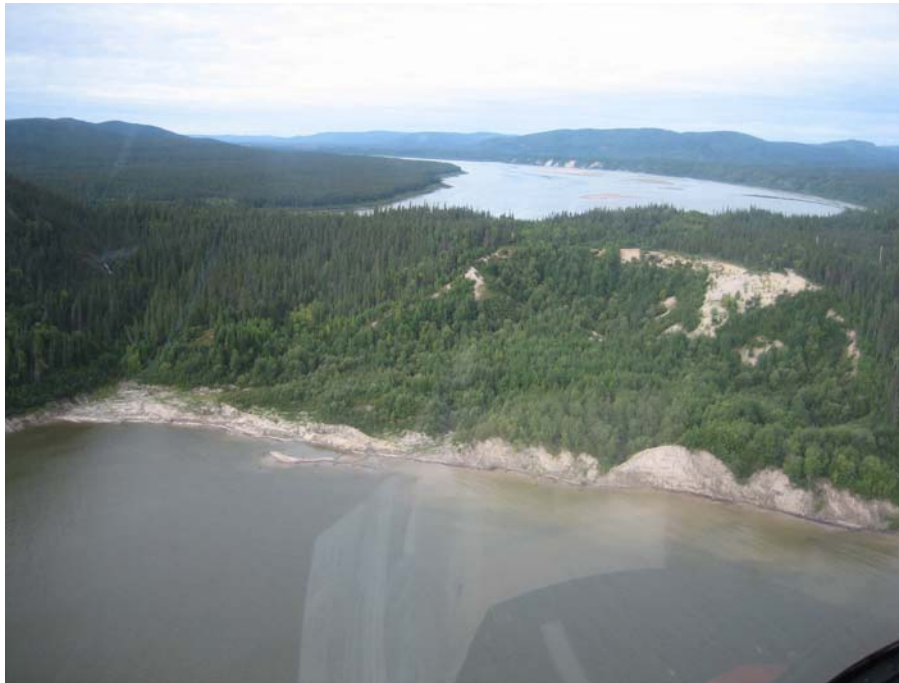
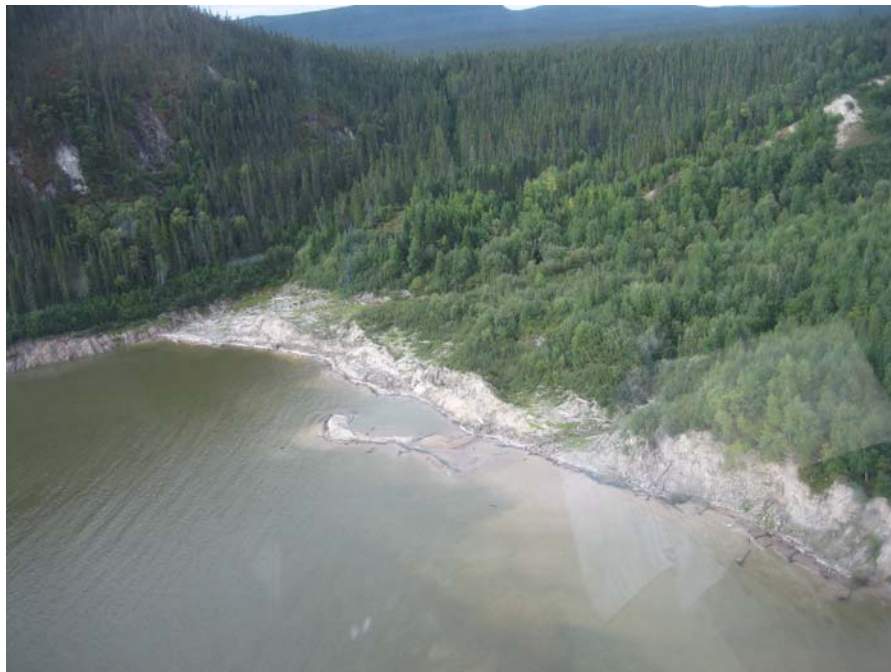
- Ongoing erosion and sloughing and active springs exist at the downstream toe of the spur.
- The upstream toe was also inspected and no significant erosion was observed.
- Access to the discharge point of the well system was difficult as the area was very overgrown.

Downstream slope (Site Visit -1)

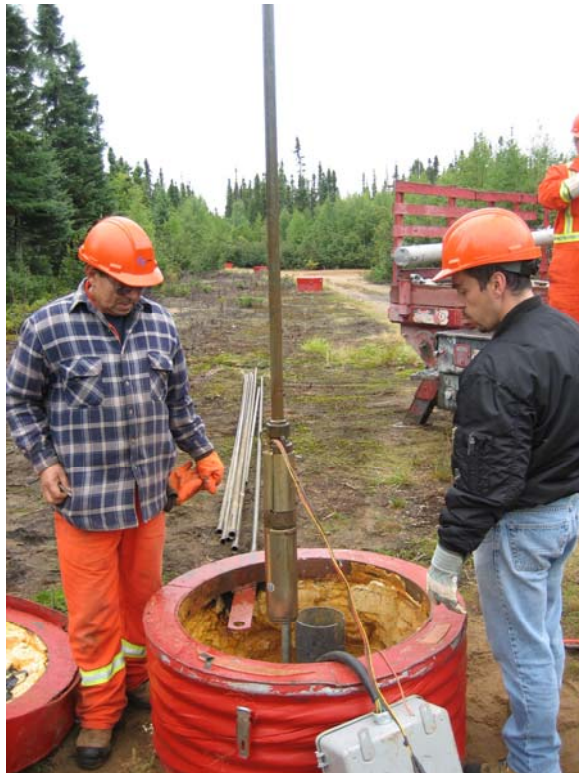
- During the site visit, the existing pump in W-4 was removed and a new pump was installed by Hydro. The replacement started about 10 am (September 11) and the system returned back to operation around 1 pm.
- Silt and fine sand were produced from W4 (observed in discharged water, the pump riser, and the pump) which may have intensified after 4 months of operation with a weaker pump (0.5 hp pump instead of 1.5 hp).
- The discharge from W4 has been reduced significantly as a result of a weaker pump.
- Silt and fine sand were also produced in Wells 9 and 10.

Pull-out of the pump in W4 (Site Visit -1)

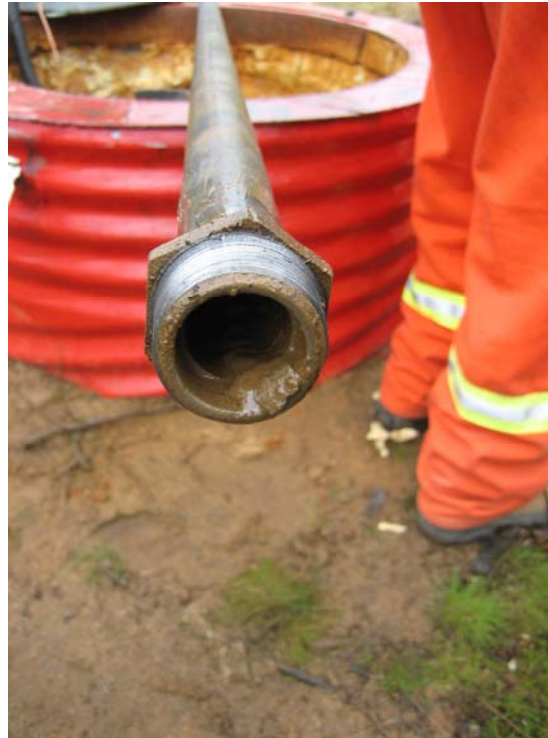
Silt and fines in W4 riser pipe (Site Visit -1)

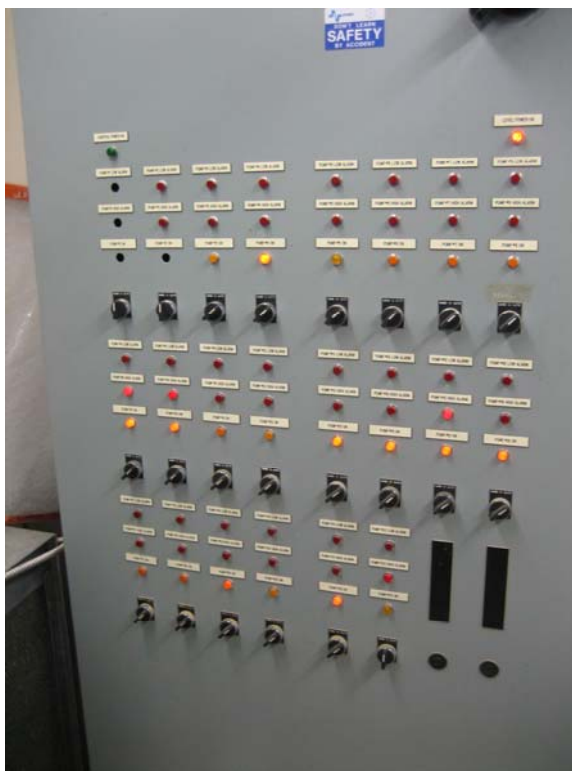
- The telephone operating via the Hawk 2 VHF radio had heavy static and was unable to transmit a call.
- W-10 relay underwent approximately 10 minutes of continuous switching between operating and high level alarms after power returned to the control panel (subsequent to system shutdown during W-4 replacement).

Control panel after system restoration (Site Visit -1)

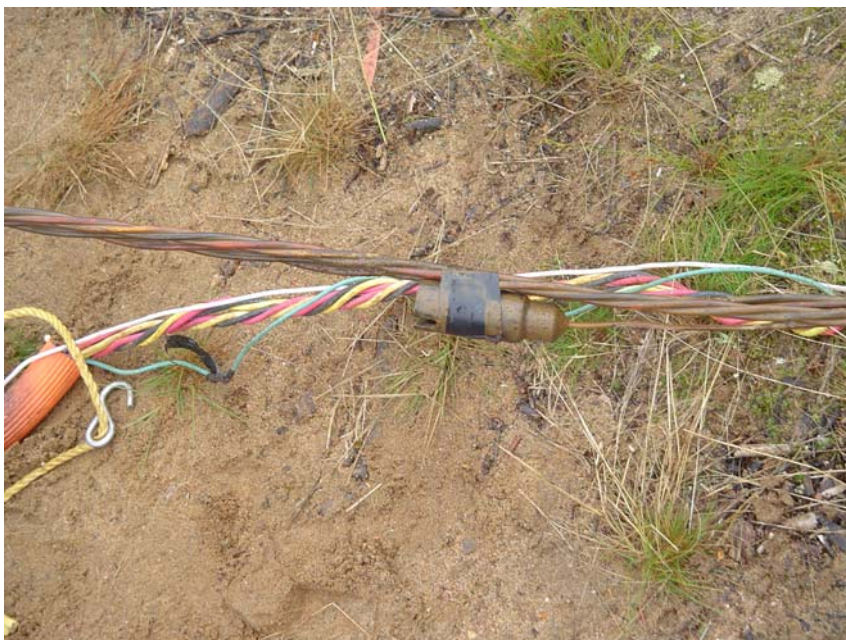
25kV Power to Control Shelter (Site Visit -1)

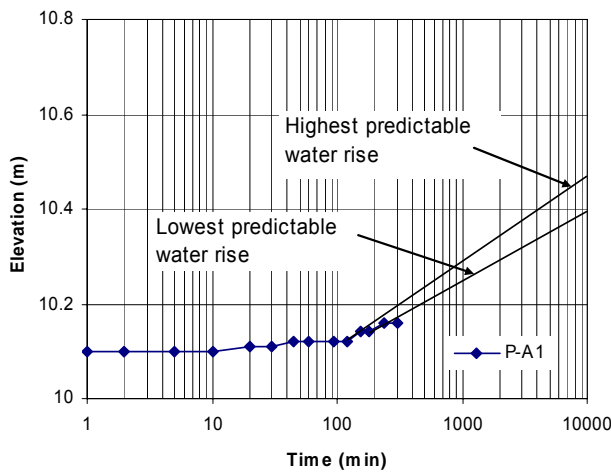
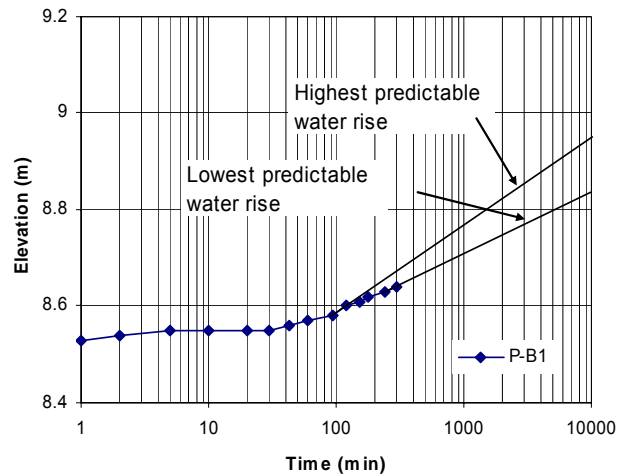
Figure B1 - Water level rise in piezometers using graphical method (a) P-A1 (lower tip), (b) P-B1 (lower tip)

It can be noticed that the level rise derived from the graphical method is considerably higher than the calculation method, about 1.6 to 2.4 times the graphical method. This is because in the graphical method, it is assumed that the rate of variation in logarithmic scale stays constant; however, as the water rises, hydraulic gradient decreases accordingly. It is recommended to consider the experimental results as conservative values as the experiments were performed for only 5 hours, which may not be considered long enough for a 7-day prediction.

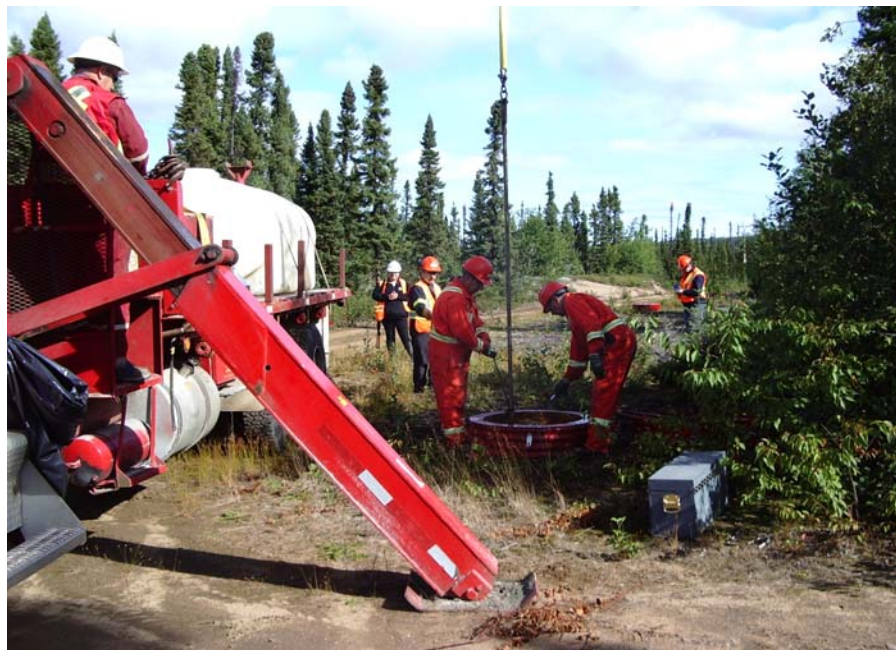
Photograph 2: The risers, wiring and pump were removed from each well.

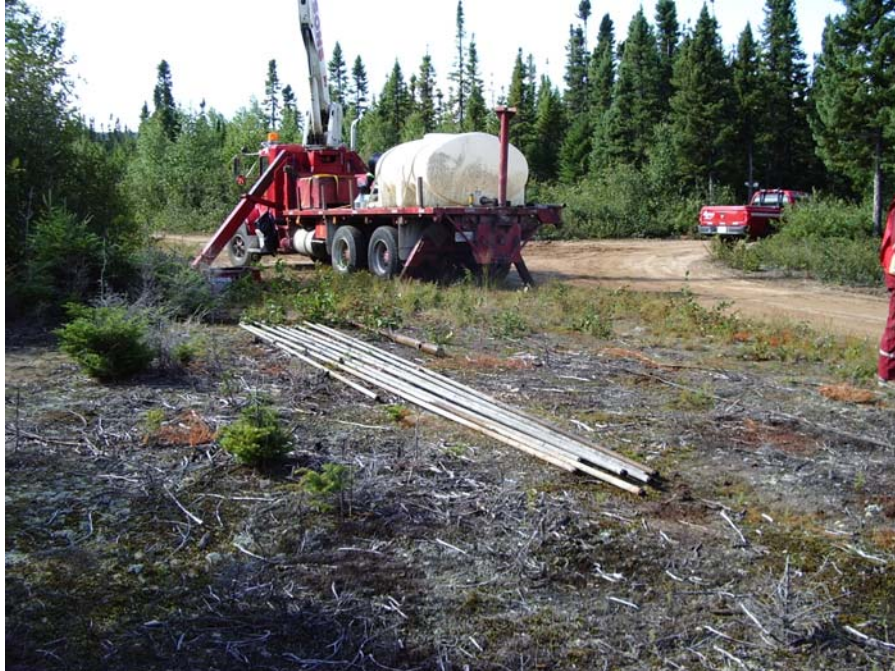
Photograph 3: The risers and pump were laid down on the ground for inspection.

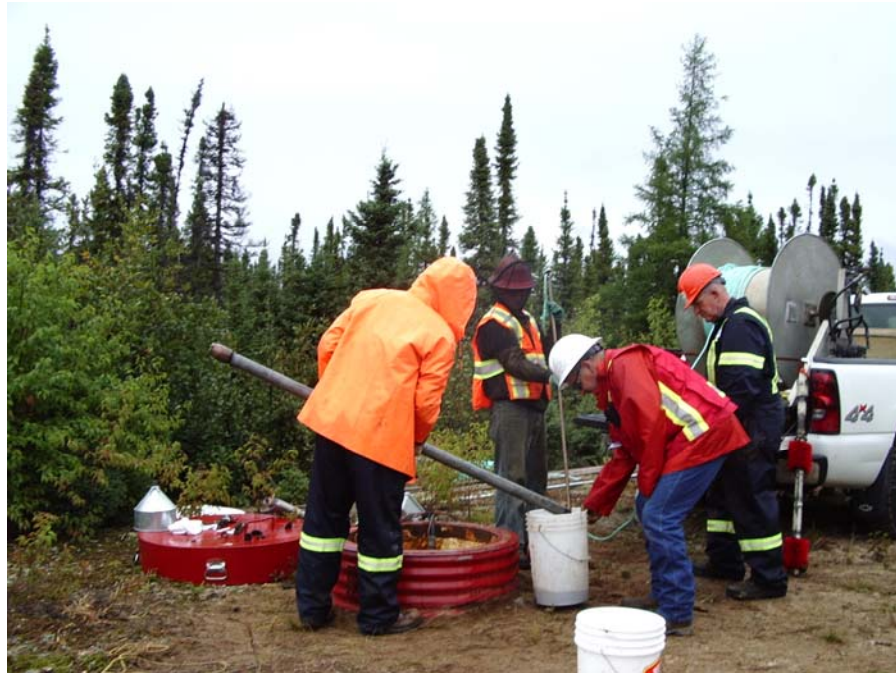
Photograph 9: A sand pump was placed down into the well, water and sediments were suctioned into the sand pump. The sand pump was brought to the surface and the sediments collected in a pail for examination.

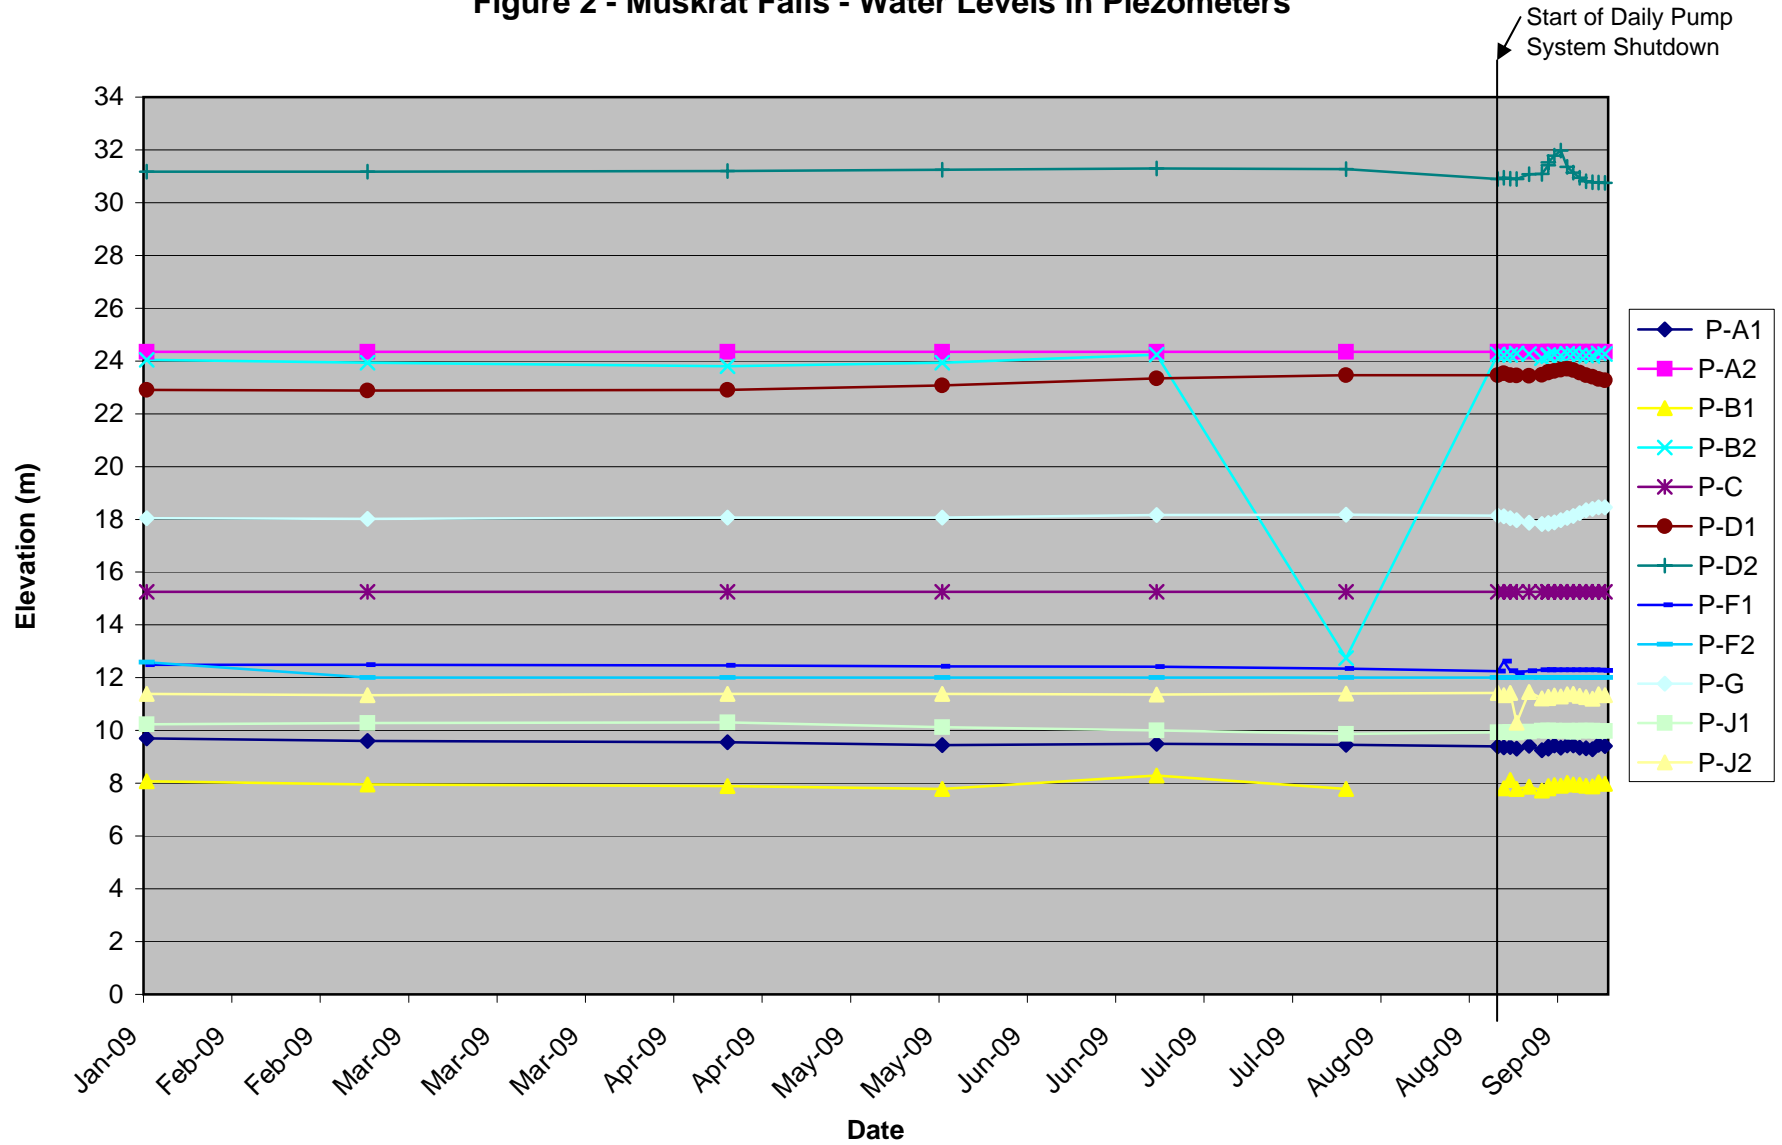
Figure 2 - Muskrat Falls - Water Levels in Piezometers

Figure 2 in Appendix C shows the water level elevations in the piezometers from January 2009 to September 8, 2009. The readings from August 27 to September 7 were taken during the full shutdown condition. The pumps were shut off completely through the work day for approximately 10 hours and then turned back on for the overnight period.

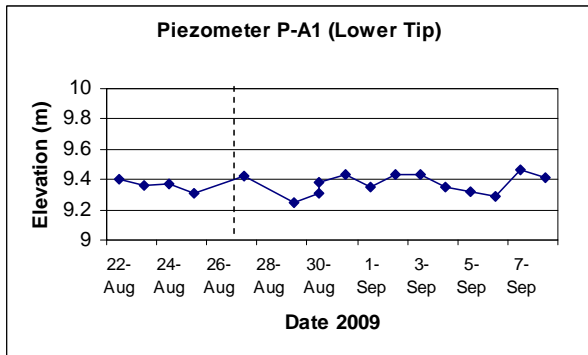
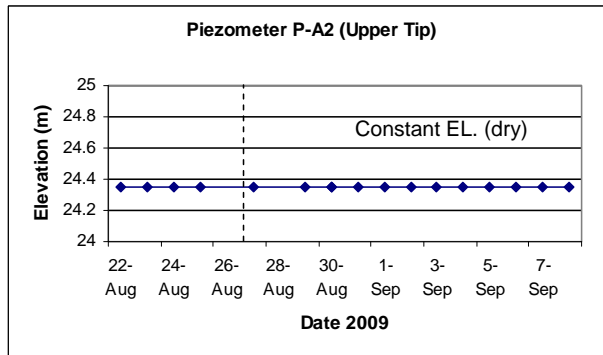
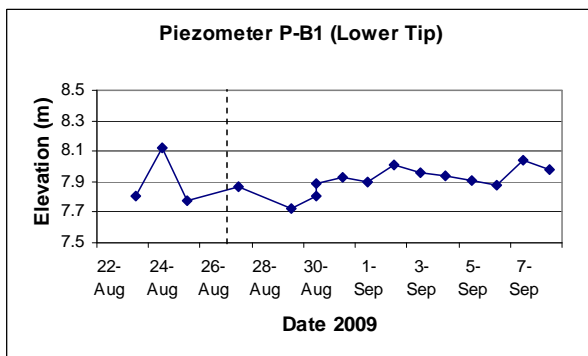
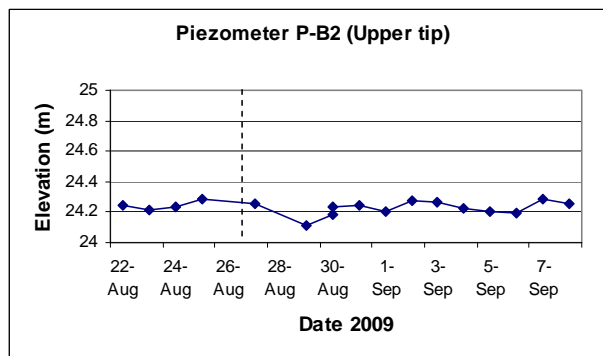
Figures 3, 4 and 5 show the water levels in each individual piezometer just prior to and during the well inspection program. In general, the water levels recovered by approximately 0.3 m to 0.6 m during the full shutdown with the exception of P-D-2, where the water level rose about 1.0 m (Figure 4 (c)).

Figure 3 – Piezometer water level variations prior to and during the well inspection program:

(a) P-A1 lower tip, (b) P-A2 upper tip, (c) P-B1 lower tip and (d) P-B2 upper tip. Note: Daily shutdown of pump system commenced on August 27, 2009, shown as vertical dashed line.

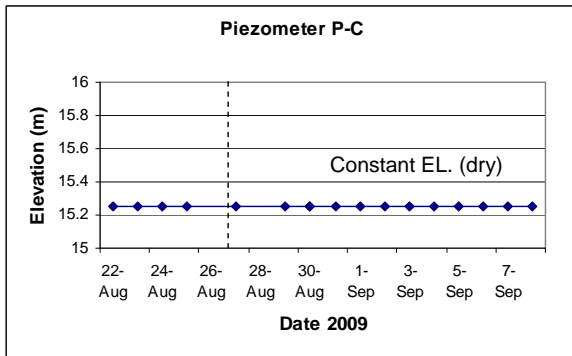
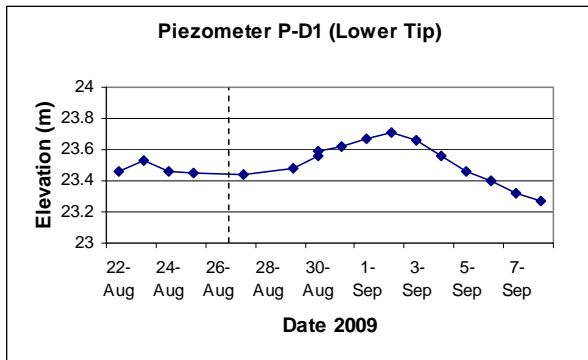
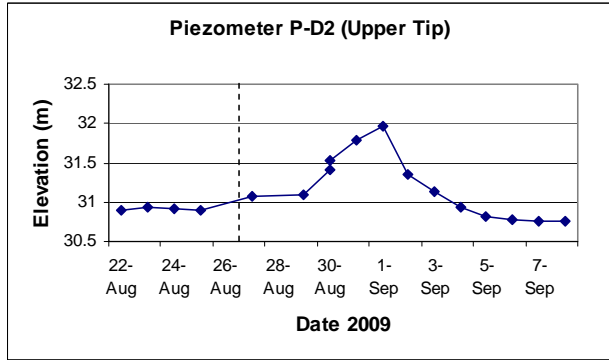
Figure 4 – Piezometer water level variations prior to and during the well inspection program:

(a) P-C, (b) P-D1 lower tip, (c) P-D2 upper tip. Note: Daily shutdown of pump system commenced on August 27, 2009, shown as vertical dashed line.

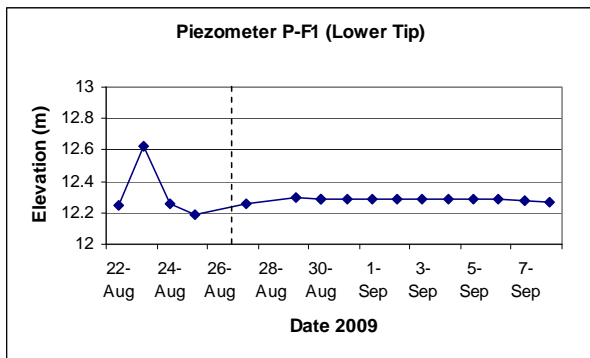
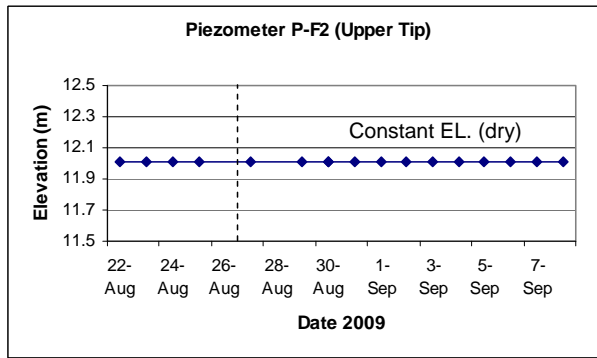
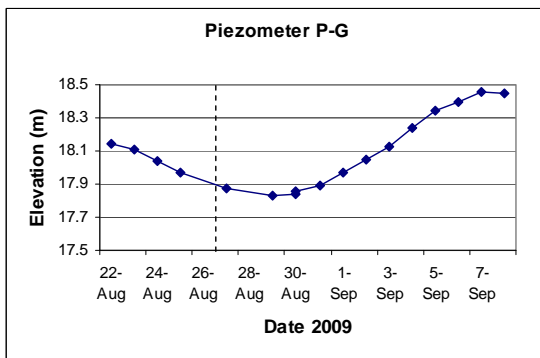
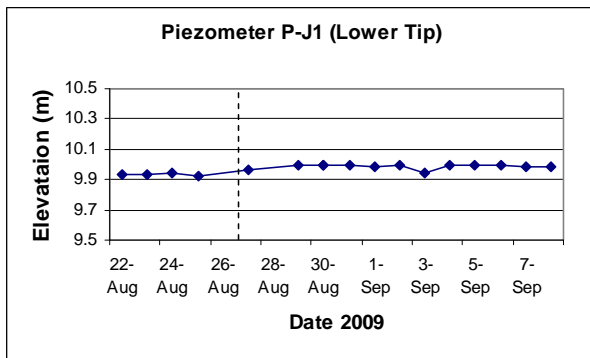
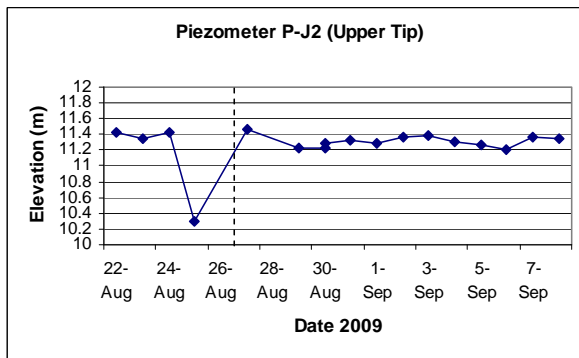
Figure 5 – Piezometer water level variations prior to and during the well inspection program:

(a) P-F1 lower tip, (b) P-F2 upper tip, (c) P-G , (d) P-J1 lower tip, (e) P-J2 upper tip. Note: Daily shutdown of pump system commenced on August 27, 2009, shown as vertical dashed line.
