**RELIABILITY STUDY
OF TRANSMISSION LINES
ON THE AVALON AND CONNAIGRE PENINSULAS**

REPORT PREPARED BY: Asim Haldar, Ph.D., P. Eng.
Sr. Engineer
Technical Support,
TRO Engineering

DATE: April, 1996

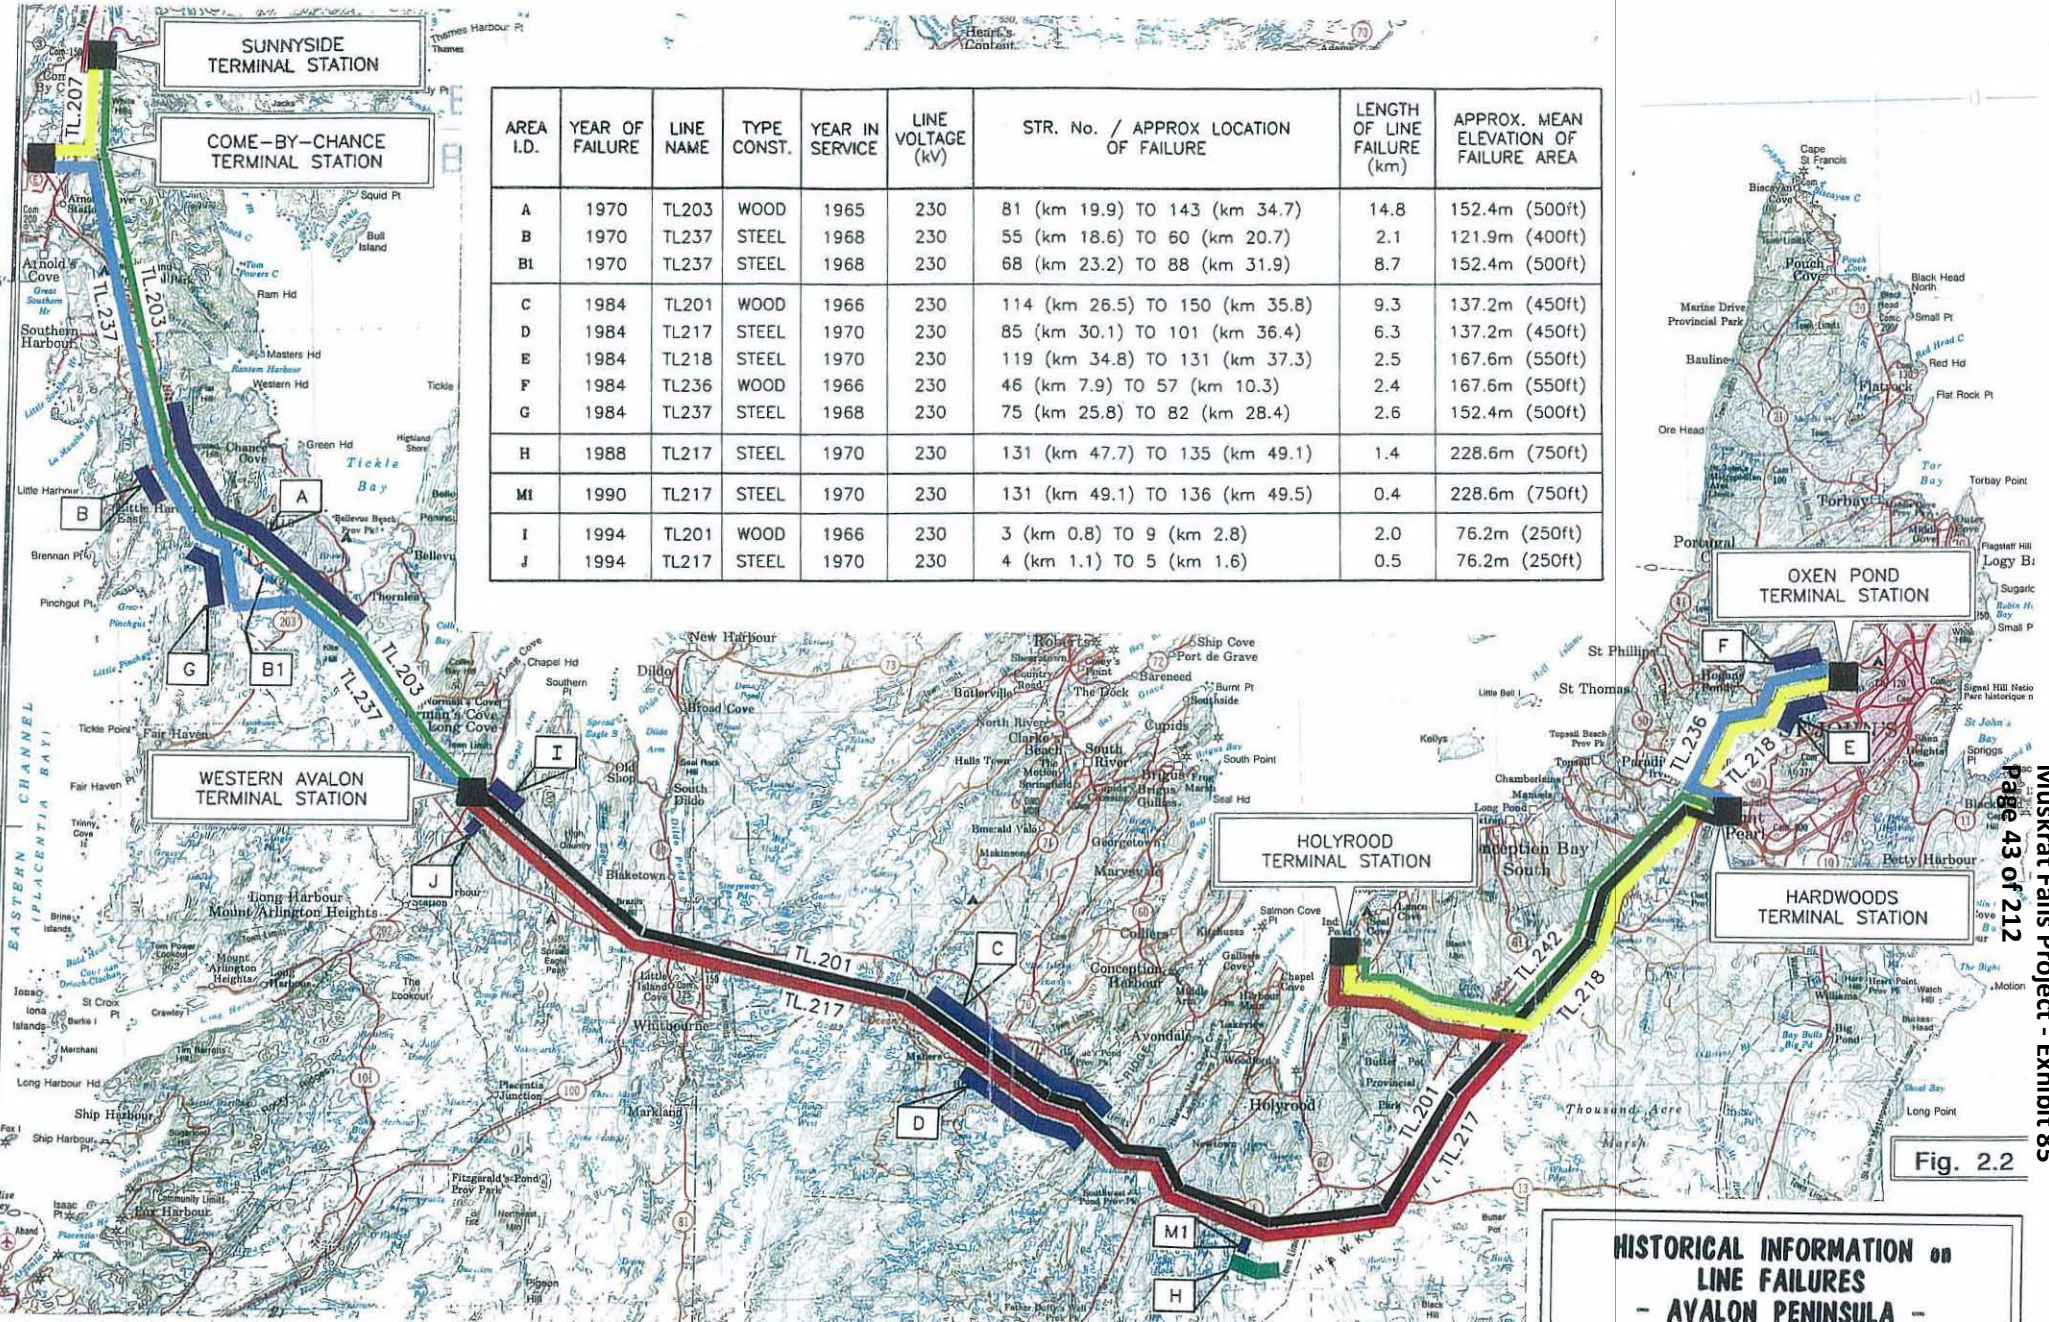
Fig. 2.3

AREA I.D.	YEAR OF FAILURE	LINE NAME	TYPE CONST.	YEAR IN SERVICE	LINE VOLTAGE (kv)	STR. No. / APPROX LOCATION OF FAILURE	LENGTH OF LINE FAILURE (km)	APPROX. MEAN ELEVATION OF FAILURE AREA
A	1970	TL203	WOOD	1965	230	81 (km 19.9) TO 143 (km 34.7)	14.8	152.4m (500ft)
B	1970	TL237	STEEL	1968	230	55 (km 18.6) TO 60 (km 20.7)	2.1	121.9m (400ft)
B1	1970	TL237	STEEL	1968	230	68 (km 23.2) TO 88 (km 31.9)	8.7	152.4m (500ft)
C	1984	TL201	WOOD	1966	230	114 (km 26.5) TO 150 (km 35.8)	9.3	137.2m (450ft)
D	1984	TL217	STEEL	1970	230	85 (km 30.1) TO 101 (km 36.4)	6.3	137.2m (450ft)
E	1984	TL218	STEEL	1970	230	119 (km 34.8) TO 131 (km 37.3)	2.5	167.6m (550ft)
F	1984	TL236	WOOD	1966	230	46 (km 7.9) TO 57 (km 10.3)	2.4	167.6m (550ft)
G	1984	TL237	STEEL	1968	230	75 (km 25.8) TO 82 (km 28.4)	2.6	152.4m (500ft)
H	1988	TL217	STEEL	1970	230	131 (km 47.7) TO 135 (km 49.1)	1.4	228.6m (750ft)
M1	1990	TL217	STEEL	1970	230	131 (km 49.1) TO 136 (km 49.5)	0.4	228.6m (750ft)

I	1994	TL201	WOOD	1966	230	3 (km 0.8) TO 9 (km 2.8)	2.0	76.2m (250ft)
J	1994	TL217	STEEL	1970	230	4 (km 1.1) TO 5 (km 1.6)	0.5	76.2m (250ft)

**HISTORICAL INFORMATION on
LINE FAILURE (TL.220)
- CONNAIGRE PENINSULA -**

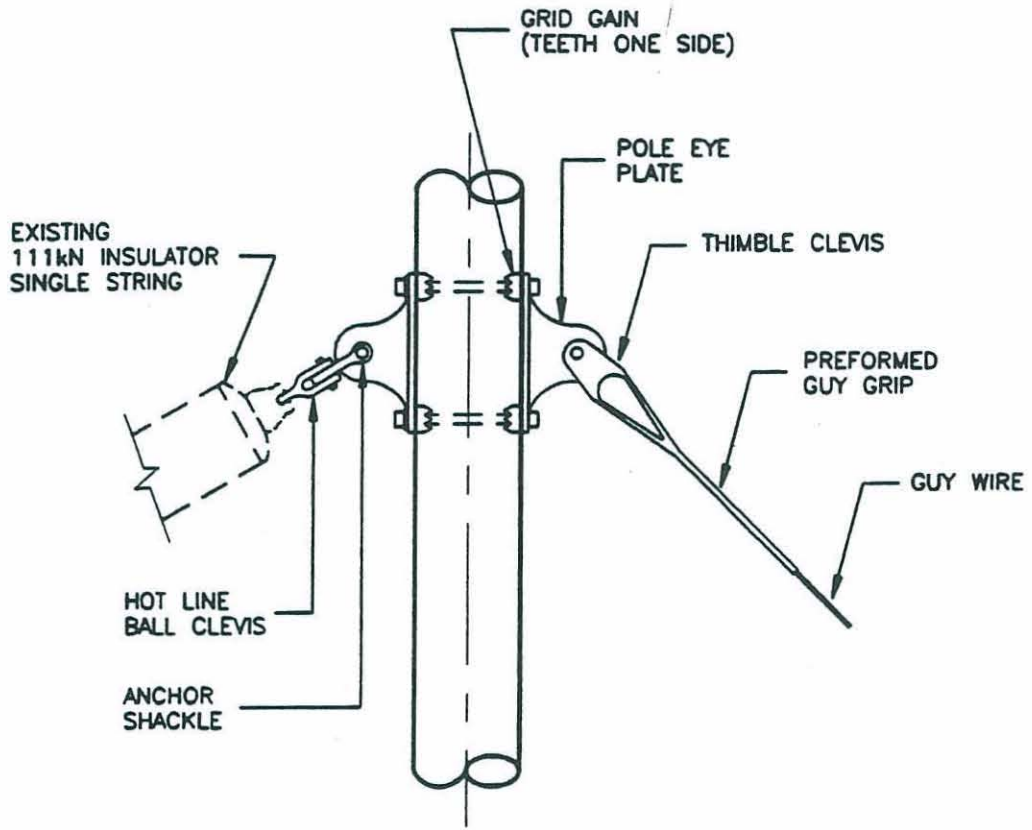
FIGURE 2.7

During this sleet storm, a number of lines that failed are detailed in Table 2.3. TL201 failed due to significant movement of a guying arrangement at a large angle structure location and this guying arrangement was subsequently modified (refer Fig. 2.7) under Work Order No. 5092 and implemented at various locations by Hydro forces in 1985. Failure of TL217 was also caused due to the collapse of a large angle (self-supported) structure (C-Type) thus causing a severe cascading failure. TL237 failure was primarily caused due to the conductor breakage in tension under 1.60 inches (41 mm) radial ice load. In all areas, ice load far exceeded the original design criteria and more than 2.0 inches (50 mm) of radial ice was observed at various places (refer Photos #2.1 and #2.2).

POLE EYE PLATE ARRANGEMENT ON
230kV ANGLE STRUCTURE TYPE "C" - TL201 & TL203
(REPLACES EXISTING GUY HOOK & BALL LINK EYE BOLT ARRANGEMENT)

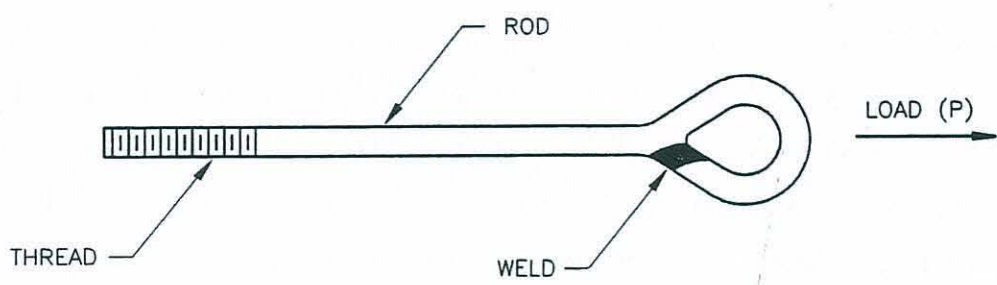
FIGURE 3.1

Eye bolts received from the failed line were taken to the strength laboratory of Memorial University and a direct pull test was performed on each bolt sample. Fig. 3.1 depicts the direction of the pull with the Table 3.2 presenting the mean value and standard deviation of the rated strength. Minimum guaranteed rated strength of this bolt should be approximately 25,000 lb (based on 3 standard deviation) with a coefficient or variation of 5%. One (1) failure out of four (4) tests occurred at the weld where it opened prematurely. Strength reported under Test No. 5 was not carried out at the laboratory rather estimated based on the strength coordination of heavily loaded iced conductor with the failure of the welded eye bolt. In this case, conductor did experience approximately 1 1/2 ~ 2.0 inches (38 mm - 50 mm) radial ice on December 8, 1994 (refer Photo #2.5) between structure #2 and #3 with a span of 2039 feet (620 meters). It is estimated that conductor tension will be approximately 24,000 lb under this load which is very close to the strength of these bolts considering the failure occurring at weld.

WELDED EYE BOLT

TABLE 3.2 WELDED EYE BOLT TEST OBSERVATIONS				
TEST No.	FAILURE LOAD (lbs)	MEAN (lbs)	STD. DEVIATION (lbs)	REMARKS
1	31,050	31,360	6,272	FAILED AT WELD; ROD O.K.
2	40,600			FAILED AT THREAD; WELD O.K.
3	24,000			WELD CRACKED; ROD O.K.
4	37,500			FAILED AT MIDDLE OF ROD
5*	25,000*			FAILED AT WELD (RECOVERED FROM SITE)

To improve the strength of the conductor hardware assembly, it is recommended that all welded eye bolts should at least be replaced by forged eye bolts where the strength of the bolt will only be governed by failure occurring at the threaded root. However, this still will not provide adequate strength when ice load on the conductor is being exceeded. TL201 and TL217, in general, have experienced 4 major failures (combined) in the past 30 years (Table 2.11), with an average failure rate of 1 failure in 7.5 years. TL201 alone has experienced 2 major failures in the past 30 years i.e.: 1 failure in 15 years (Table 2.9). Table 4.6 provides information on probability of encountering an ice storm as 49% (third storm) which is quite high when compared to a 50-year load which is only 5%. As these lines were designed with ice load as 1.0 inch (25 mm) radial which has been underestimated severely with regard to a real 50-year load, probability of a line failure, in future, is extremely high. Therefore, standard dead-end assembly shown in Fig. 5.3 is strongly being recommended in view of Item (d) in Section 5.4.1. To improve the strength of the conductor itself, several discussions were held with Aluminum Company of Canada (ALCAN) (Ref. 14) and it was suggested that a high strength special alloy conductor (equivalent to "Drake" 795 ACSR 26/7 in ampacity) be used for re-conductoring option. Strength of this 804 kcmil conductor is twice that of "Drake" and Table 5.6

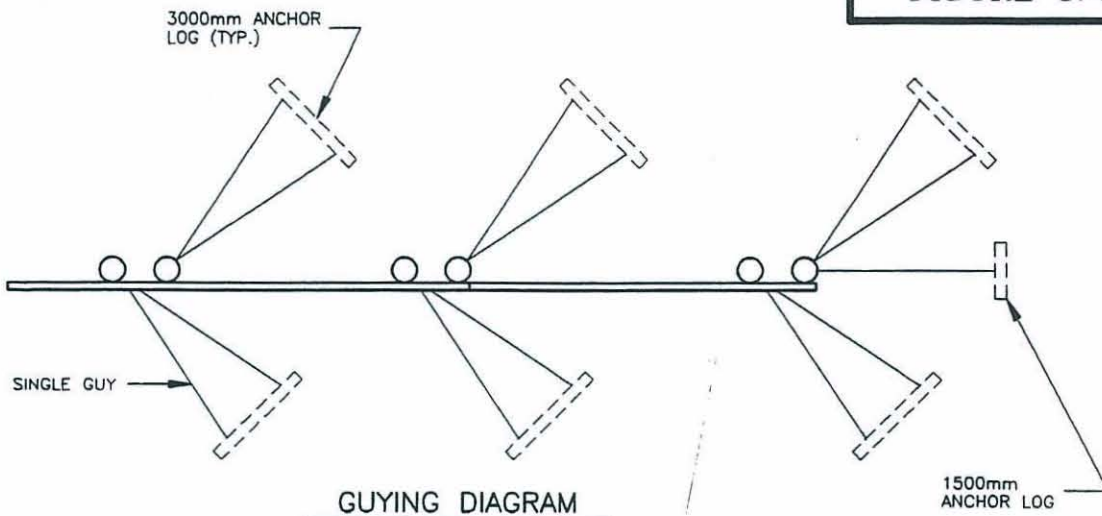
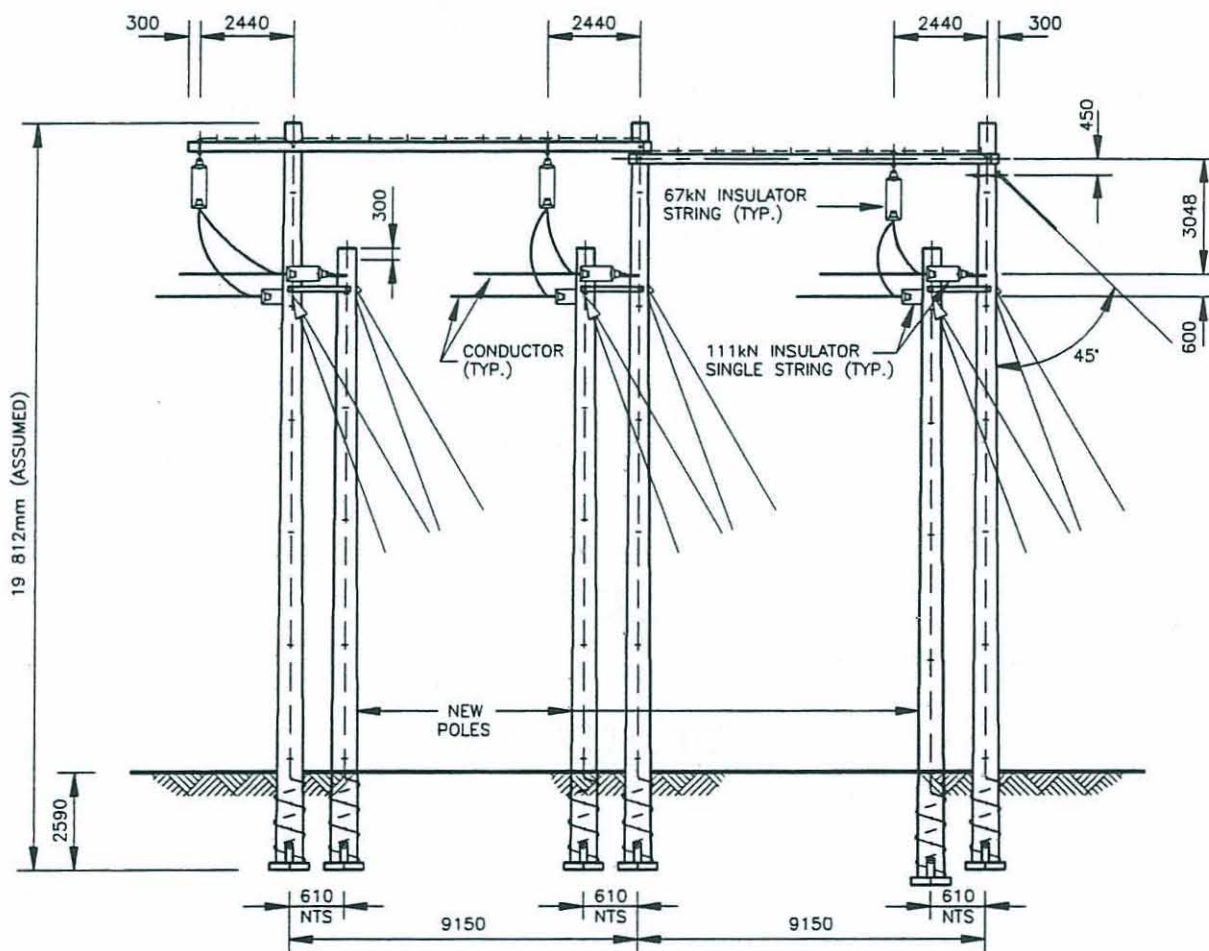
One of the weaknesses that has generally been observed in lines on Avalon Peninsula is minimum protection against failure containment loads (security requirements) particularly with regard to wood pole lines such as TL201. There may have been more than seventy (70) structures placed in "series" without any

TYPICAL 230kV STRUCTURE TYPE "D"
UPGRADED TO 6 POLE DEADEND
(ANGLE DEADEND - NORMAL ZONE - TL201)

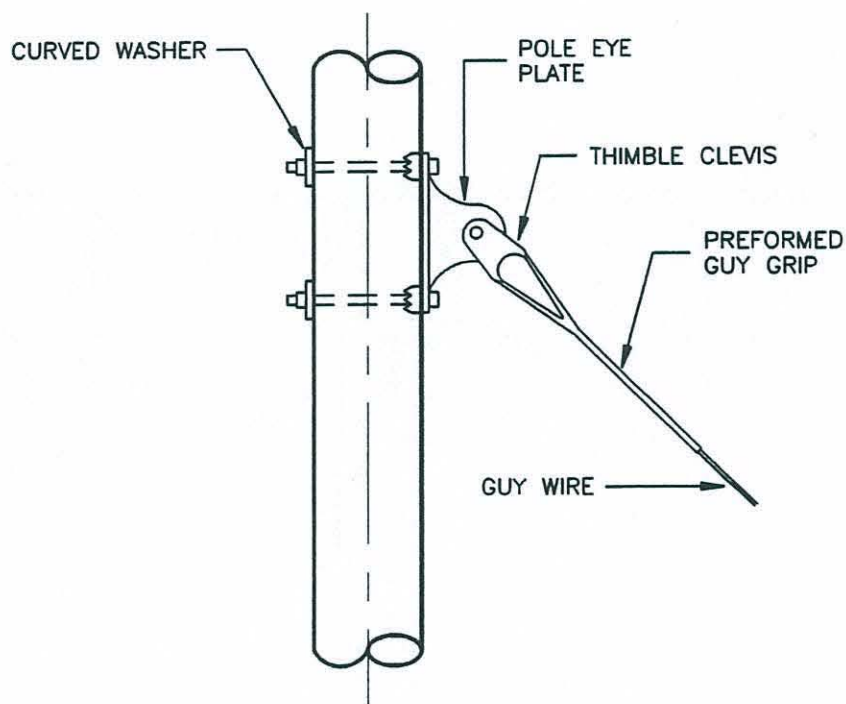
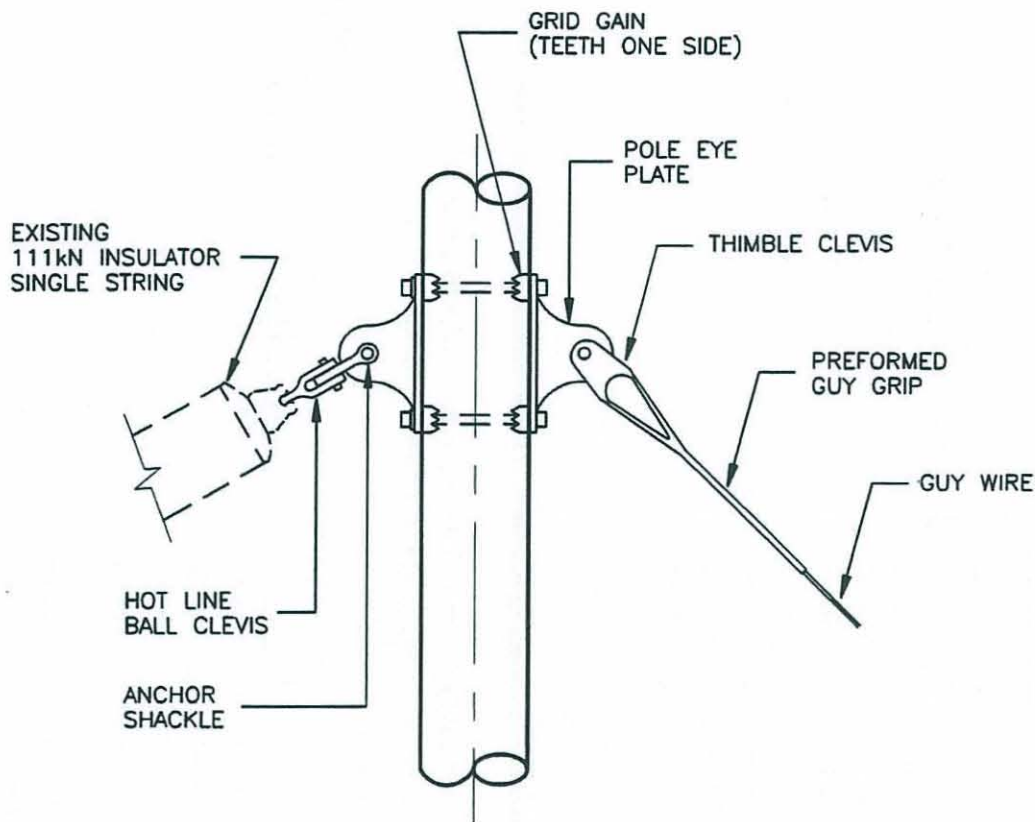
FIGURE 5.5

POLE EYE PLATE ARRANGEMENT ON
230kV ANGLE STRUCTURE TYPE "B" - TL201 & TL203

(REPLACES EXISTING GUY HOOK ARRANGEMENT)

POLE EYE PLATE ARRANGEMENT ON
230kV ANGLE STRUCTURE TYPE "C" - TL201 & TL203
(REPLACES EXISTING GUY HOOK & BALL LINK EYE BOLT ARRANGEMENT)

This option includes implementation of all works associated with installation of full dead-end assembly on all existing dead end structures (Fig. 5.3). These are 19 on TL201, 43 on TL203 and 11 on TL236 respectively. In addition, scope of work includes installation of pole eye plates (Fig. 5.5 and 5.6) on light and medium angle wood pole structures (11 structures on TL201 and 1 structure on TL203, respectively) and replacement of fifteen (15) type F structures (uplift structures) on TL201, six (6) on TL203 by dead-end. Under this option, six (6) dead-end (anti-cascading) structures on TL201, two (2) on TL203 and eleven (11) on TL236 will be added to wood pole lines with particular reference to security containment. For steel tower lines, one (1) structure on TL207, three (3) structures on TL237, four (4) structures on TL217 and two (2) structures on TL218 will be added as anti-cascading towers with particular reference to security containment. Even though reliability increase will be marginal, security will be improved substantially.

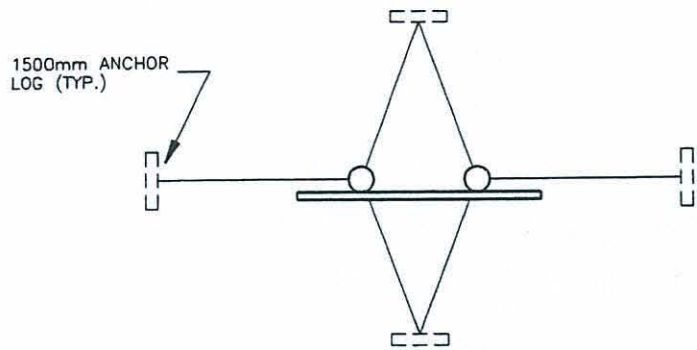
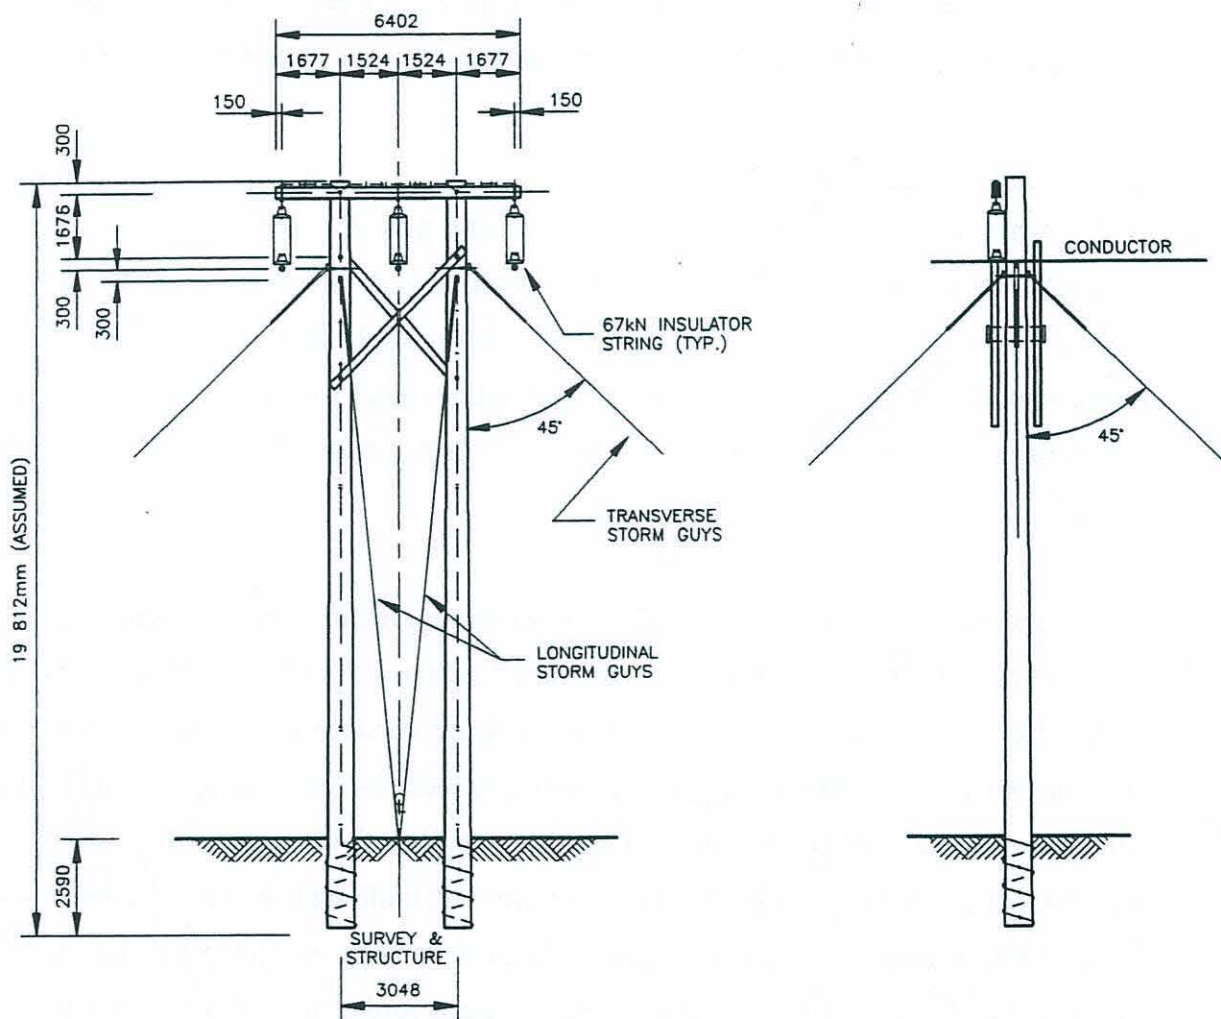
FIGURE 5.7

EXISTING 69kV STRUCTURE TYPE "A"
WITH STORM GUYS ADDED

(TANGENT - TL220)

The suggested improvement of TL220 is based on upgrading and/or building a new section of the line to revised 50-year, return period load as 2.0 inches radial (refer Table 4.10). Conductor was chosen as a 559 Kcmil Alloy conductor and typical structure would be wood pole H-Frame. Upgrading would include re-conductoring 17 km section from Str. #89 to English Harbour station by installing double crossarms on every structures, strengthening 3-pole dead-end structures etc; building new line sections would include approximately 18 km to 35 km of lines depending on the particular option selected. Details of these various options are discussed further in Section 7. Due to one (1) wind storm damage earlier, Fig. 5.7 presents the typical storm guying arrangement that needs to be implemented on TL220.

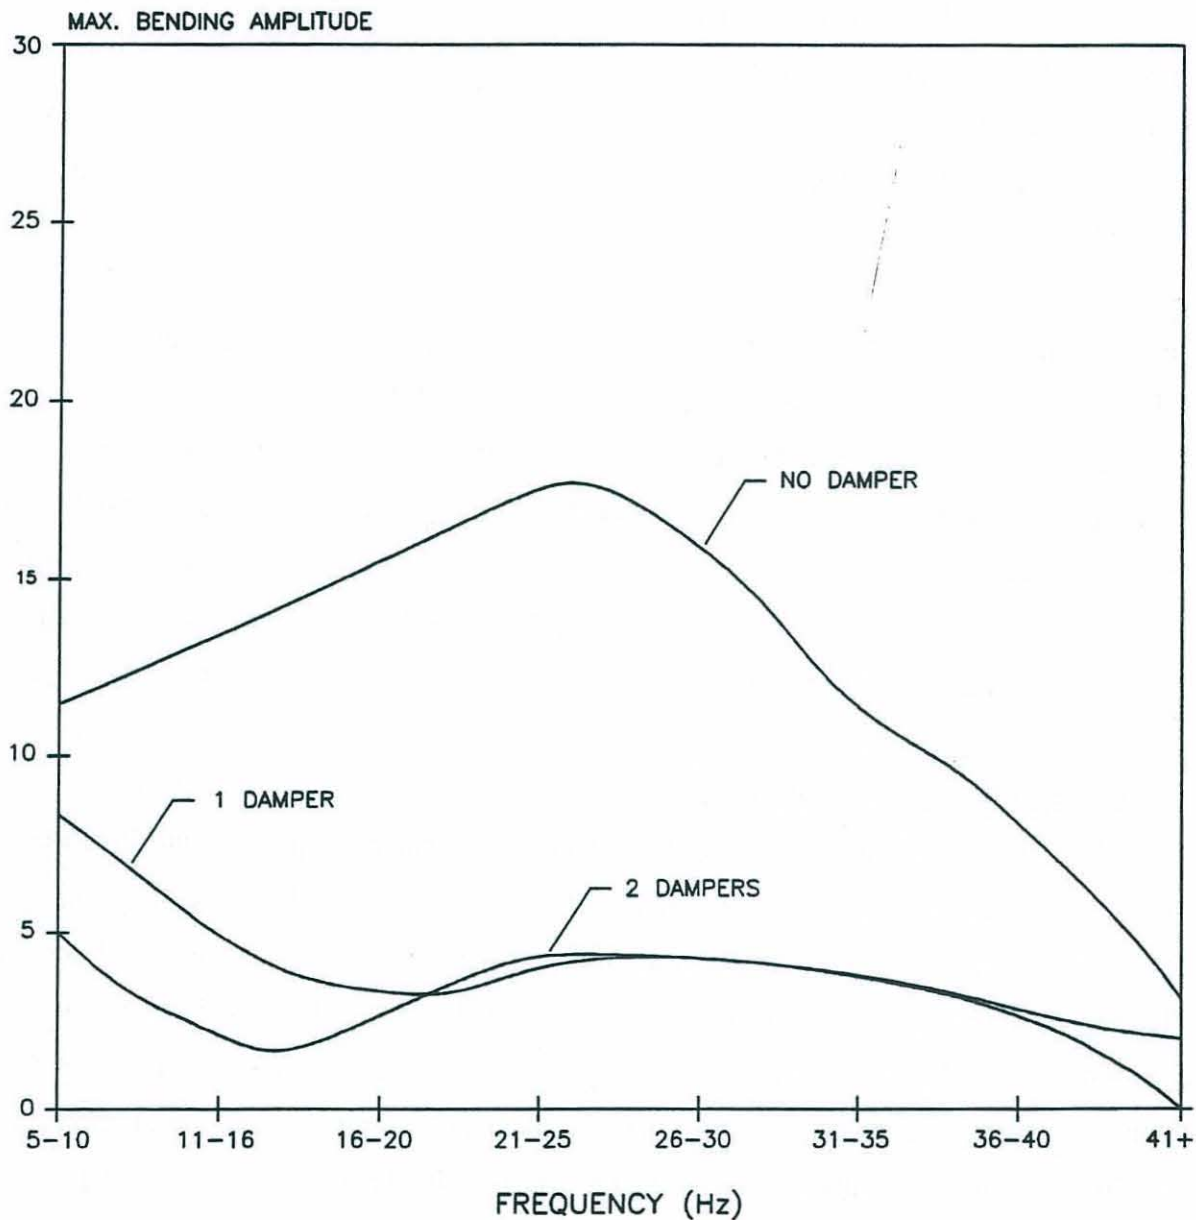
The results of this study indicated that the line would face severe problems without dampers and, in certain cases, two (2) dampers per span were required. In many places, it was observed that dampers were not in the proper position; i.e., at antinode points, and the condition of these dampers was in poor shape. A typical stockbridge damper can withstand one hundred (100) million cycles of vibration with certain amplitude levels. Field measurements in TL217 indicated that line could have a central frequency of vibration 20-25 cycles/second with no damper, one damper and two dampers (refer Fig. 6.1). This control frequency of vibration relates to a steady laminar wind of 5 - 6 mph and will provide an expected service life of five to ten years for a typical damper. Therefore, on-line monitoring is very important to ensure that these dampers are working effectively to reduce bending near the clamp to an acceptable level (EPRI, 1979).

MAX. BENDING AMPLITUDE VS. FREQUENCY AUGUST 30, 1991 - MARCH 17, 1992
